**STRUCTURAL DATA RECORD****Sufficiency Rating: 83.0****IDENTIFICATION**

Bridge ID: 1748N059	(2) District: 01	(3) County: 3
Inventory Route:	(B) Highway Type: 1	(4) Place Code: 77580
(A) On/Under: 1	(E) Direction: 0	(C) Service Lvl: 1
(D) Route No: 00095		6B) Critical: *
6A) Features Intersected: SR 4		11) Km. Point: 4.220 mi
(7) Facility Carried: I 95 NB		
(9) Location: SOUTH WILMINGTON VIADUCT		
16) Latitude: 39^44'26.24"	17) Longitude: 75^33'44.14"	
98) Border Bridge Code: NA	99) Border Br. Str. No.: NA

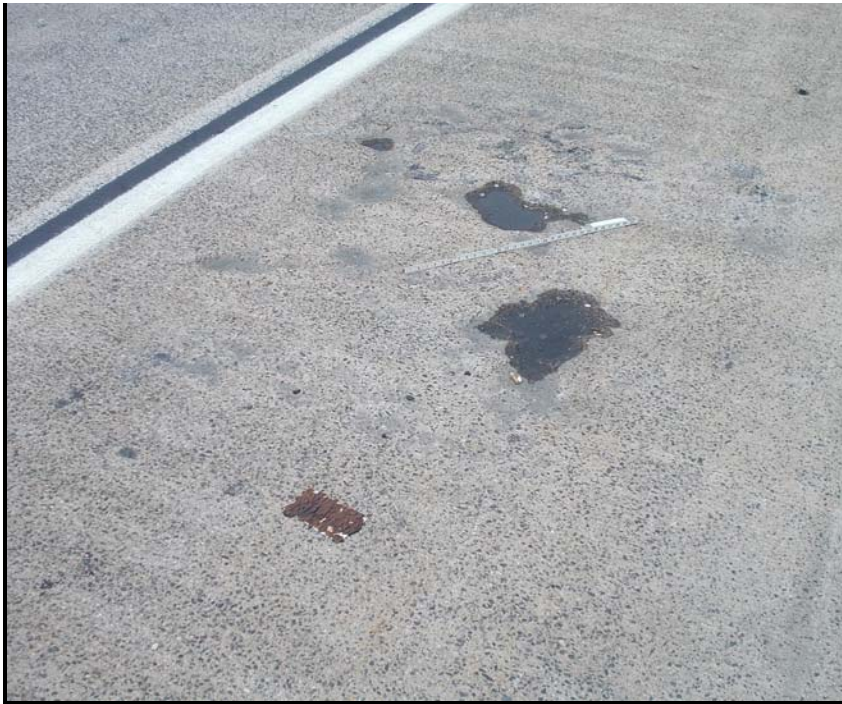
ELEM	ENV	DESCRIPTION	UNITS	TOTAL	CS1	CS2	CS3	CS4	CS5	COMMENTS
22	4	P Conc Deck/Rigid Ov	(SF)	99006	0	99006	0	0	0	CS2: (99006 SF) Typical wear with exposed aggregate. Span 32: Area of fire damage in East shoulder (30 SF) (see Photo 19). Span 40: Area of fire damage up to 1-inch deep (20 SF).
65	4	Drainage	(EA)	1	0	0	1	0	0	CS3: (1 EA) Scupper clogged (see Photo 22), downspout with section intentionally removed at bottom.
300	4	Strip Seal Exp Joint	(LF)	42	0	42	0	0	0	CS2: (42 LF) Filled with debris at the shoulder, depressed and debonded areas with active leakage in Bay 3.
321	4	R/Conc Approach Slab	(EA)	0	0	0	0	0	0	0
107	3	Paint Stl Opn Girder	(LF)	436	295	134	7	0	0	CS2: (134 LF) Localized areas of minor spot corrosion on bottom flanges or top flange edges. CS3: (7 LF) Beam 1 end at Pier 27N and random areas with exposed steel to the flanges at the corroded drain holes in the deck. The west edge of the top flange at Beam 1 exhibits painted pitting with flaking paint and active corrosion. The east bottom flange of Beam 1 exhibits flaking paint with exposed and corroded steel. CS4: (0 LF) The previously noted corrosion and section loss in Beam 1 at Pier 26N was not observed during the 2013 inspection.

19. Span 32, East Shoulder, looking north - Fire damage.

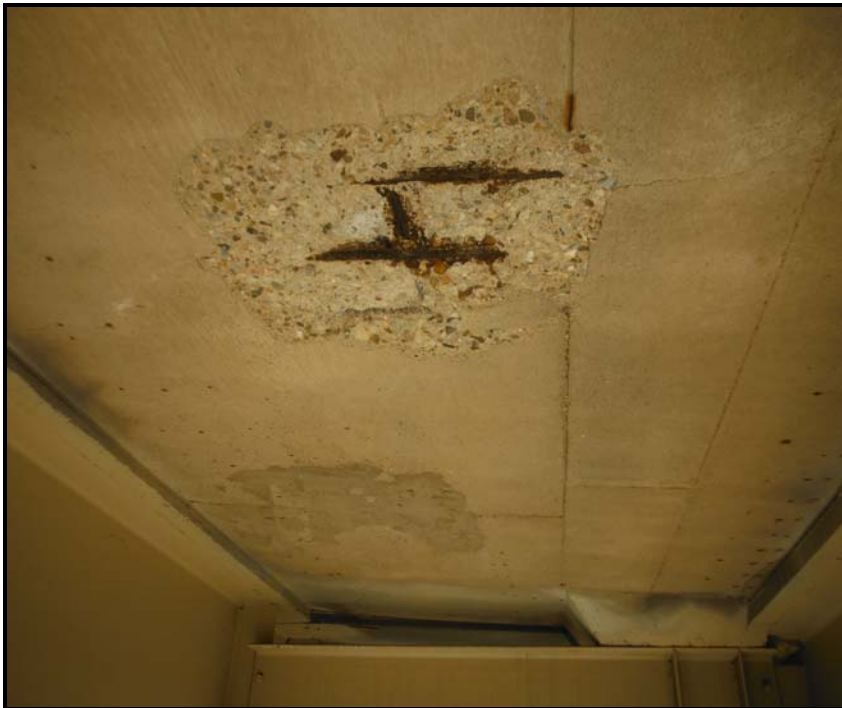
20. Span 42, Bay 5 at N. end - 26" L x 22" W x 2" D spall w/ exp corr steel reinf.

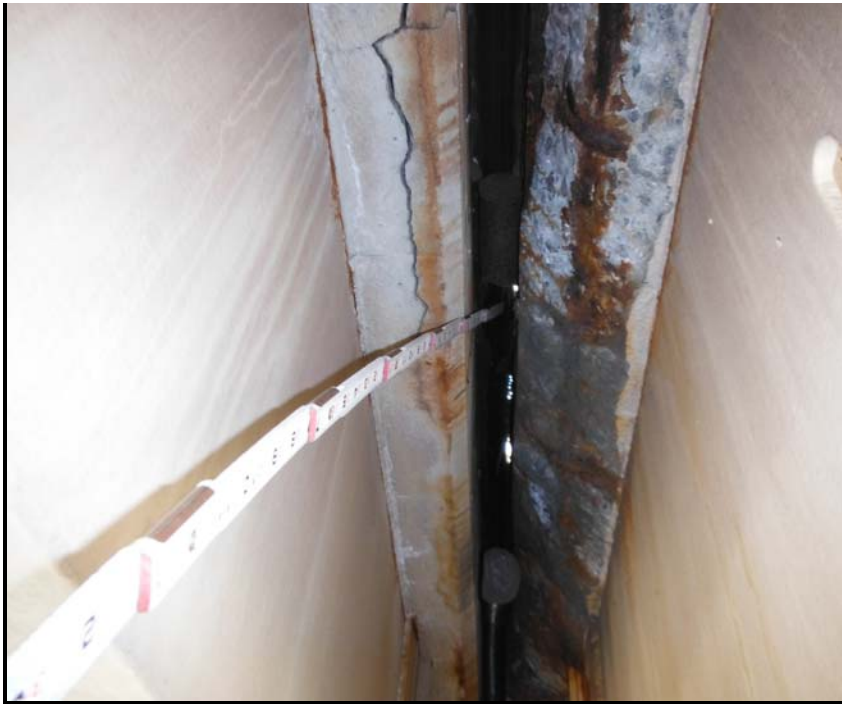
21. Span 54, Bay 3 n. haunch - 7' L x FW x 4" D spall w/ exp corr steel reinf.

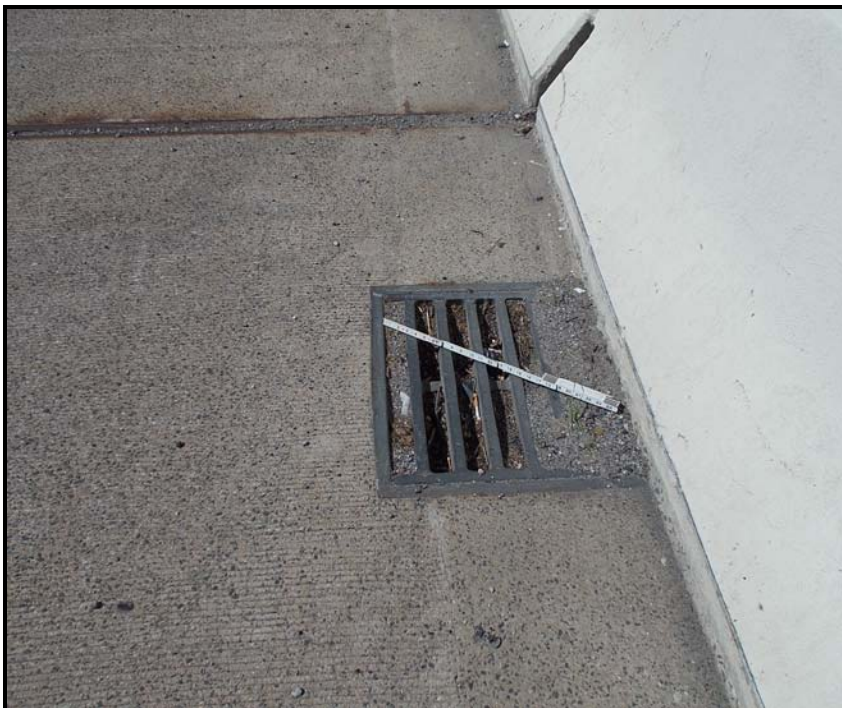
22. Span 27, East Shoulder - Typical clogged scupper.

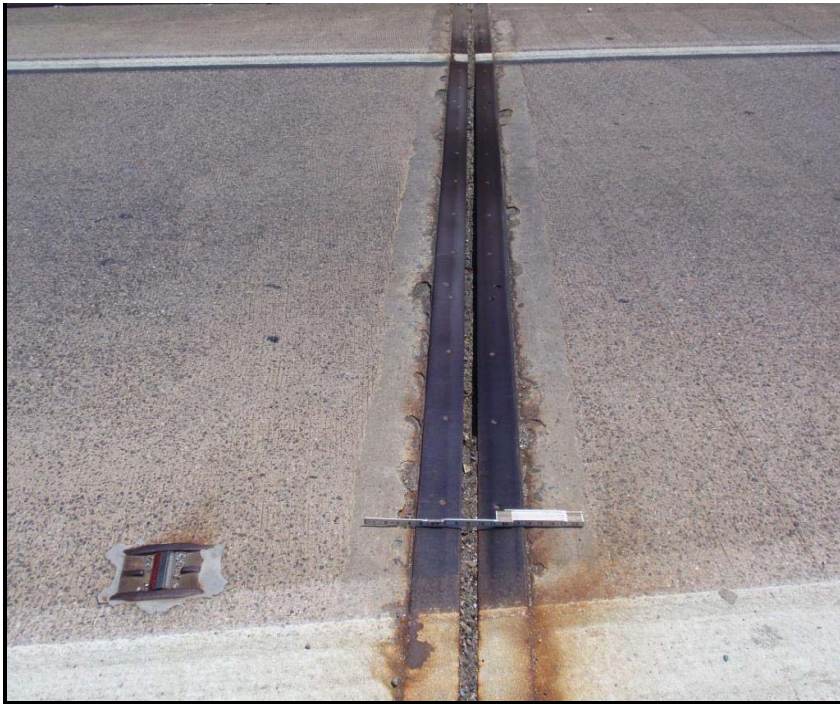
23. Pier 52 strip seal joint - Typ debris, depressed & debonded material.

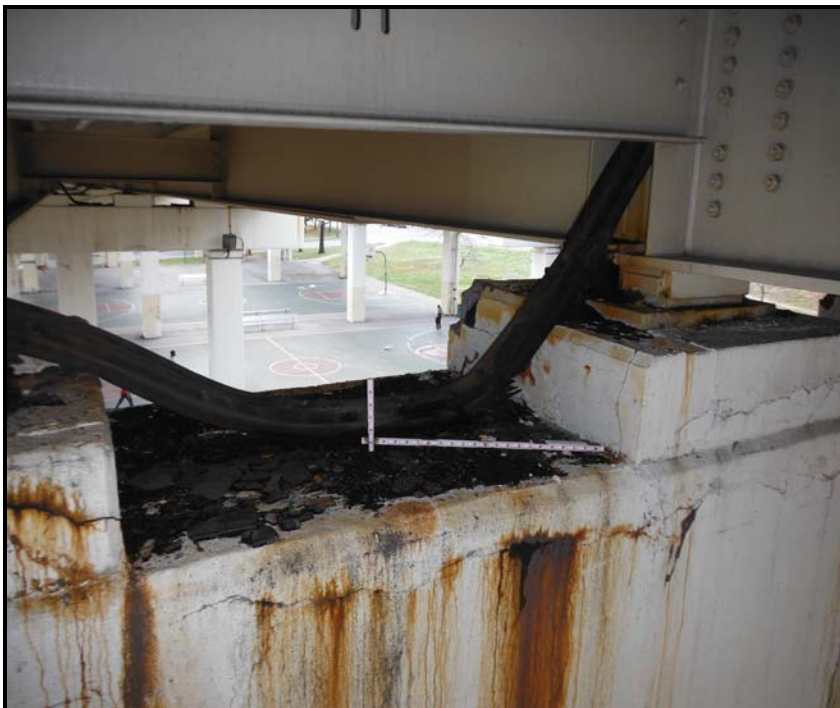
24. Pier 55 joint u/s - Joint material hanging down onto Pier 55 cap.

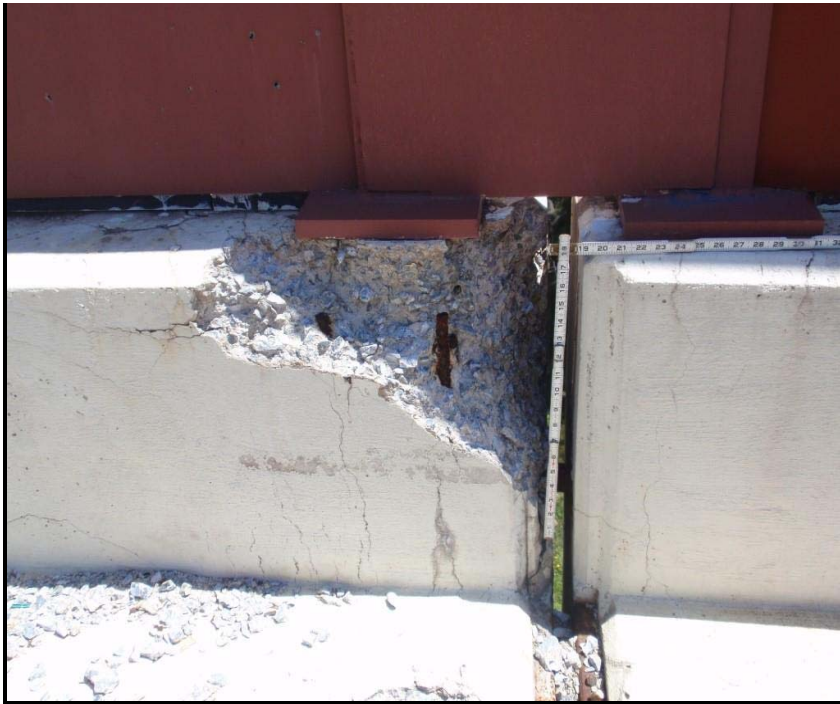
25. Sp 59, East Ppt - 20" L x 14" H x 10" D spall w/ exp corr steel reinf.

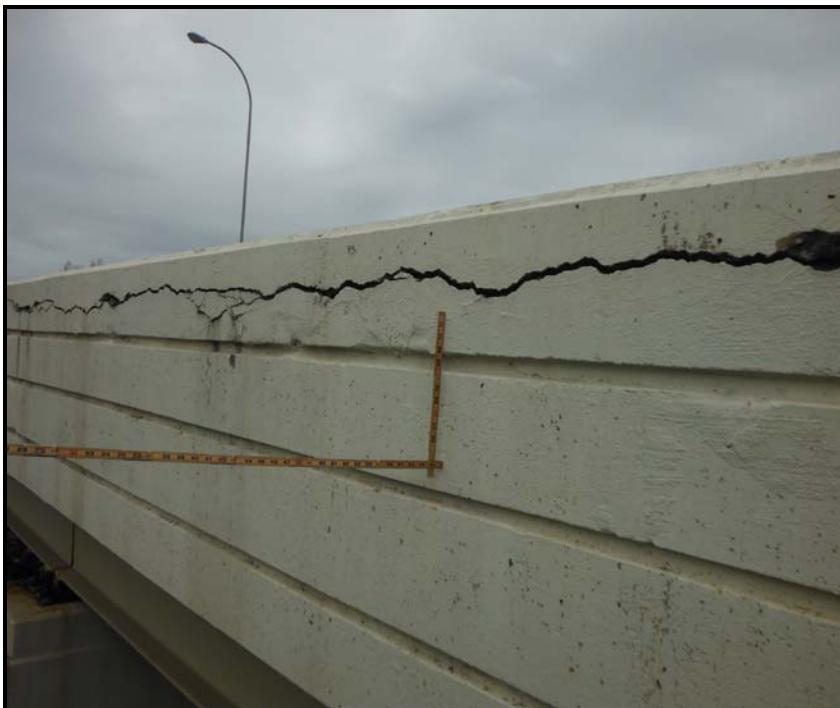
26. Span 46, W. Ppt ext face, n. end - Up to 5/8" W horizontal crack.

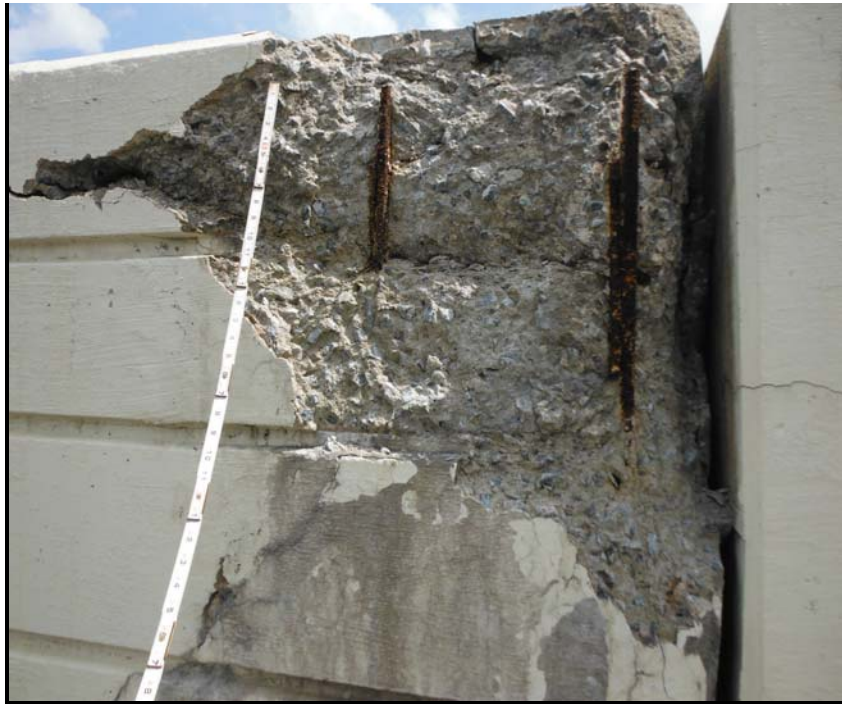
27. Sp 56, W. Ppt ext face, s. end - 3' L x FH x 4" D spall w/ exp corr steel reinf.

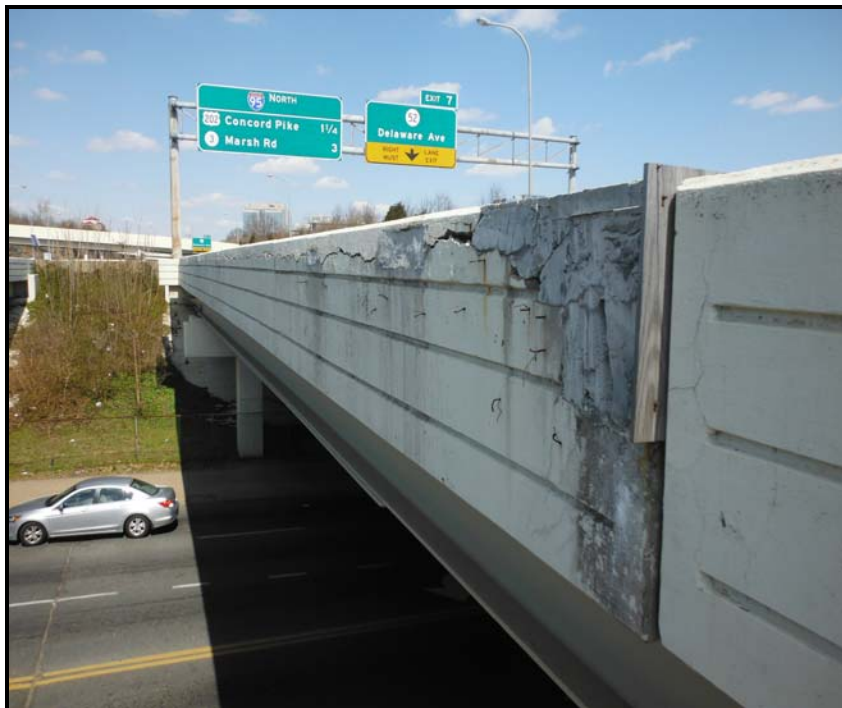
28. Sp 59, W Ppt ext face, s end - Patched delam/spalls w/ 5/8" W horiz crk.

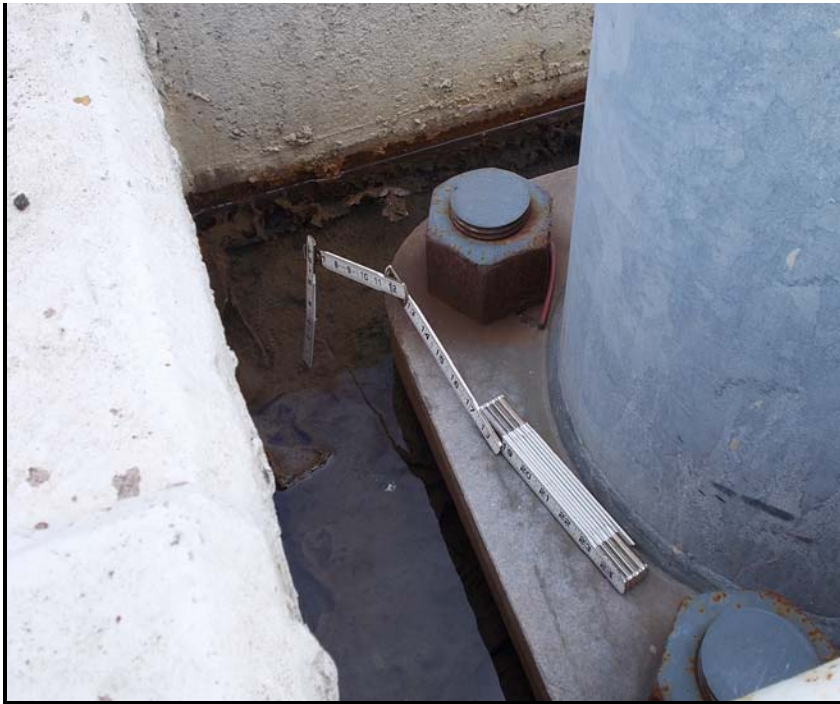
43: Cantilever sign structure with minor  
 surface corrosion to the anchor bolt nuts.  
 Note: The concrete parapet box for sign  
 structure is retaining water 3 1/2-inches deep  
 and has corroding bolts (see Photo 29).  
 Missing cover plate for junction box with  
 exposed wires attached to Beam 4 at 2/3 span.  
 Span 44: Light pole on East Parapet has 8" L x  
 6" H delamination on the northwest corner with  
 up to 1/8" wide cracks on the north and west  
 sides. Span 51: Light pole pedestal exhibits a  
 7" H x 6" W x 3" D spall at the southwest  
 corner and is missing a hand hole cover. Span

29. Sp 43, E. Ppt conc box for sign struct. - Ponding water up to 3 1/2" D.

L. Anderson (I) (P) / T. Potts (I) (P)  
 Maintenance Requests: Repair/replace hand  
 hole/junction box covers in parapet and light  
 poles. Seal cracks & repair spalls in  
 parapets. Flush scuppers/downspouts. Repair  
 broken/damaged soundwall panels. Drill weep  
 holes into the concrete box out for sign  
 structure at Span 43. Repair delaminations in  
 soffit over DART parking & patch soffit  
 spalls. Inspection Notes: Span 37: Light pole  
 on East Parapet is missing hand hole cover and  
 has 10" H x 7" W x 1" D spall at southwest  
 corner of pedestal. Span 41: Light pole on  
 East Parapet is missing fastener for the  
 handhole cover and 9" L x 7" H x 1 1/2" D  
 spall at northwest corner of pedestal. Span

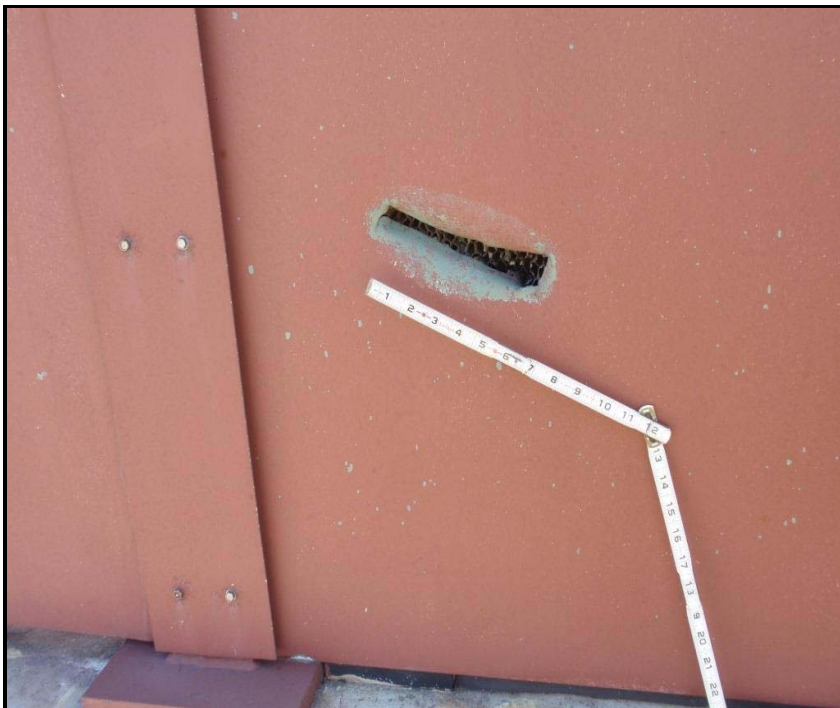
30. Sp 46, E. Ppt metal railing - 6 1/2" L x 1 1/2" H hole in panel.
