**STRUCTURAL DATA RECORD****Sufficiency Rating: 83.0****IDENTIFICATION**

Bridge ID: 1748S059	(2) District: 01	(3) County: 3
Inventory Route:		(4) Place Code: 77580
(A) On/Under: 1	(B) Highway Type: 1	(C) Service Lvl: 1
(D) Route No: 00095	(E) Direction: 0	
6A) Features Intersected: SR 4 & SR 48		6B) Critical: *
(7) Facility Carried: I 95 SB		
(9) Location: SOUTH WILMINGTON VIADUCT		11) Km. Point: 8.420 mi
16) Latitude: 39^44'26.27"	17) Longitude: 75^33'44.99"	
98) Border Bridge Code: NA	99) Border Br. Str. No.: NA

**UNDER RECORD**  
**For**  
**Bridge: 1748S059**

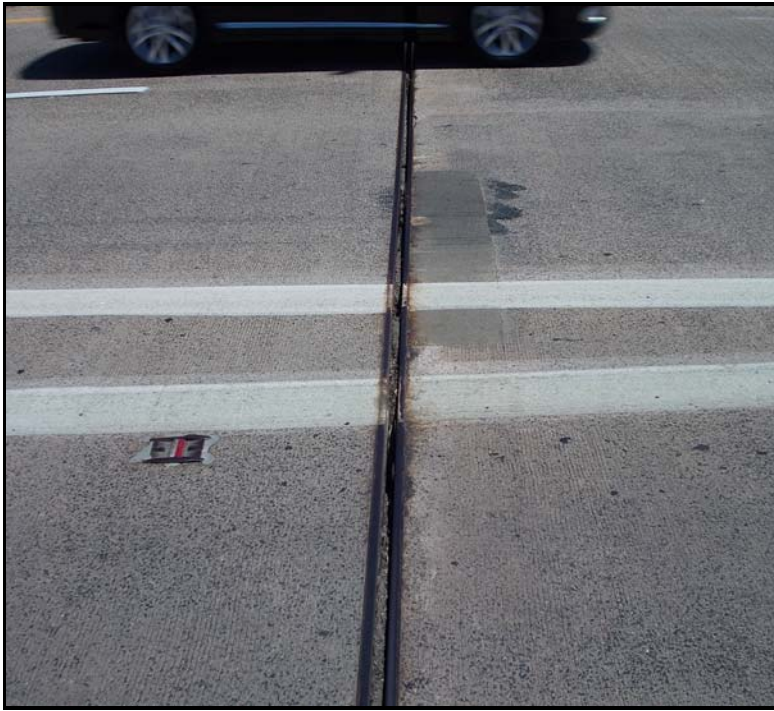
17. Span 30, right lane, concrete patch at joint.

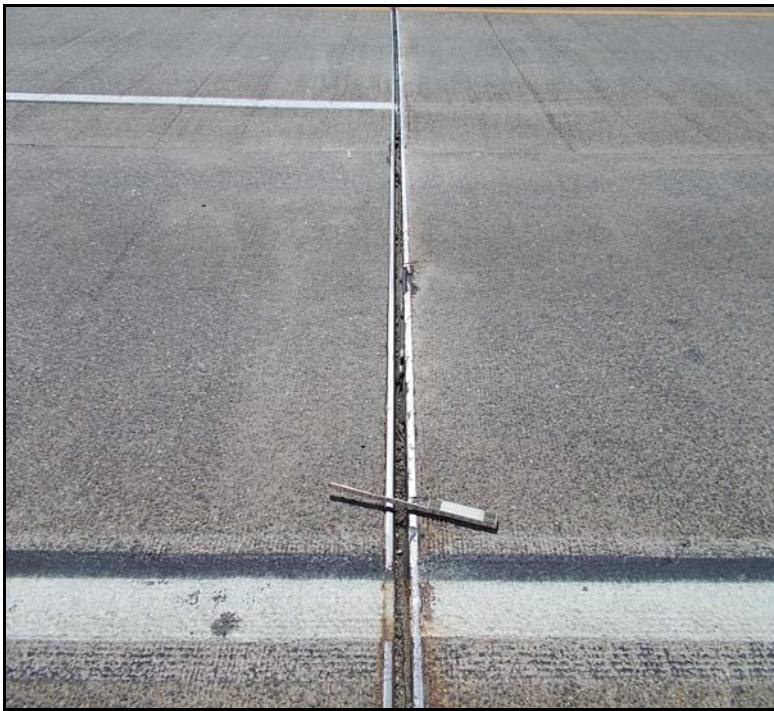
18. Span 55, right lane is missing extrusion.

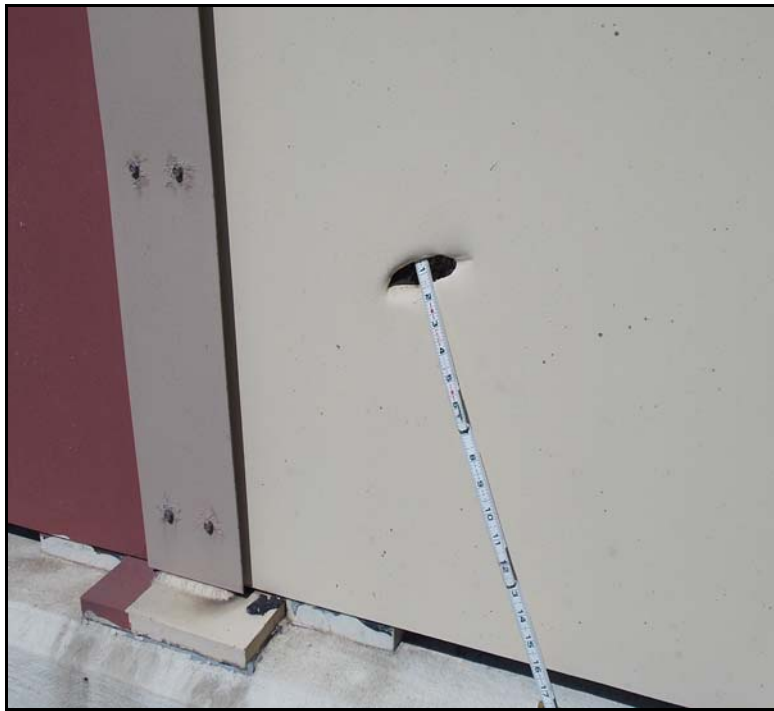
20. Span 52, Panel 5 of metal rail has a hole.

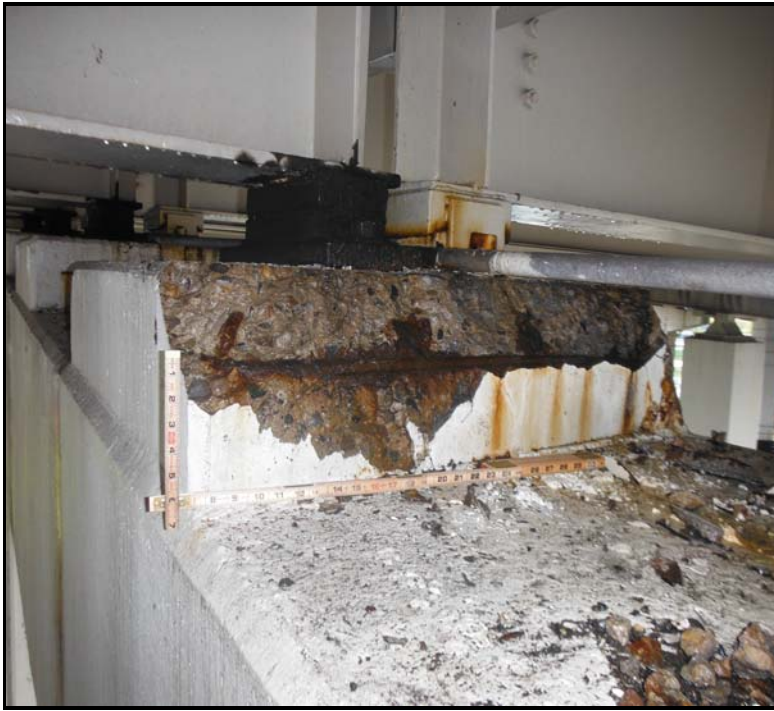
21. Span 27, Pedestal 4 west face with spall with exposed steel.

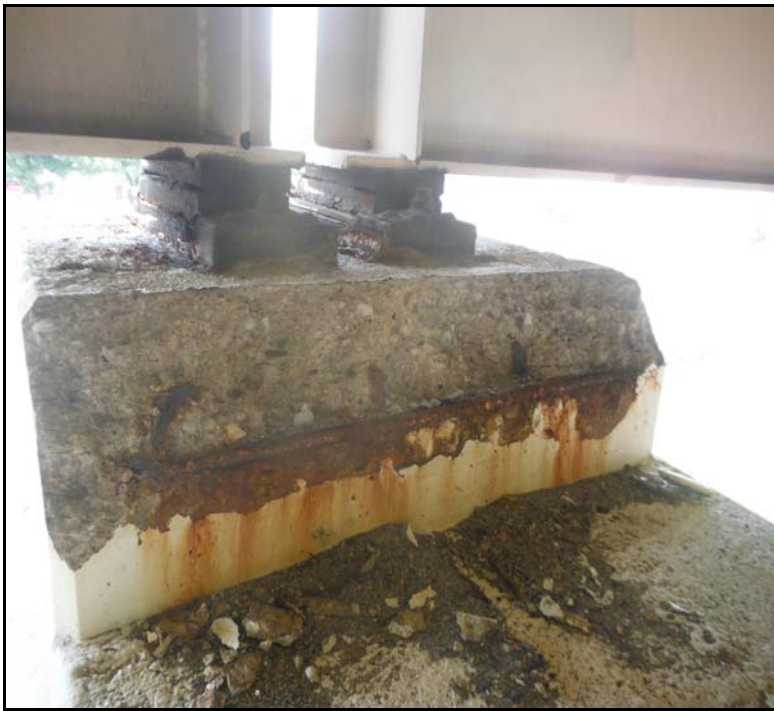
22. Span 41, Pedestal 1 east face with spall with exposed steel.

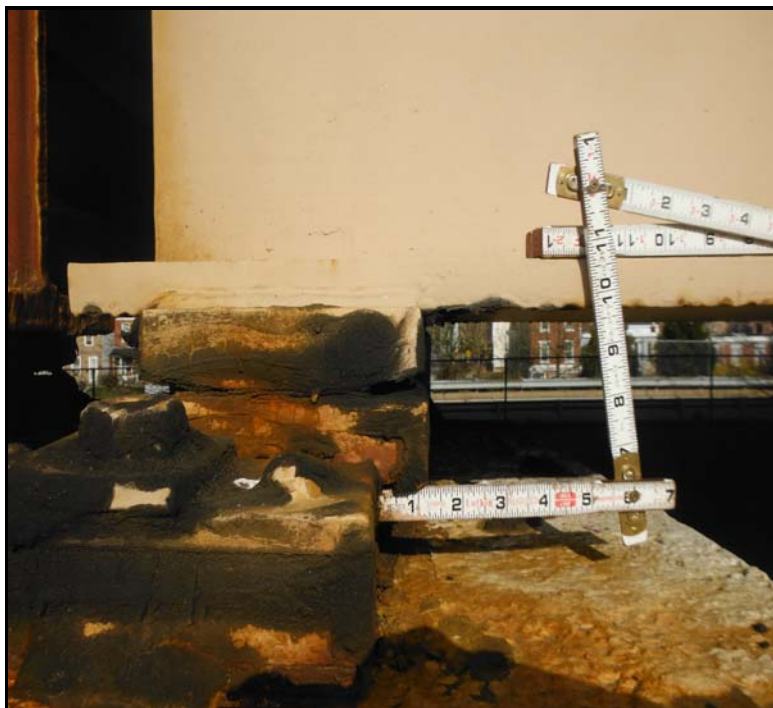
23. Span 44, Brg 6 at Pier 43, overcontracted at 65 deg.

REPAIR/RESET EXPANSION BEARINGS. SEAL  
CRACKS/SPALLS IN SOFFIT.

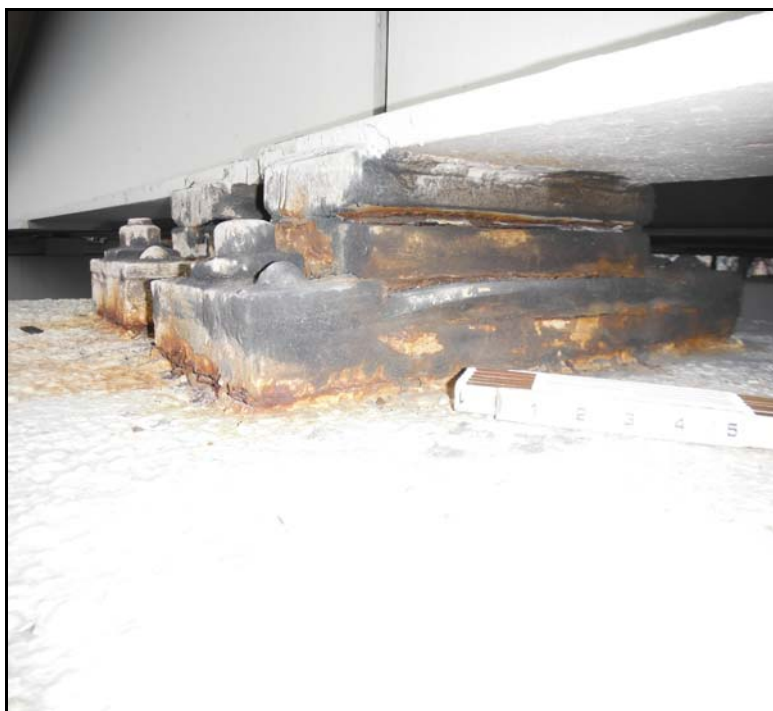
24. Span 52, Brg 6 at Pier 51. NE corner w/ pack rust (appears frozen).

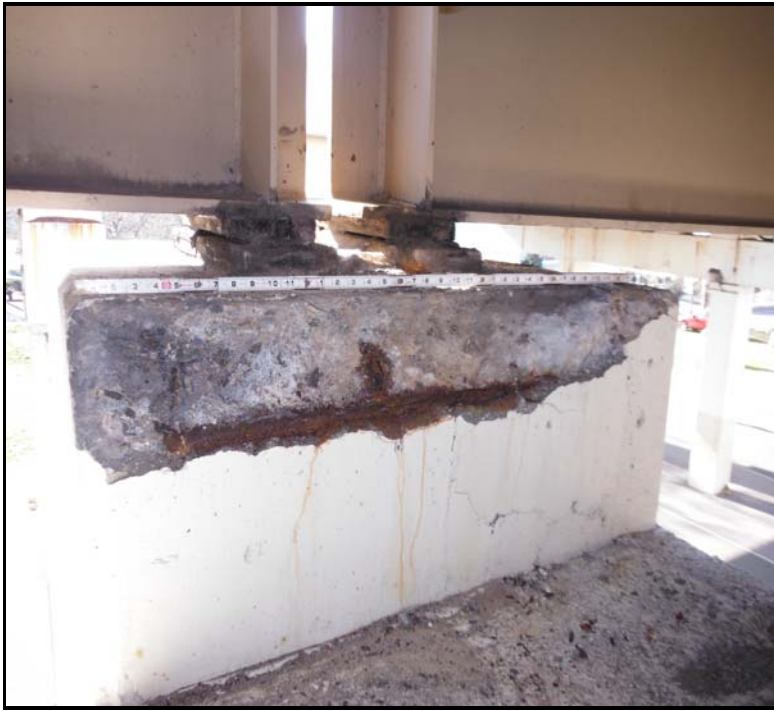
25. Span 54, Pedestal 6 spall with exposed steel.
