**STRUCTURAL DATA RECORD****Sufficiency Rating: 77.0****IDENTIFICATION**

Bridge ID: 1748 059 (2) District: 01 (3) County: 3  
 Inventory Route: (4) Place Code: 77580  
 (A) On/Under: 1 (B) Highway Type: 1 (C) Service Lvl: 1  
 (D) Route No: 00095 (E) Direction: 0  
 6A) Features Intersected: MARYLAND AVE. & AMTRAK 6B) Critical: \*  
 (7) Facility Carried: I 95 11) Km. Point: 3.480 mi  
 (9) Location: SOUTH OF WILMINGTON  
 16) Latitude: 39^44'0.78" 17) Longitude: 75^33'55.65"  
 98) Border Bridge Code: NA 99) Border Br. Str. No.: NA

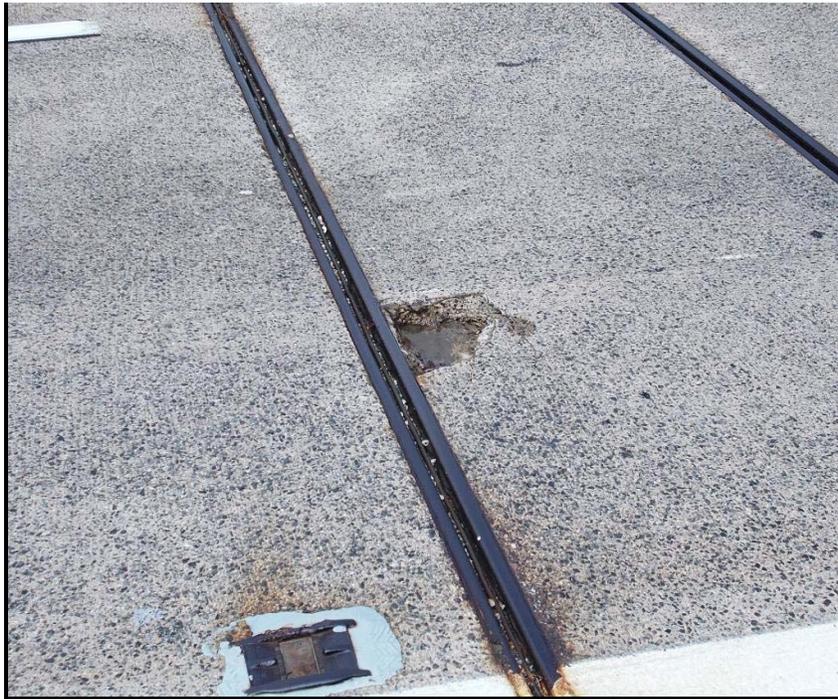
13. Span 22 NB right lane - 12" Diam. x 2 1/2" D spill.

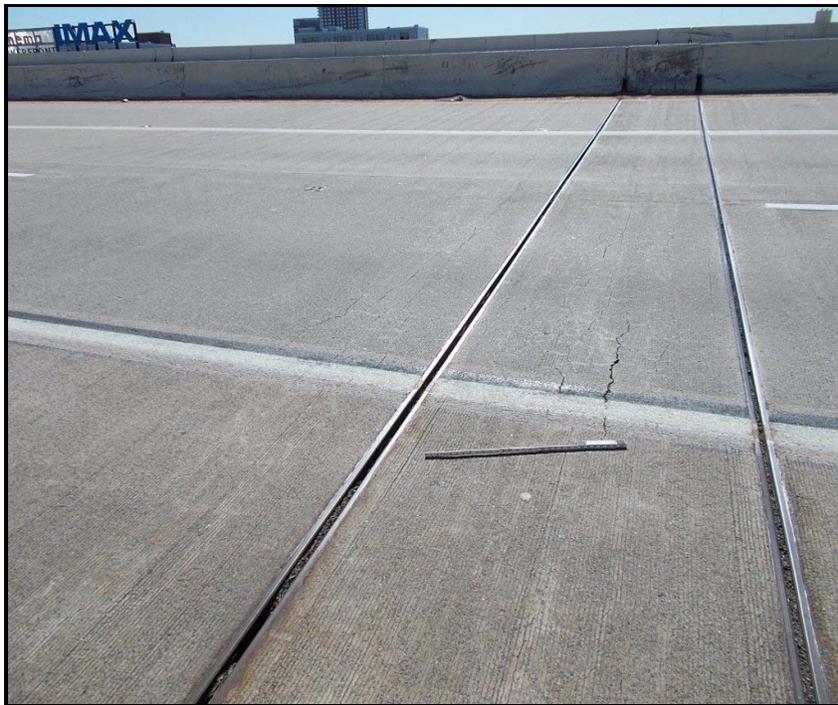
358	1	Deck Cracking SmFlag	(EA)	1	0	1	0	0	0	CS2: (1 EA) Typically HL to fine cracks in deck. Span 20 with 3' L x up to 1/4" W trans. crack over P20 in SB right lane and Span 21 w/ up to 1/16" wide trans. crack adj. to joint @ P20 in SB right lane (See Photo 14).
359	2	Soffit Smart Flag	(EA)	1	0	1	0	0	0	See Additional Sheet for MSPE Notes.
363	2	Section Loss SmFlag	(EA)	1	1	0	0	0	0	CS1: (1 EA) Typically areas of painted over pitting and minor section loss up to 3/8" mostly @ the ends of the beam, end diaph's and on top of the bottom flange of exterior girder fascias. Several beam ends w/ minor section loss/ active pitting (See Painted Steel Girder Notes). Span 22: BM 1 at midspan with section loss on bottom of stiffener FW x 1 1/2" H with a 3/4" diam. area of 100% Sx loss. Bottom flange in same location with (2) areas of Sx loss 4" diam. x 3/8" D. Span 25:

14. Span 20 SB at P20 - Trans cracks up to 1/4" W at P20 and 1/16" W in Span 21.

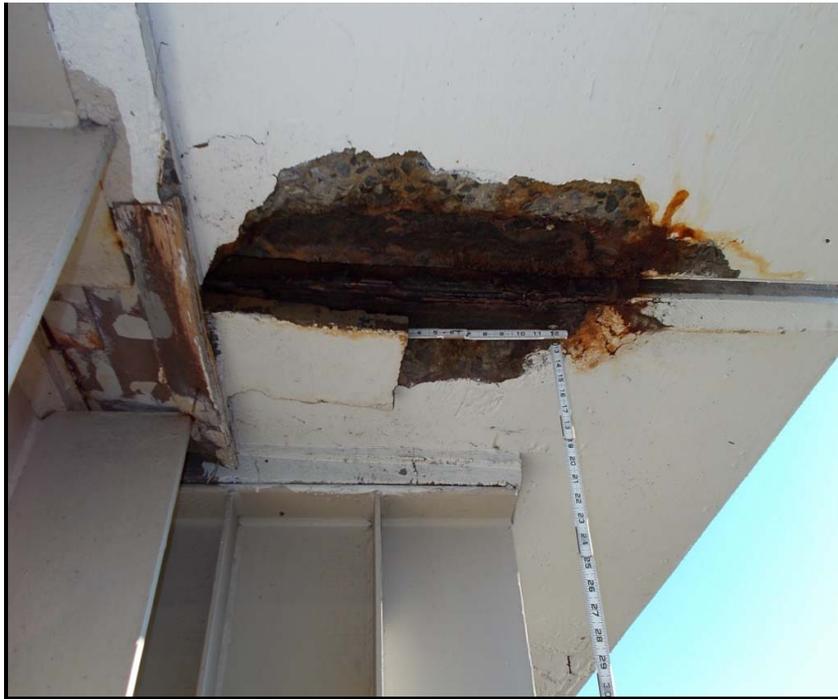
15. Span 5, E. o/hang at P05 - 30" W x 9" L x 2" D spalls w/ exp corr deck jt angle.

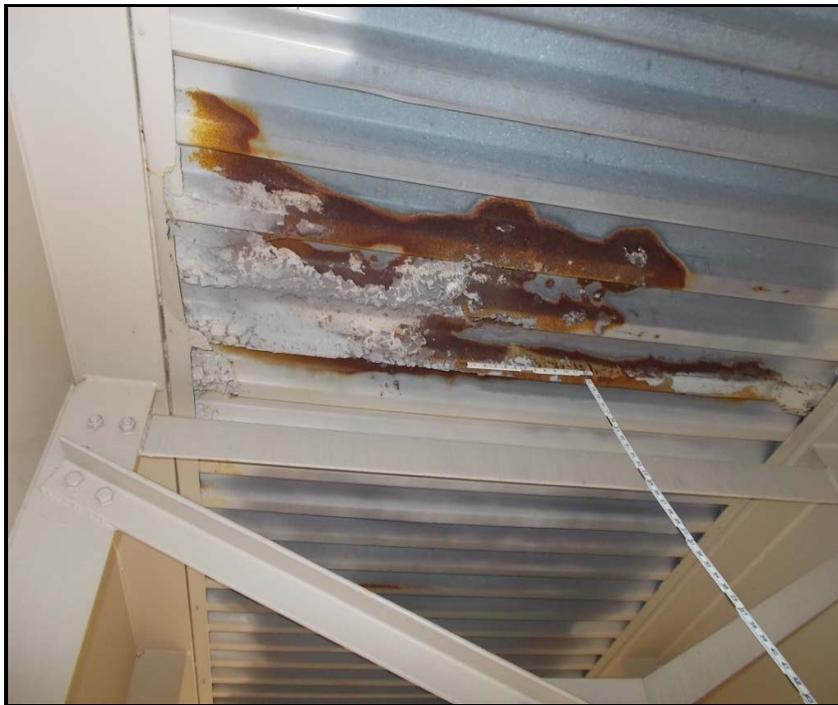
16. Span 6, Bay 11 - SIP w/ 36" L x FW area of corr. and conc. voids.

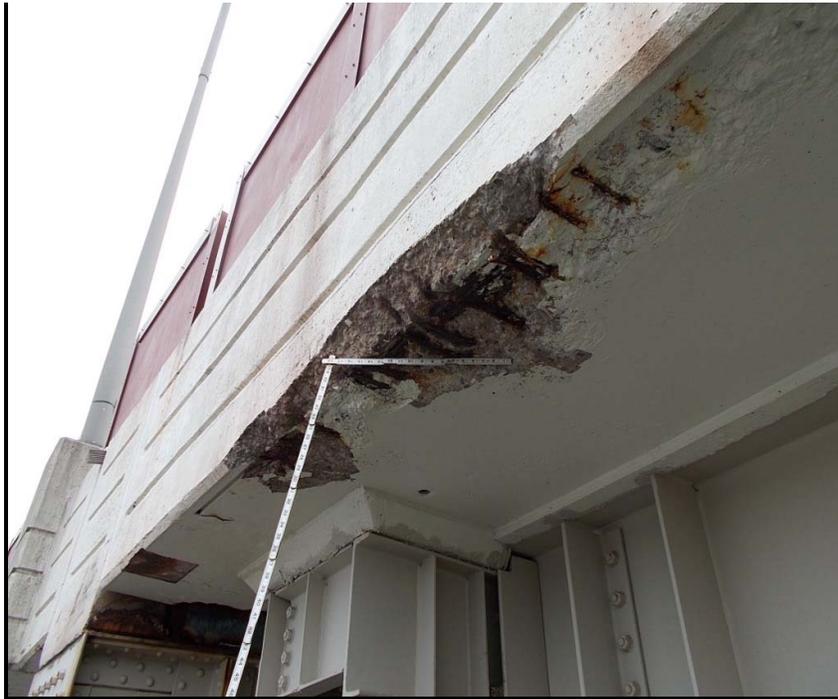
17. Span 26, W. o/hang at P26 - 4' L x 20" W x 2 1/2" D spall w/ exp corr steel.

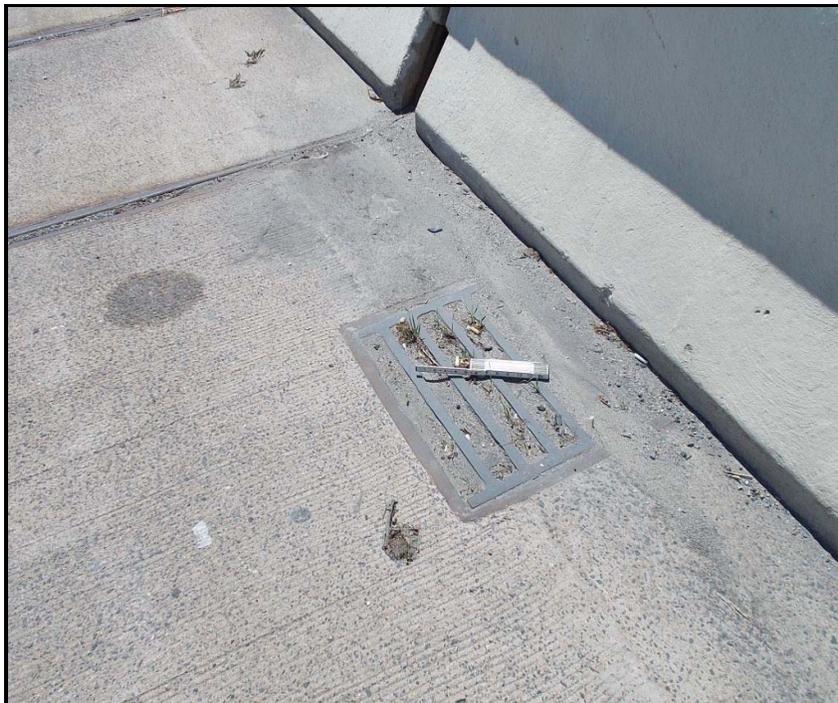
18. Span 24, SB west shoulder at P23 - Clogged scupper.

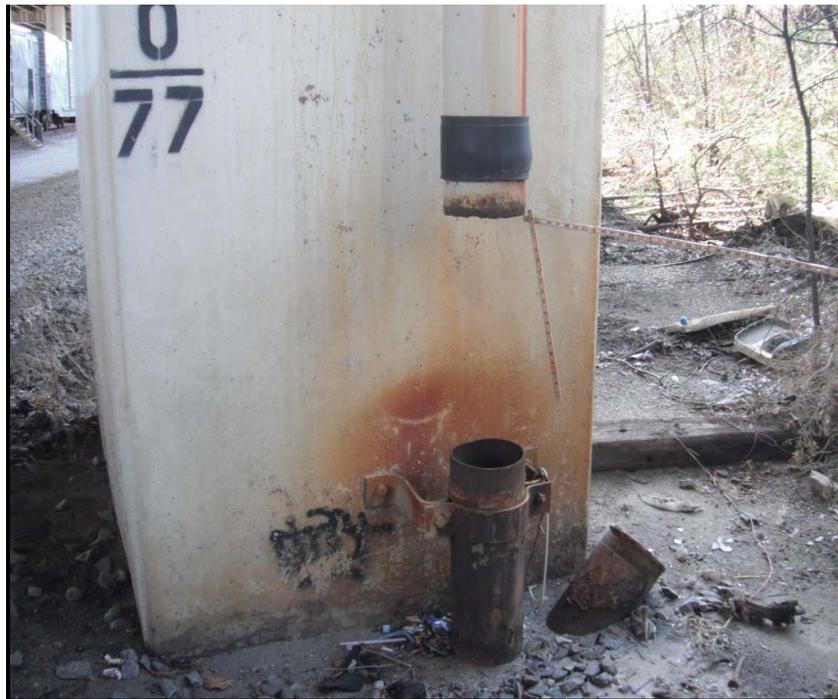
BM 17 at Pier 24 with painted over section loss in web, stiffeners and bottom flange w/ area of 100% section loss in the east bearing stiffener 4" H x 3 1/2" W w/ minor active corrosion.
364	1	Erosion Smart Flag	(EA)	1	1	0	0	0	0	CS1: (1 EA) The previously noted erosion @ the base of Pier 13, Col. 3 due to the disconnected downspout has been repaired, and the downspout has a new PVC connection. There was no erosion observed at the disconnected downspout at Pier 22.

19. P22, Col. 1 downspout - Bott. portion of downspout disconnected.

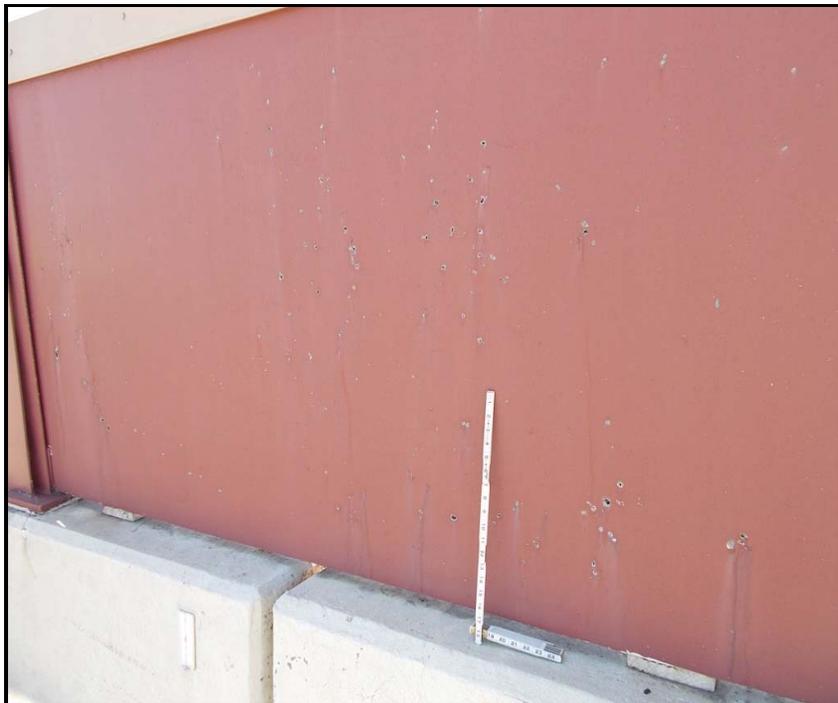
22. Span 25 at P25, W. Ppt - Numerous small holes throughout panel.

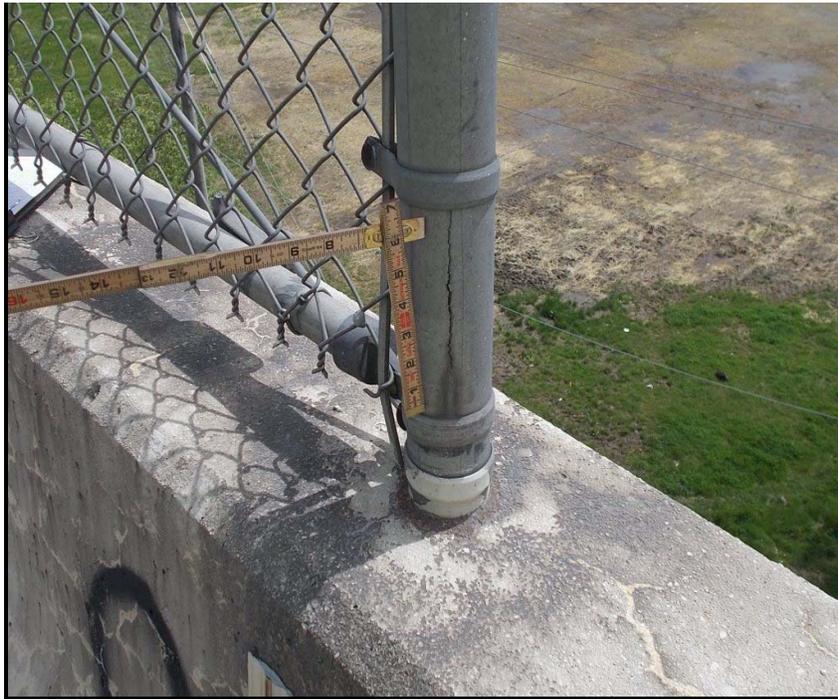
23. Span 13, E. Ppt fence at P12 - 6" H x 1/16" W vert. crack in post.

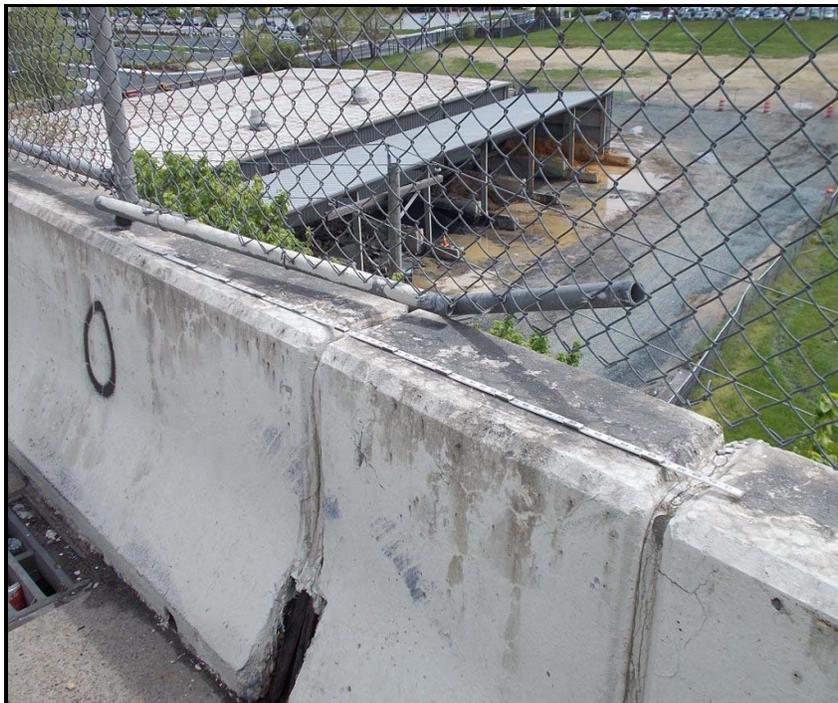
24. Span 15, E. Ppt fence at P14 - Horizontal support is disconnected.

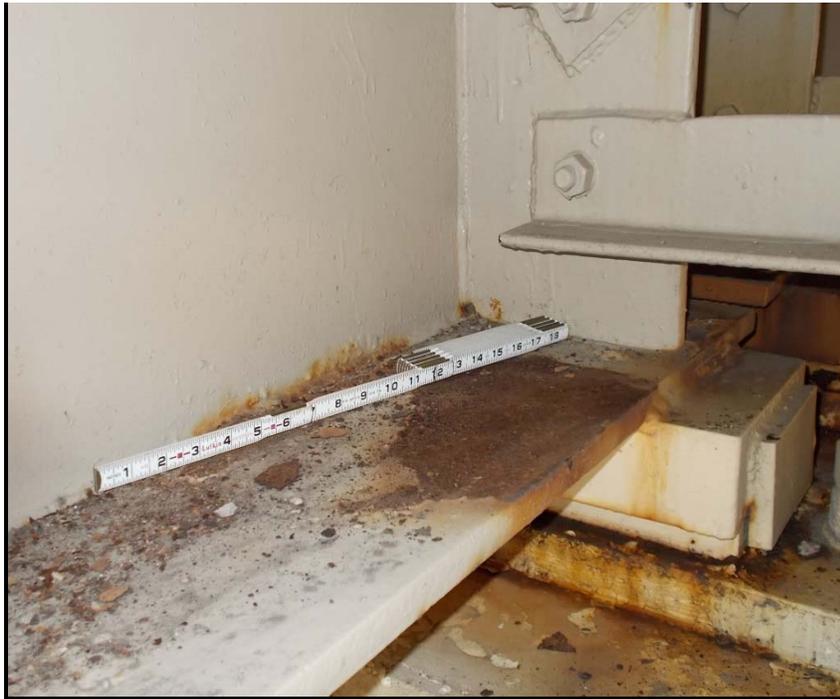
25. Sp 7, BM12 at P06, B.F. - Exp corr steel w/ minor rust lam (negl SL).

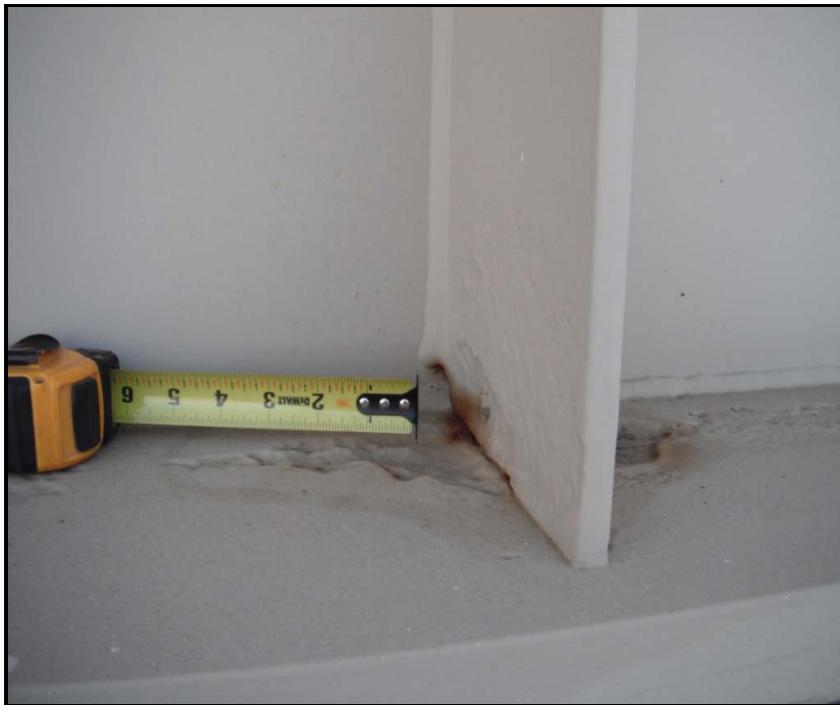
26. Span 22, BMI at midspan, W. BF - S.L. prev. painted over now active.

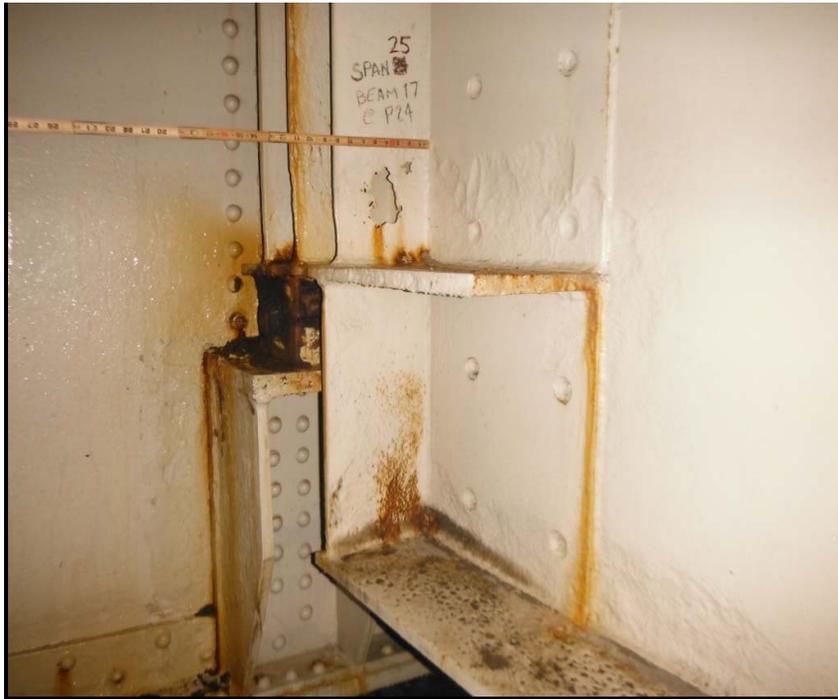
27. Sp 25, BM17 at P24, E. face, stiff - 4" H x 3 1/2" W 100% S.L. w/ active corr.

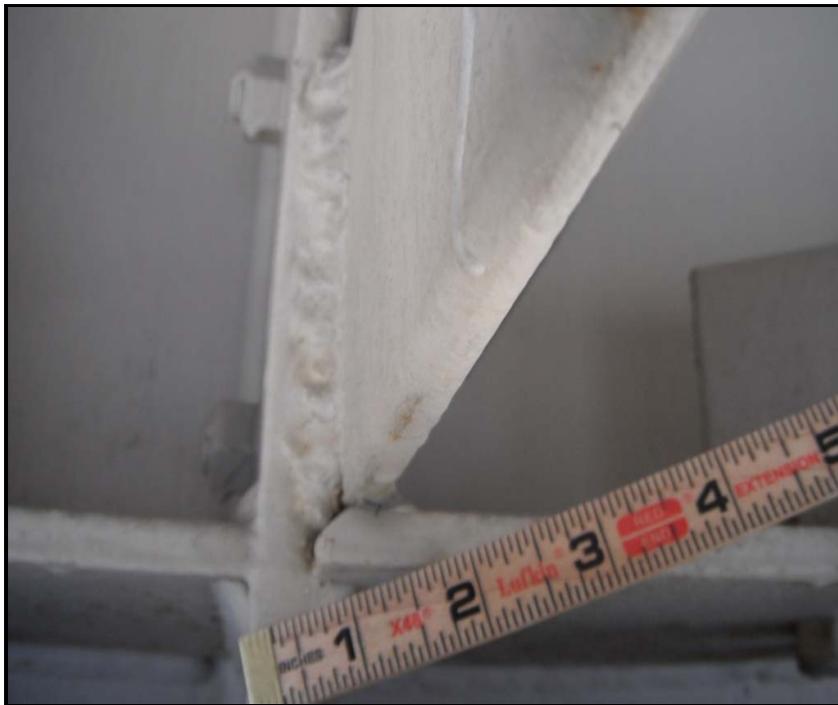
28. Sp 22, Bay 14, 2nd diaph - 1/4" L cr. weld b/t horiz. and conn pl.

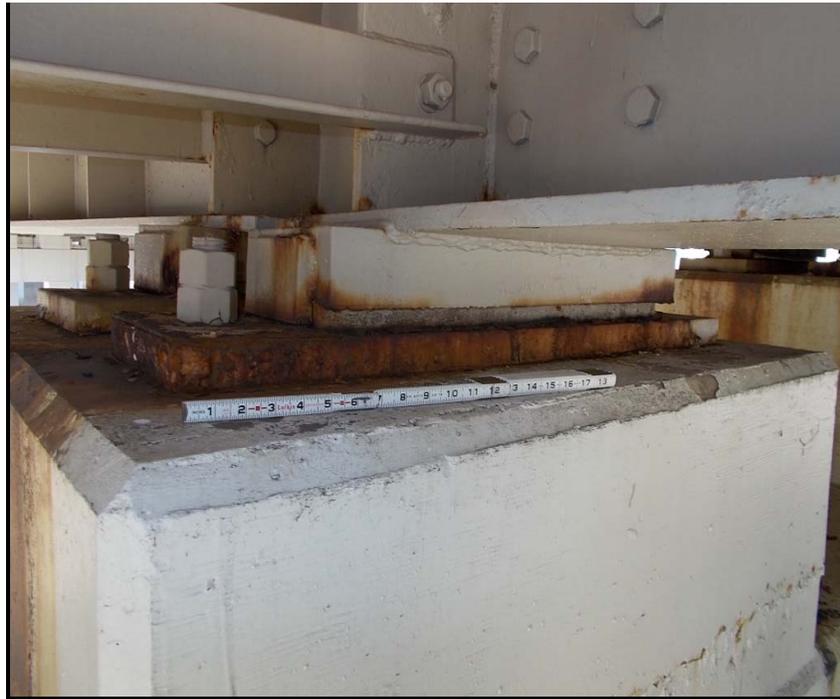
331	4	Conc Bridge Railing	(LF)	221	160	50	11	0	0	CS2: (50 LF) 1/16" to 1/8" longitudinal cracks on outside face @ top of West Parapet. CS3: (11 LF) Cracks with rust on the inside face of the West Parapet and a 5' Dia. x 3/4" D spall with exposed steel reinforcement on the inside face of West Parapet, at the base.
334	4	Metal Rail Coated	(LF)	0	0	0	0	0	0	0
381	4	Painted Steel Diaphr	(EA)	84	35	42	7	0	0	CS2: (42 EA) Minor spot or freckled rust. CS3: (7 EA) Isolated areas of exposed metal with corrosion in Bays 1, 2, 4, 5, 6, 11, and 13 at P09.
311	4	Moveable Bearing	(EA)	16	5	11	0	0	0	CS1: (5 EA) Pier 8 sliding plate bearings are w/in limits and many have spot corrosion, random flaked paint, and some blisters to masonry plates. Some bearings have more corrosion than typical, usually in areas below the leaking joint. CS2: (11 EA) Bearings 1-5, 7, 10, 12, 13, and 16 have bent anchor bolts. BMS 13 & 15 Brgs exhibit moderate rust to plates (See Photo 29).

29. P08, Span 9, BM15 fix brg w/ mod corrosion on masonry and sole PL's.

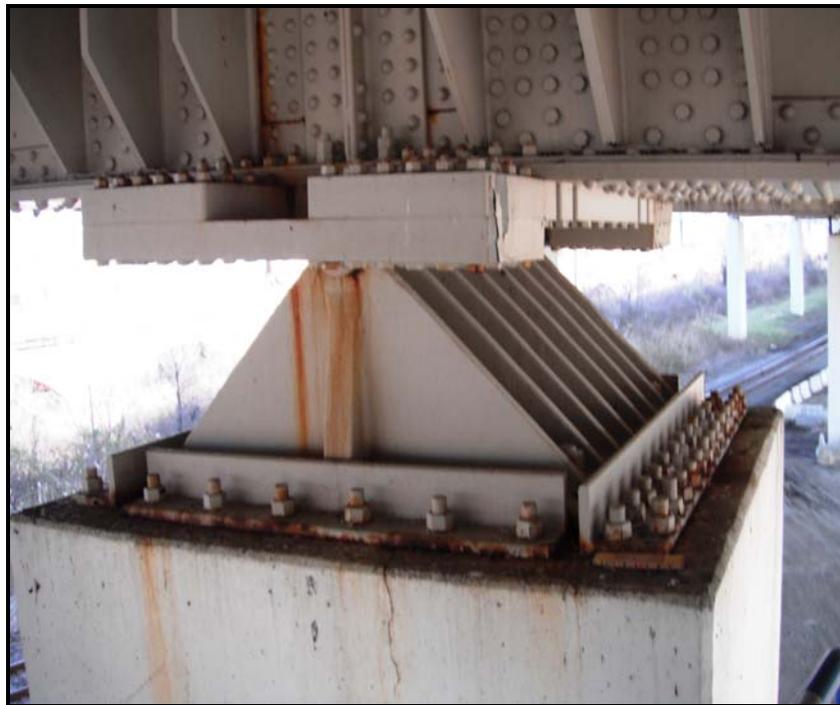
313	4	Fixed Bearing	(EA)	17	16	1	0	0	0	CS1: (16 EA) Pier 11 brgs (16 total) are heavily greased w/ NDO. CS2: (1 EA) Cap brg @ center with corroded nuts, bleeding rust from pin areas and corrosion randomly to plate edges (See Photo 30); sole pl w/ peeling paint w/ exp primer.
205	3	R/Conc Column	(LF)	95	95	0	0	0	0	NDO
215	2	R/Conc Abutment	(LF)	0	0	0	0	0	0	0
										CS2 (66 LF): Exterior (50 LF): Typ freckled rust on built up pl's, stiff's or fasteners for brgs, corrosion along web adj to brg bolsters, spot rust to edge of fl's or cover pl's, web pl's w/ corrosion around some tie rods. Interior (16 LF): Typ top fl over portal and isolated areas throughout interior w/ freckled rust, web fasteners and portals thru diaph's w/ minor bleeding and freckled

30. Typ cond pier fixed brg w/ bleeding rust & mod corr on nuts & keeper angles.

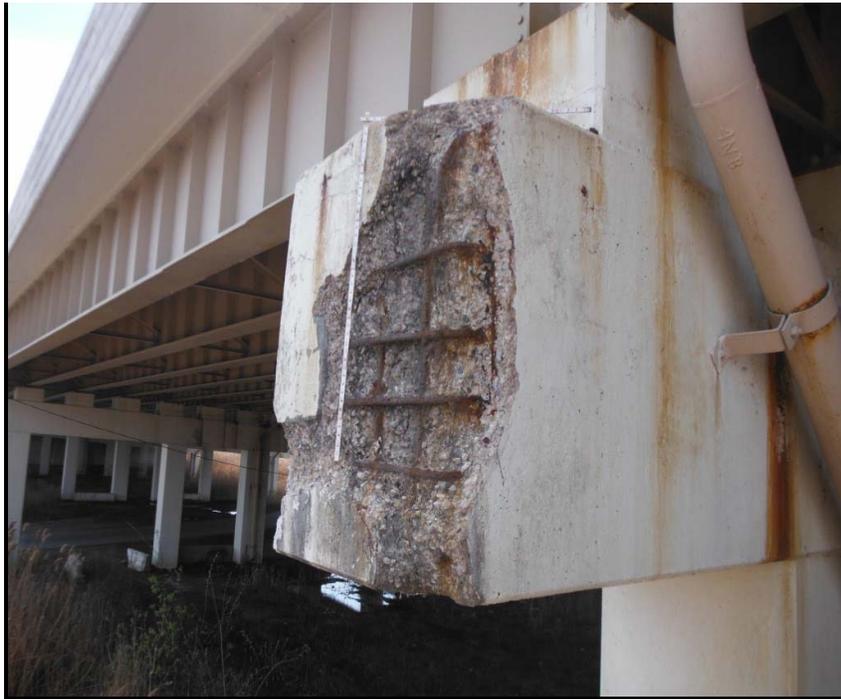
31. P04 Cap, E. face, looking SW - 54" H x 43" L x 4" D spall w/ exp corr steel reinf.

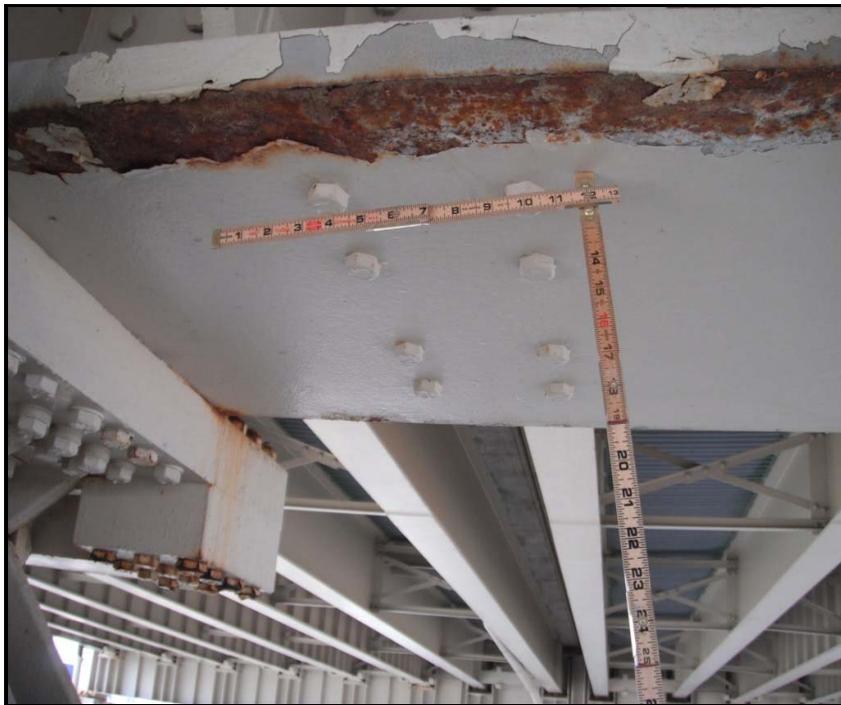
32. P14, u/s of Cap @ BM8- 4'Lx4"W area of peeling paint w/ exp corr steel.

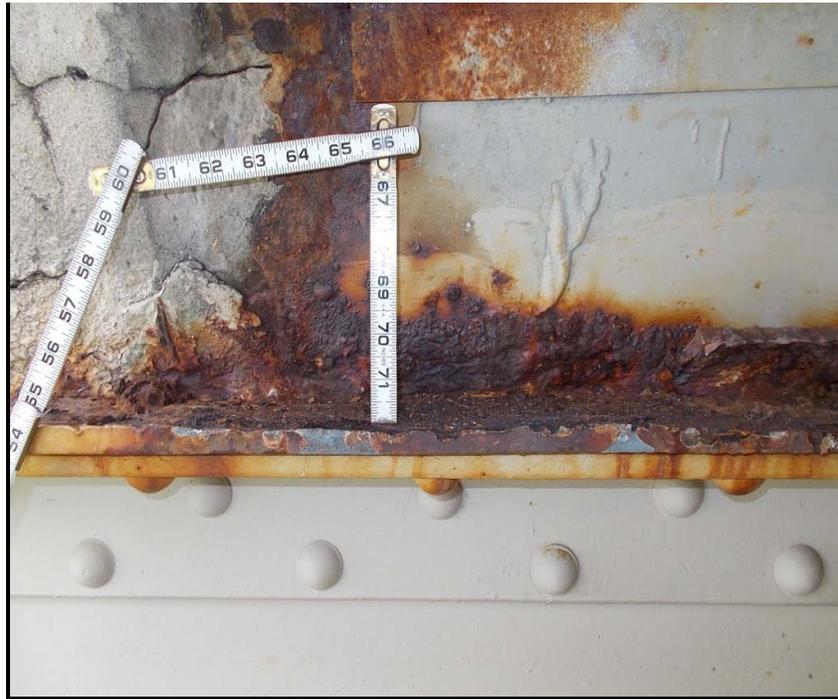
33. P25 Cap ext, T.F., S. edge near BM1 w/ 17" L x 3" W x up to 3/16" S.L. in cov pl.

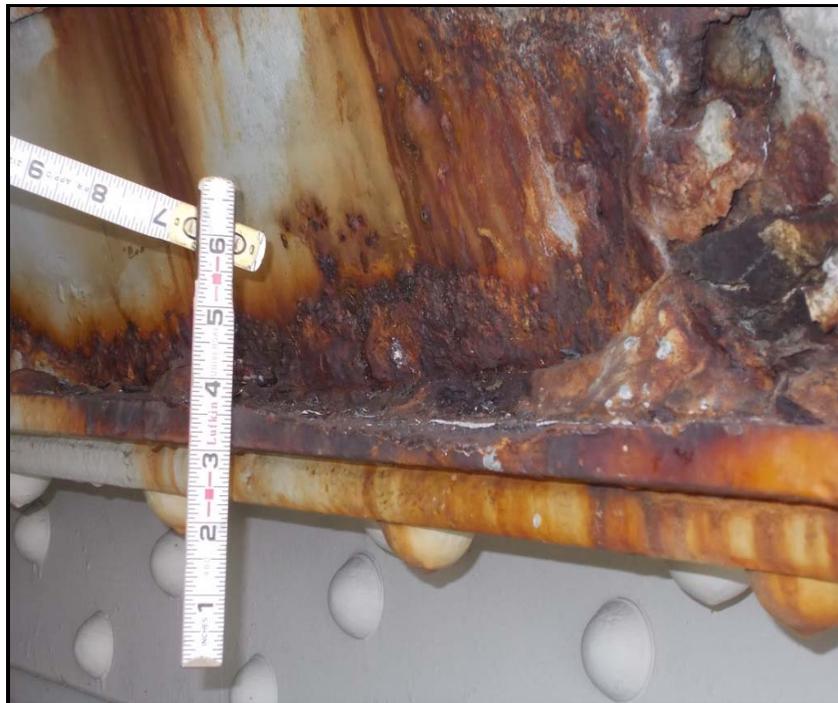
34. P25 Cap ext, T.F., N. edge @ BM1 w/ 15" L x 2 1/4" W x up to 5/16" S.L. in cov pl.

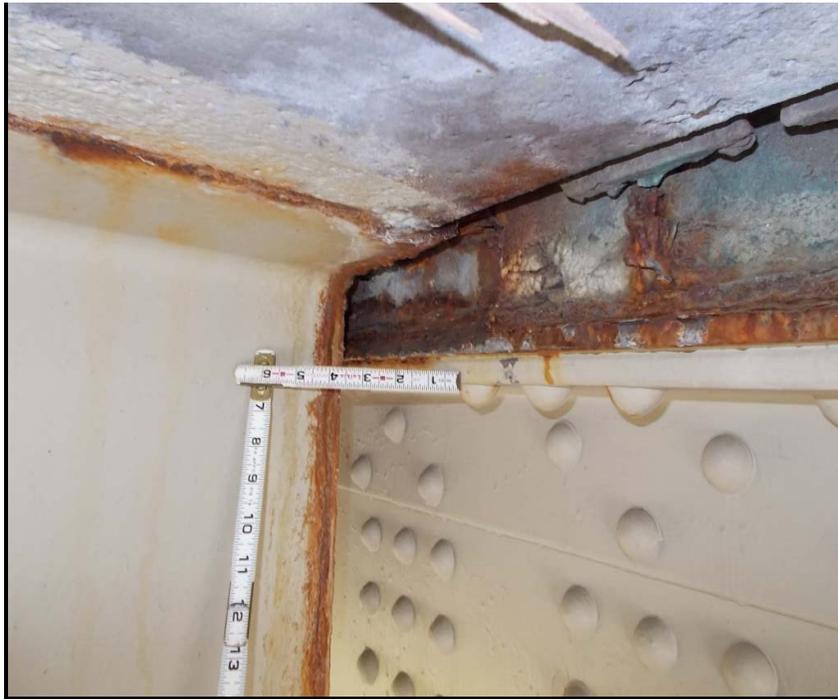
231	4	Paint Stl Pier Cap	(LF)	121	22	90	7	2	0	brg stiff's, top fl & brg bolsters w/ minor rust stains throughout. S. face of bot flange in Bay 16 kinked upward. Interior: (8 LF) E & W access holes w/ freckled rust to fl's, bot fl at W. access hole w/ freckled rust and evidence of water @ W end but no corroded steel. Freckled rust on bot flange and webs at the tie rod holes on south face of the web throughout and few fasteners with minor corrosion at fixed pier cap bearing. CS3: (7 LF) Exterior: (4 LF) Bay 11 @ BM 12 w/ painted pitting to web w/ active corrosion and rust laminations up to 3/8". W. end of top fl w/ exp corroded steel and minor rust laminations, exp corrded steel on N. side to top flange in Bays 6 & 8, bot flange in Bay 7 and top flange in Bay 12 w/ minor rust laminations. Rust lam in top cover plate on S. face at Bay 6 Interior: (3 LF) Bay 7 w/ ponding water noted on top of bott flange at the N. side and bot fl angle and web w/ exp corroded steel. Bot fl E. of the 2nd diaph east of fixed bearing w/ peeling paint and exp corroded steel. CS4: (2 LF) Top fl plate, N. edge at Bays 11 and 12 w/ 2' L x 1" W x up to 3/8" S. L. to flange plate (1/8" remains at edge, orig. = 1/2" ) and up to 1/4" S. L. to flange cover plate (1/4" remains at edge, orig. = 1/2" ) . (See Photos 35 & 36).

35. P26 Cap ext, T.F., N. edge @ Bay 11- 2'L x 1'W S.L. up to 3/8" in flg and cov pl.

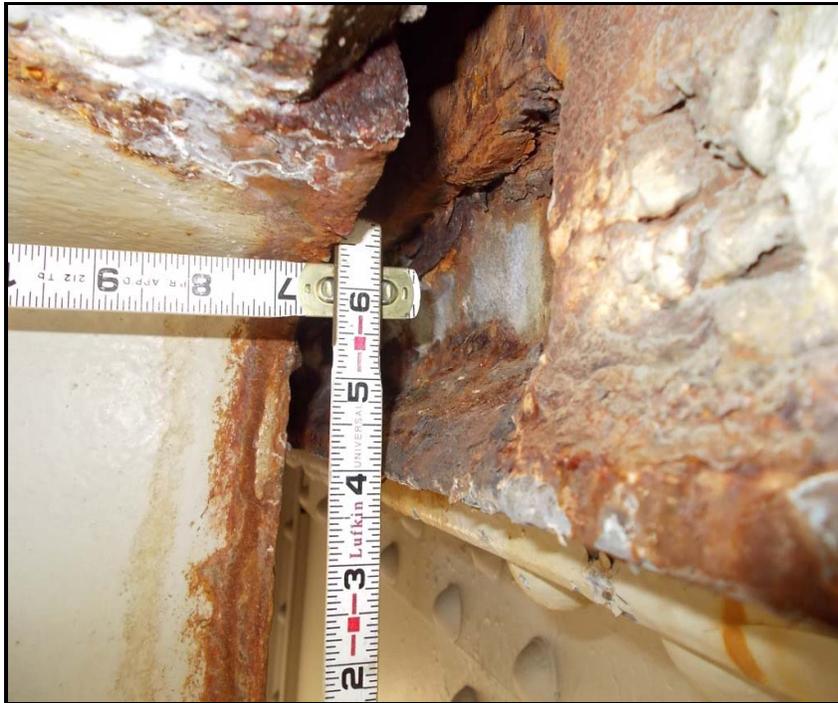
36. P26 Cap ext - Close up of Photo 35 w/ up to 3/8" S.L. in T.F. and cov. pl.

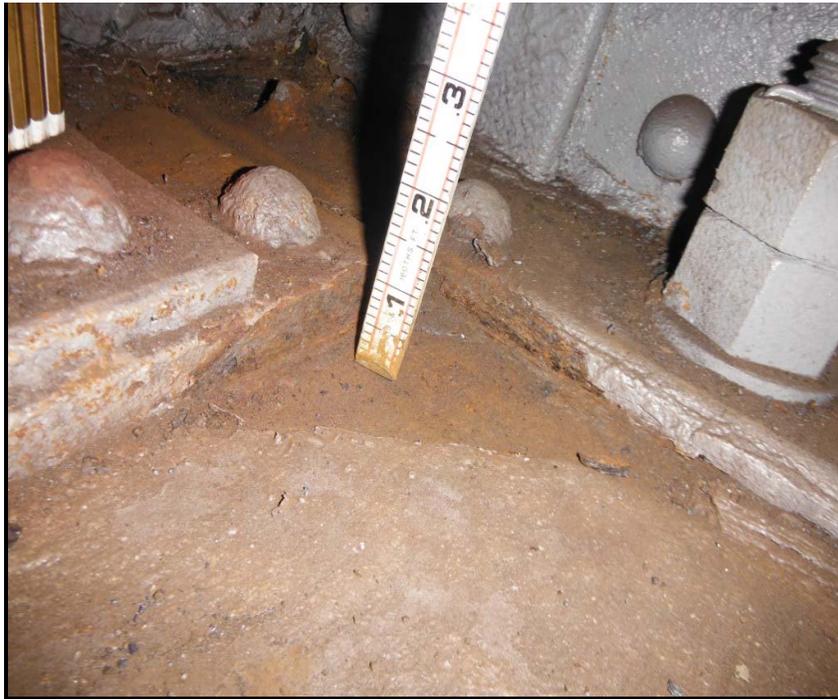
37. P12 Cap int, B.F. at SE - 12"L x 9"W area of 1/4" S.L. & 75% S.L. to rivet.

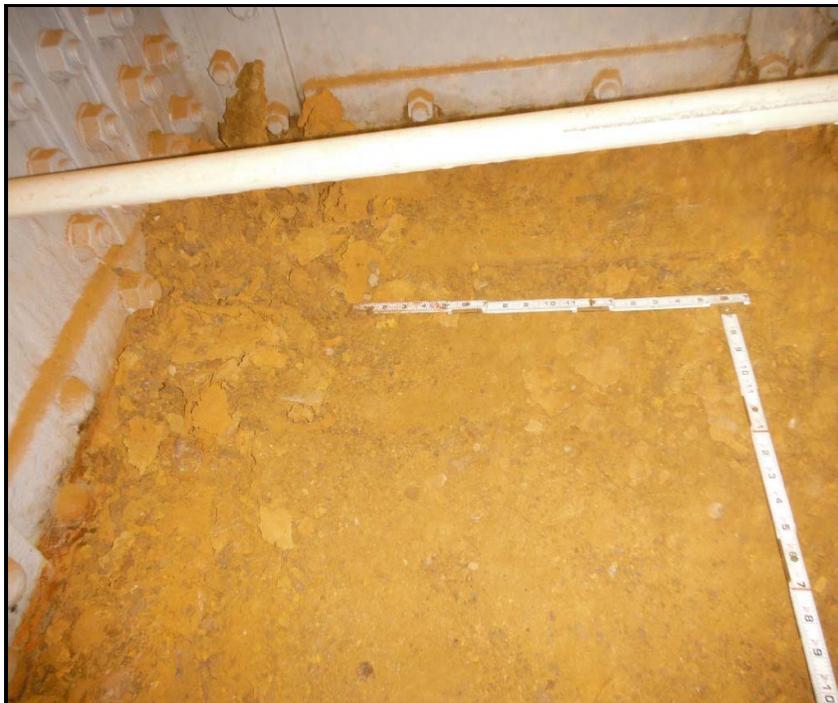
38. P22 Cap int, B.F., Bay 8 w/ 4' L x 3' W area of 1/16" S.L. to BF and angles.

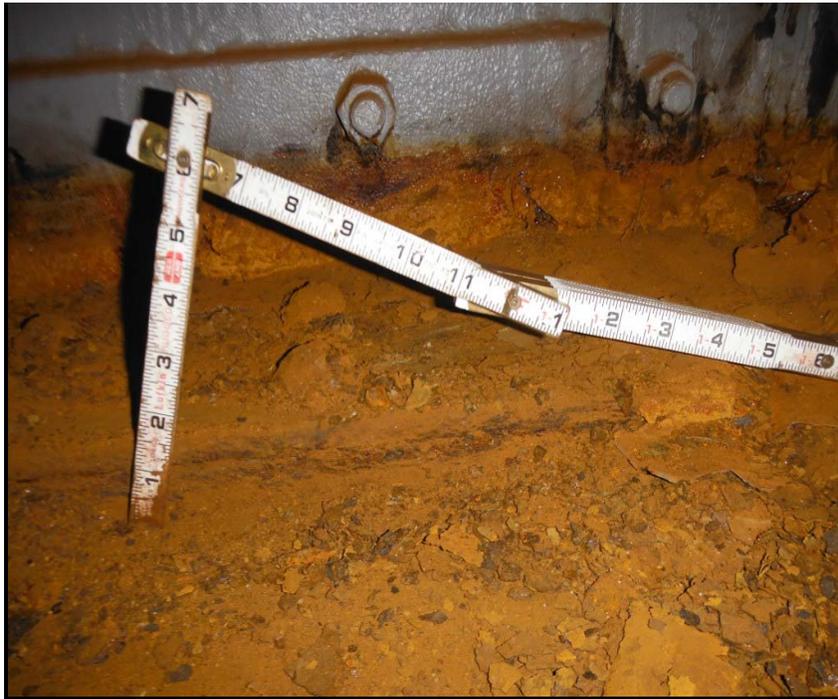
39. P22 Cap int - Close up of Photo 37 S.L. at N. end/bot flange angles.

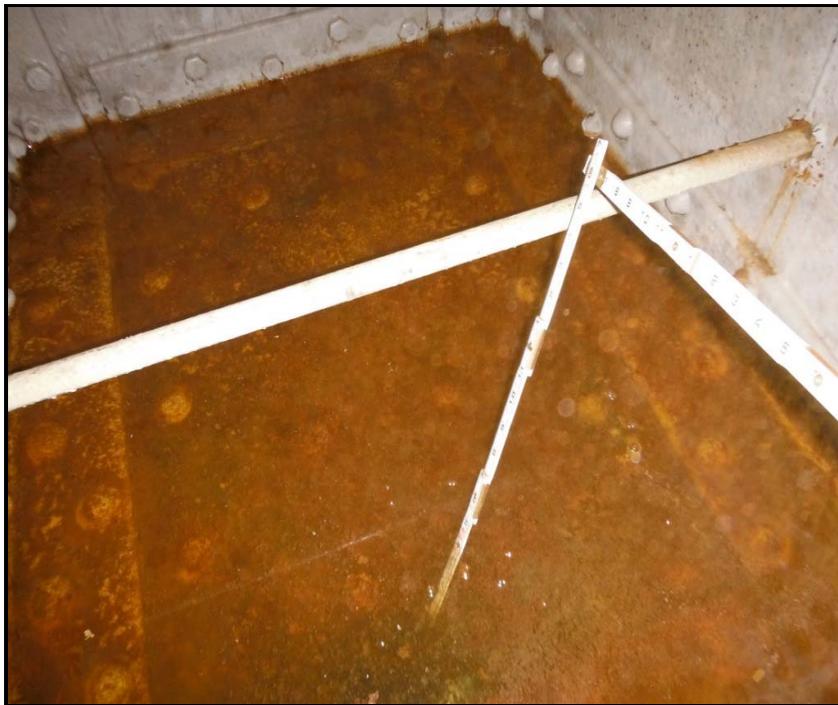
40. P22 Cap int, Bay 10 - FL x FW ponding water up to 3 1/2" D.

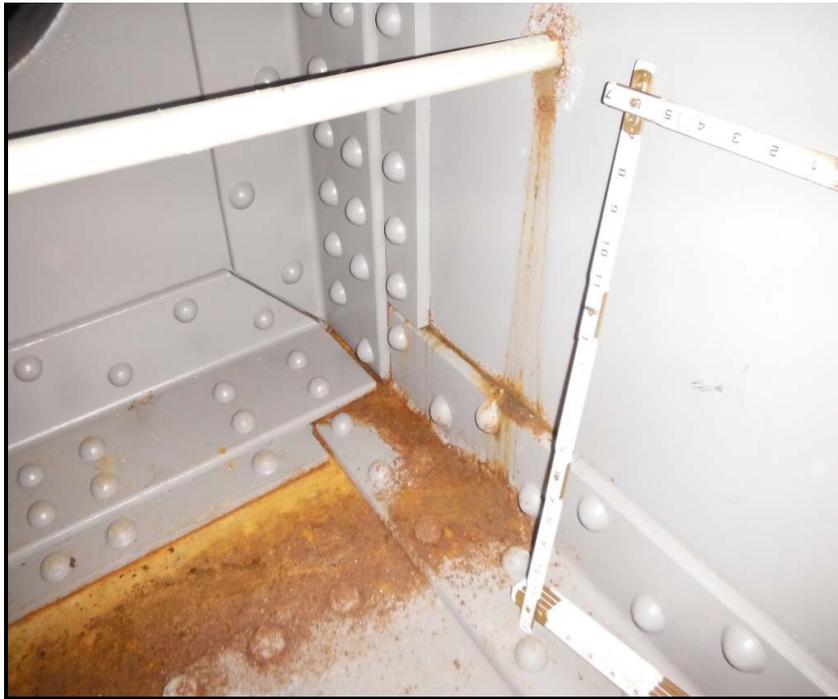
41. P25 Cap int, W. end of cap - Tie rod w/ evid of water & exp corr steel.
