STRUCTURAL DATA RECORD**Sufficiency Rating: 90.9****IDENTIFICATION**

Bridge ID: 1749 6142	(2) District: 01	(3) County: 3
Inventory Route:		(4) Place Code: 77580
(A) On/Under: 1	(B) Highway Type: 1	(C) Service Lvl: 7
(D) Route No: 00095	(E) Direction: 0	
6A) Features Intersected: LIBERTY STREET		6B) Critical: *
(7) Facility Carried: I 95 NB TO SR 4		
(9) Location: WILMINGTON		11) Km. Point: 0.012 mi
16) Latitude: 39°44'16.81"	17) Longitude: 75°33'44.34"	
98) Border Bridge Code: NA	99) Border Br. Str. No.: NA

Bridge Management Section MultiSpan PONTIS Element Report for Span No. 1

Inspection Date: 3/28/2013

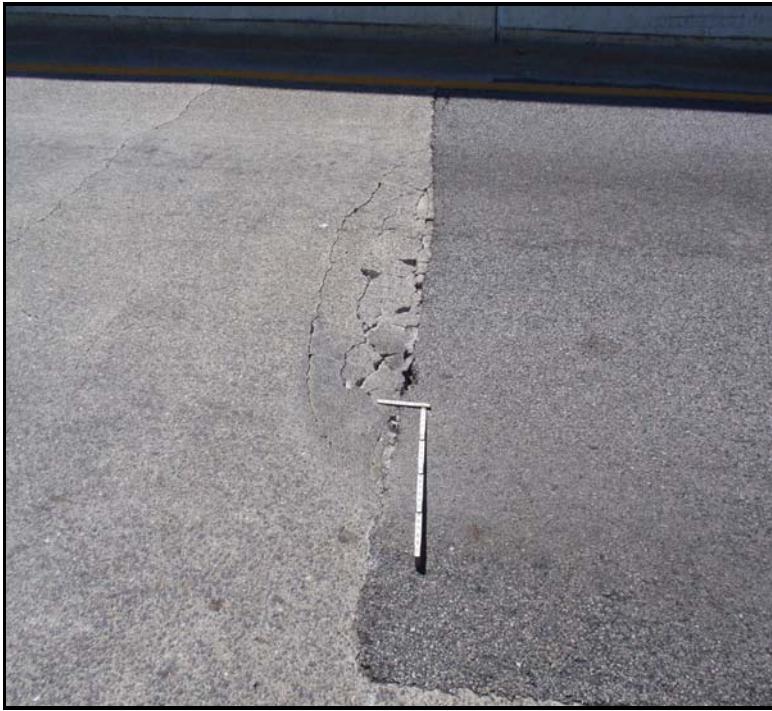
9. Span 5, S of bitum patch - 1/4" W cracks & up to 2" Diam x 1 1/2" D spalls.

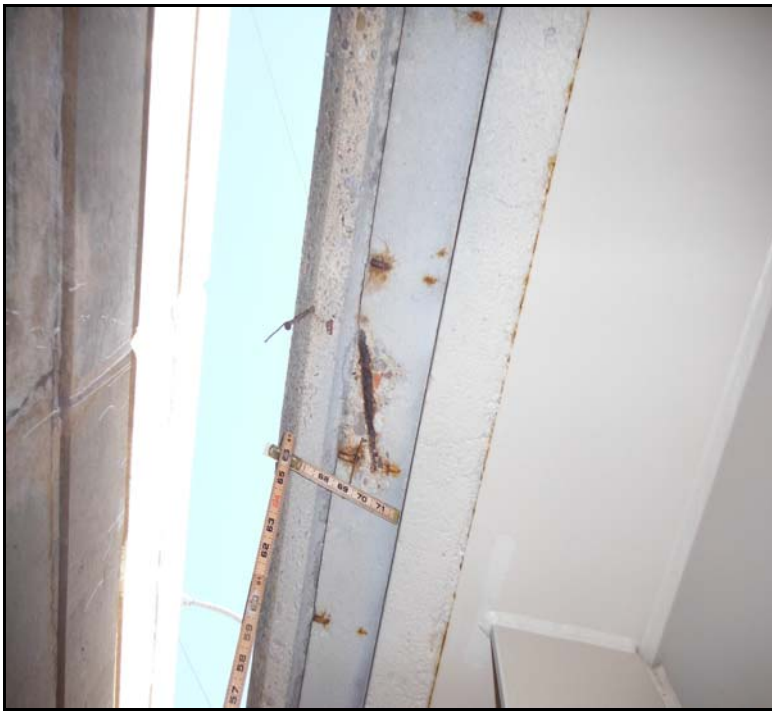
359	1	Soffit Smart Flag	(EA)	1	1	0	0	0	0	CS1: (1 EA) Several fine transv cracks. Span 1: W overhang w/ 6" L x 3" W x 1 1/2" D spall w/ exposed corroded steel reinforcement (See Photo 10). Span 2: At Pier 1A, E overhang w/ diagonal cracks w/ associated delamination. Span 3: Spall in Bay 3 at Pier 2A 18" L x 6" W x 1 1/4" D. Span 4: Random HL cracks. Bay 3, N & S end w/ diag cracks w/ efflo and associated delaminations (1 SF). Span 5: Bays 1 & 2 w/ exposed concrete w/ cracks w/ efflo. Previously noted spalling along deck haunch in Bay 3 @ Beam 4 top flange not observed. Span 6: Typ trans cracks w/ efflo and stalactites. Some small haunch spalls and delaminations. Random spots of rust stains from some soffit cracks. Typ scaled areas and map cracks throughout. SIP's - Span 6 w/ leaking & efflo from pans at abutment Bays 2 & 3, and minor in Bay 1. Also leaking at intermediate diaph's Bays 2 & 3. Typ thruout w/ areas of severe corrosion to pans at drainholes.

10. Span 1, N o/hang at midspan - 6"L x 3"W x 1 1/2"D spall w/ exp corr steel reinf.

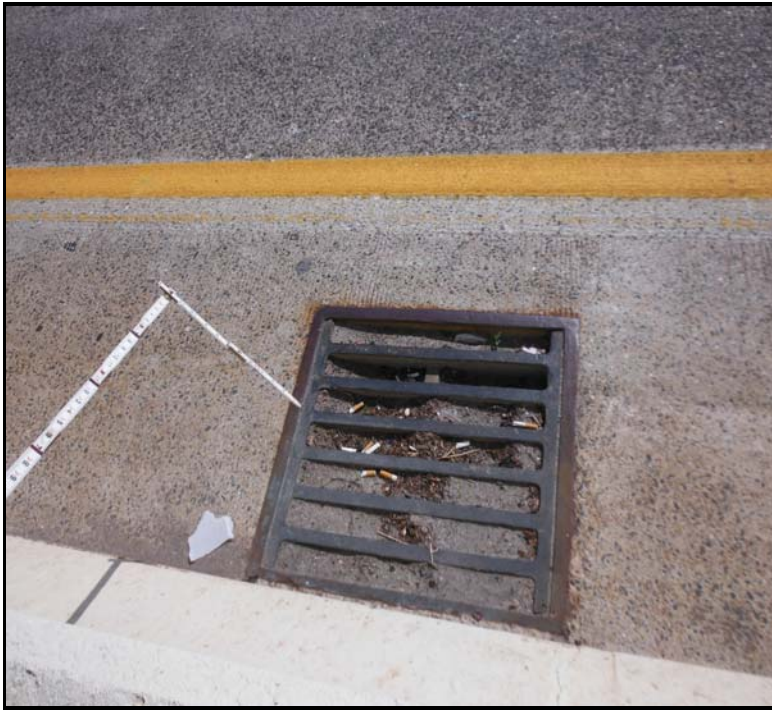
ELEM	ENV	DESCRIPTION	UNITS	TOTAL	CS1	CS2	CS3	CS4	CS5	COMMENTS
22	4	P Conc Deck/Rigid Ov	(SF)	0	0	0	0	0	0	0
65	4	Drainage	(EA)	1	0	0	1	0	0	CS3: (1 EA) Scupper clogged (See Photo 11) and downspout w/ removed section at bottom.
300	4	Strip Seal Exp Joint	(LF)	27	0	27	0	0	0	CS2: (27 LF) Partially filled w/ debris and evidence of leakage on pier at ends.
321	4	R/Conc Approach Slab	(EA)	0	0	0	0	0	0	0
107	3	Paint Stl Opn Girder	(LF)	296	260	20	16	0	0	CS2: (20 LF) Rolled Beams - Localized areas of spot rust on bottom & top flanges. Beam 1 w/ rust stains to top flange edge throughout. CS3: (16 LF) Few small areas of scraped paint w/ minor corrosion to exposed steel on bottom flanges, cover plates, and top flange of BM 1 and ends of BM 1 & 4 @ Piers 3A & 4A. Fascia flange edges of BM 4 w/ a few areas of corrosion near mid-length and BM 1 w/ corrosion to top flange at midspan.
331	4	Conc Bridge Railing	(LF)	150	133	7	10	0	0	CS2: (7 LF) W Parapet at S end w/ 6" Diam x 1" D corner spall @ base of interior face (1 LF). Exterior face of parapets w/ typ vert cracks (up to 1/8" W) that start at parapet jts and extend into soffit. CS3: (10 LF) Exterior face of E Parapet w/ horiz HL cracks w/ rust stains at S end and midspan (See Photo 15).

11. Span 4, W shoulder - Clogged scupper.

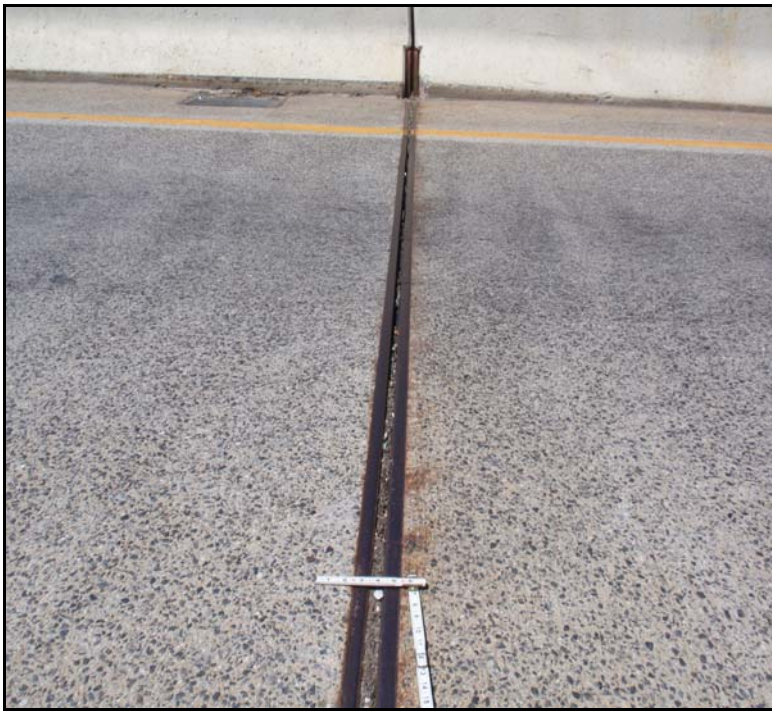
12. Pier 1A deck joint - Debris full-width and minor tears throughout.

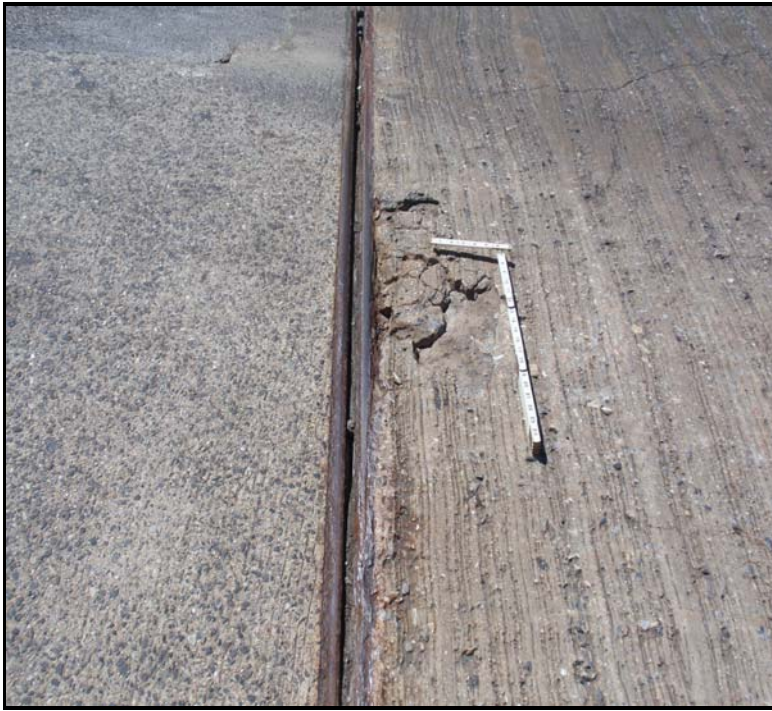
13. N Aprpr slab - 22" W x 11" L x 1" D spall & adj. joint armoring w/scrapes.

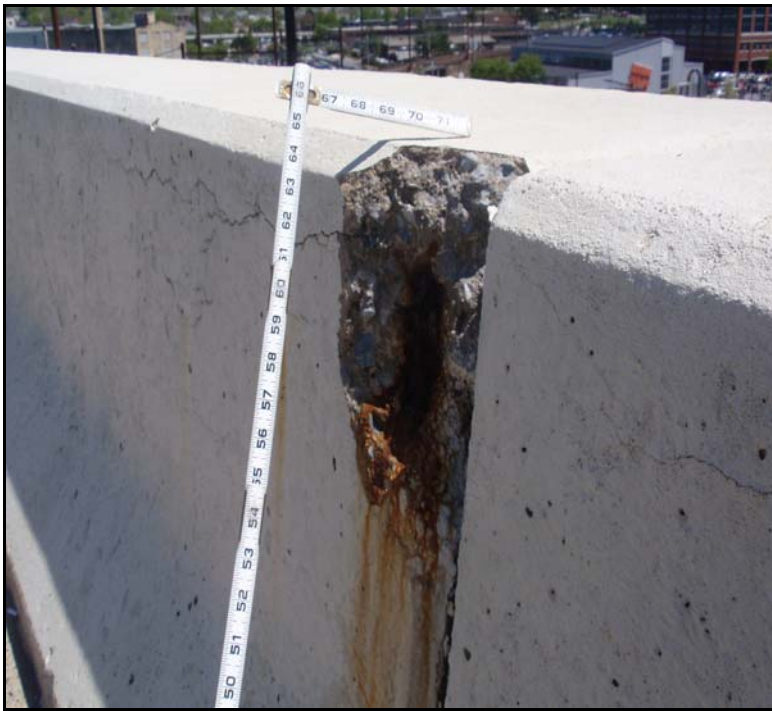
331	4	Conc Bridge Railing	(LF)	289	282	6	1	0	0	CS2: (6 LF) Ext face of barriers w/ typ vert cracks (up to 1/8" W) that start at parapet joints and extend into soffit. CS3: (1 LF) E. Parapet, S end w/ two spalls w/ exposed steel reinforcement 7" L x 11" W x 3" D at the top (See Photo 14) and 5" L x 7" H x 2 1/2" D at the base.
334	4	Metal Rail Coated	(LF)	16	16	0	0	0	0	NDO
381	3	Painted Steel Diaphr	(EA)	21	6	15	0	0	0	CS2: (15 EA) Most diaph's w/ minor spot/freckled rust and Bay 3 intermediate diaphragms near Pier 1A have some peeling paint.
311	4	Moveable Bearing	(EA)	4	4	0	0	0	0	CS1: (4 EA) Sliding plate bearings @ Pier 1A w/ minor corrosion to plate edges.
313	4	Fixed Bearing	(EA)	4	4	0	0	0	0	CS1: (4 EA) Fixed bearings at Pier 24 (Bridge 1748) are heavily greased w/ NDO.
205	3	R/Conc Column	(LF)	0	0	0	0	0	0	0
210	3	R/Conc Pier Wall	(LF)	7	6	0	1	0	0	CS3: (1 LF) 4" Diam delamination on S face at top near cap w/ rust stain.

14. Span 1, E Ppt at S end - 7"L x 11"H x 3"D spall @ top w/ exp corr steel reinf.

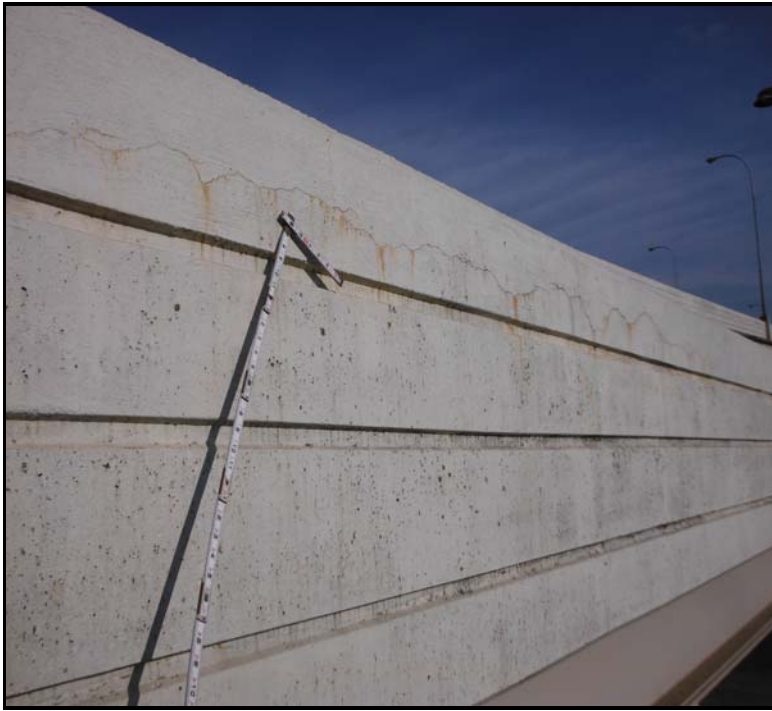
15. Span 4, E Ppt exterior face@ midspan - 10' L x HL crack w/ minor rust staining.

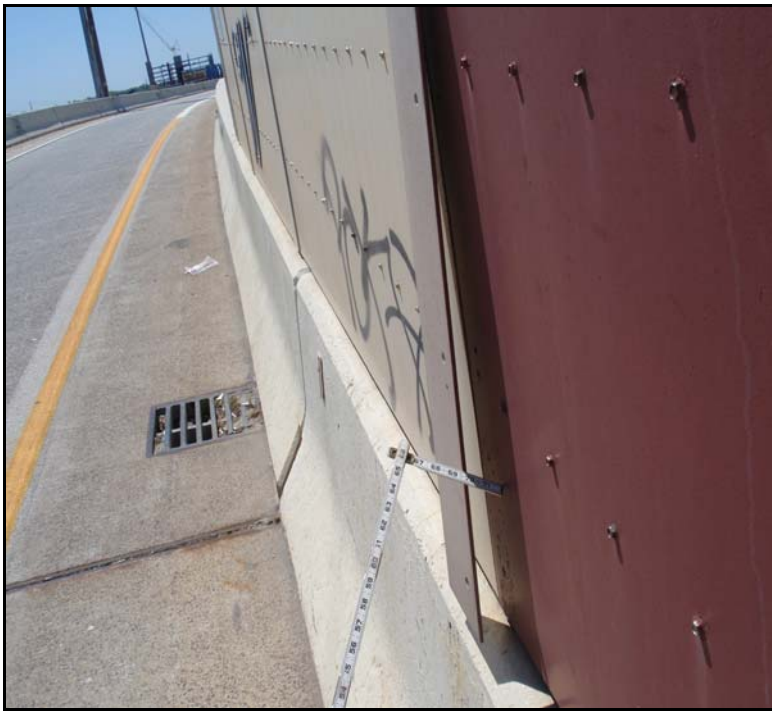
334	4	Metal Rail Coated	(LF)	220	214	6	0	0	0	CS2: (6 LF) Missing (12) and loose (1) fasteners for splice plates @ five total locations (5 @ west rail & 8 @ east rail). Worst case @ SW end of span w/ loose & protruding splice panel. (See Photo 16).
381	3	Painted Steel Diaphr	(EA)	18	8	10	0	0	0	CS2: (10 EA) Many have minor spot/freckled rust.
311	4	Moveable Bearing	(EA)	4	4	0	0	0	0	CS1: (4 EA) Sliding plate bearings @ Pier 2A w/ corrosion on plates; worst case @ Bearing 1.
313	4	Fixed Bearing	(EA)	4	4	0	0	0	0	CS1: (4 EA) Pier 1A bearings w/ corrosion to plate edges.
205	3	R/Conc Column	(LF)	0	0	0	0	0	0	0
210	3	R/Conc Pier Wall	(LF)	7	0	1	6	0	0	CS2: (1 LF) S. face w/ 26" H x 12" W x 1" D spall at bottom. CS3: (6 LF) S. face w/ vert crack w/ rust staining at mid-height w/ assoc. delam (4 LF). N. face of cap at W. end w/ few HL cracks w/ minor rust stains and assoc. delam (1 SF). W. face near bottom w/ vert crack w/ rust stains (30" L).

16. Span 2, W Ppt steel railing @ S end - Splice panel missing 6 of 8 fasteners.

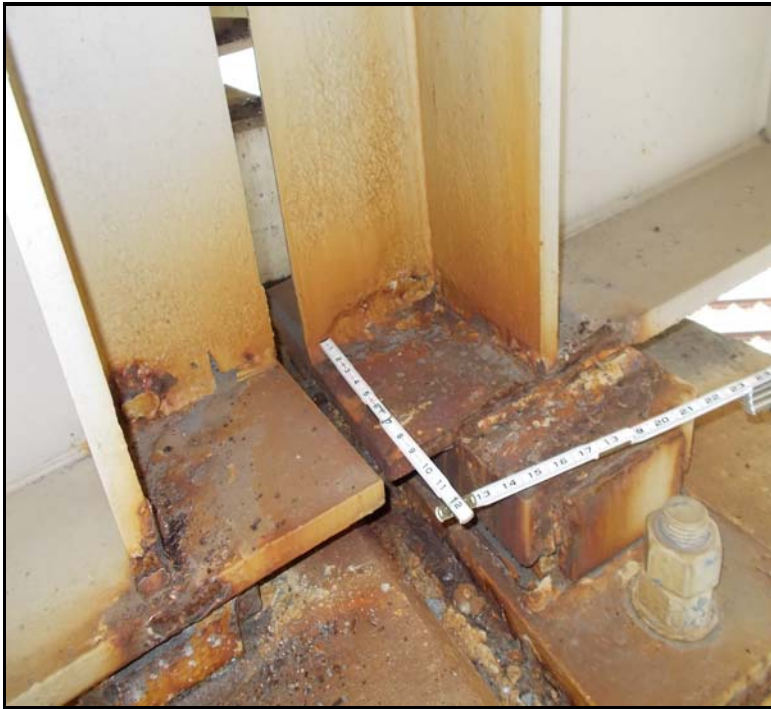
17. Span 2, G1 at P02A - Previously painted S.L. w/ exposed steel in web and flg.

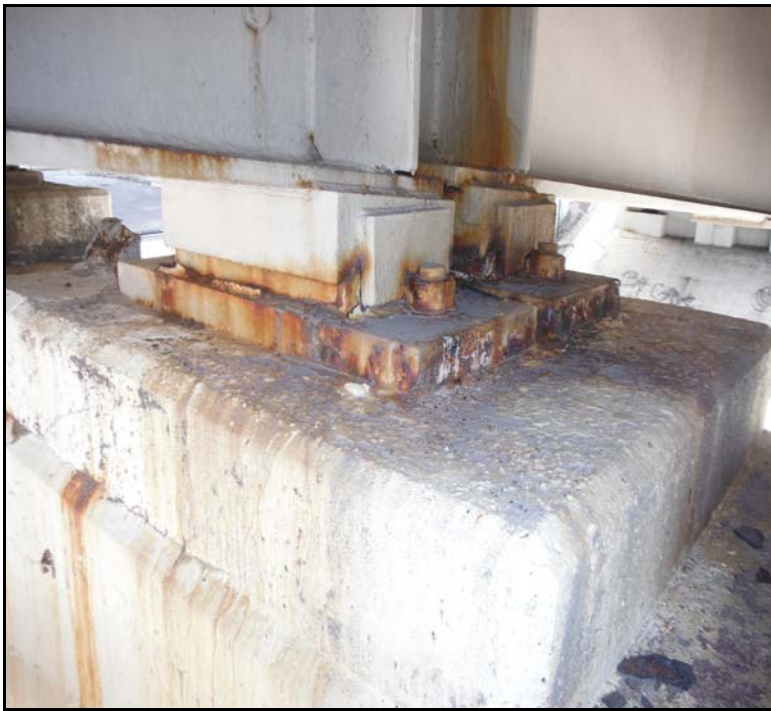
18. Pier 5A, BM 4, Span 5 Brg - Flaking paint w/ corrosion and rust lam on plates.

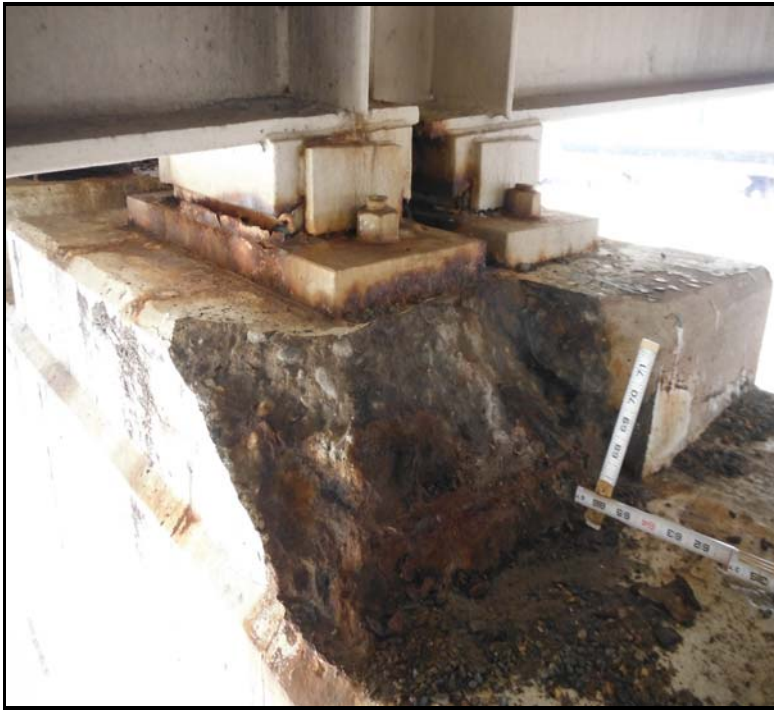
19. P05A, Ped 4, SW corner - 12"L x 18"W x FH spall w/ exp corr steel reinf.

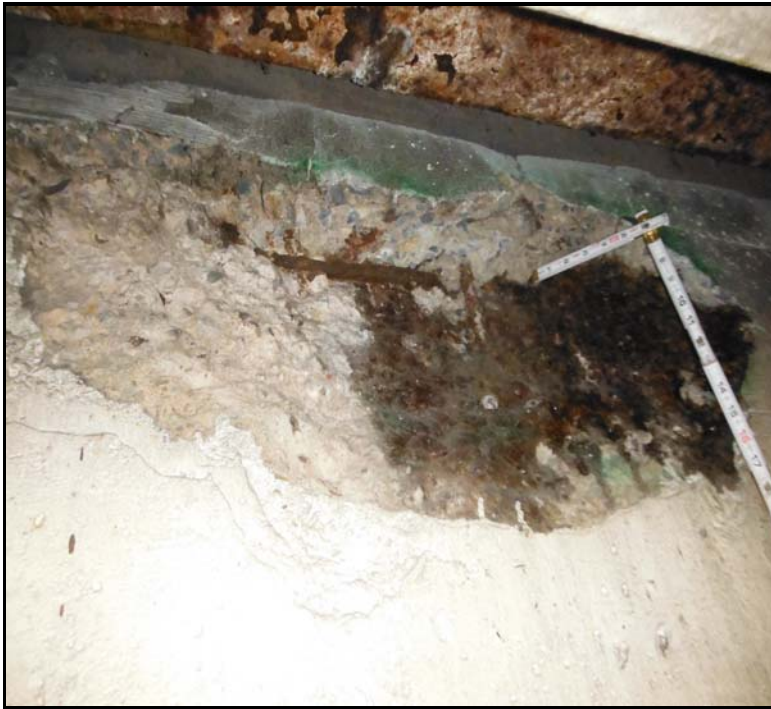
21. N Abut backwall @ Bay 3 - 15" H x 32" W x 3" D spall w/ exp corr steel reinf.

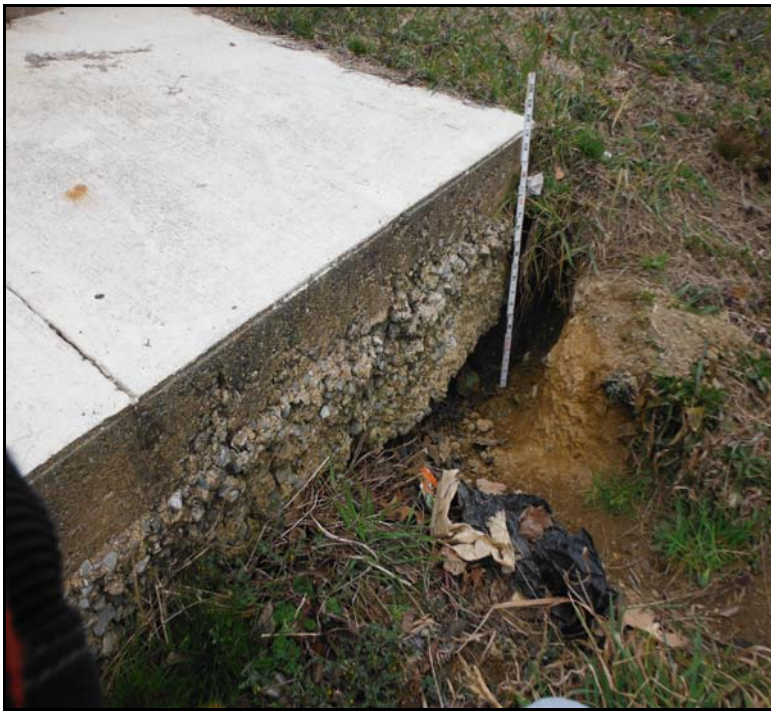
364	1	Erosion Smart Flag	(EA)	1	1	0	0	0	0	CS1: (1 EA) Area of erosion adjacent to the NE corner of the NE Wingwall (54" L x 24" W x 22" D). (See Photo 22).

22. NE Wingwall at NE corner - 54" L x 24" W x 22" D area of erosion.
