STRUCTURAL DATA RECORD**Sufficiency Rating: 97.8****IDENTIFICATION**

DELAWARE DEPARTMENT OF TRANSPORTATION

Bridge Management Section MultiSpan PONTIS Element Report for Span No. 1

Bridge ID: 1758E6141

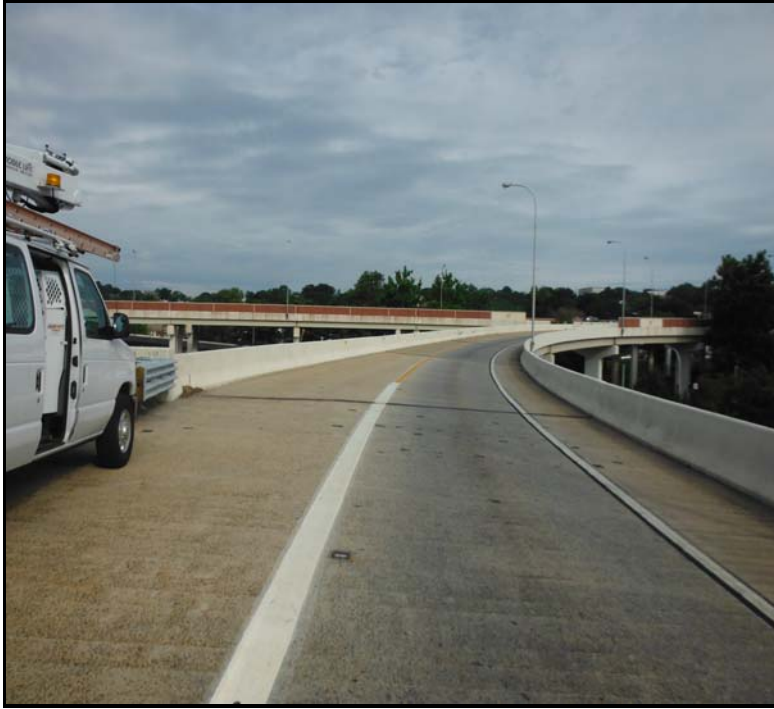
1. East approach, looking west onto the bridge.

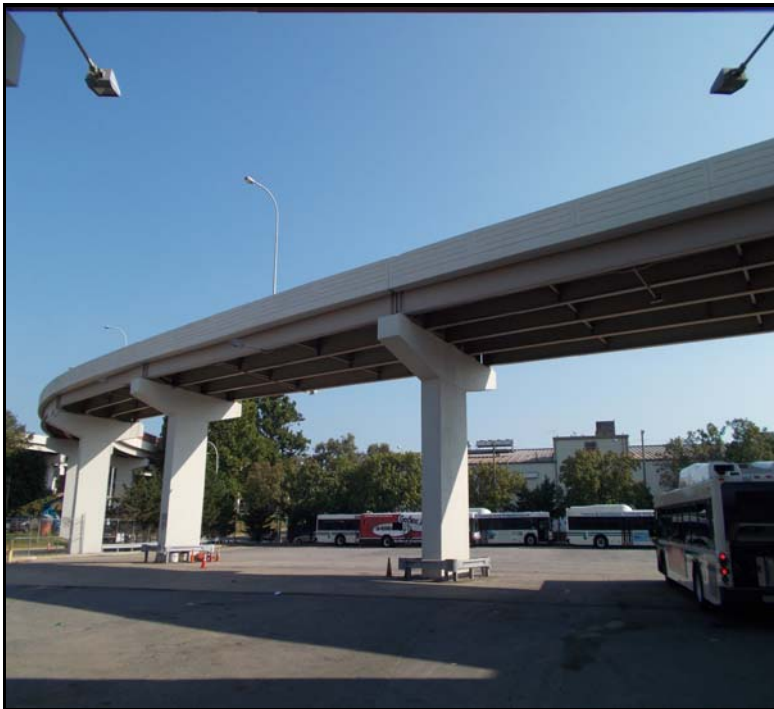
2. East elevation.

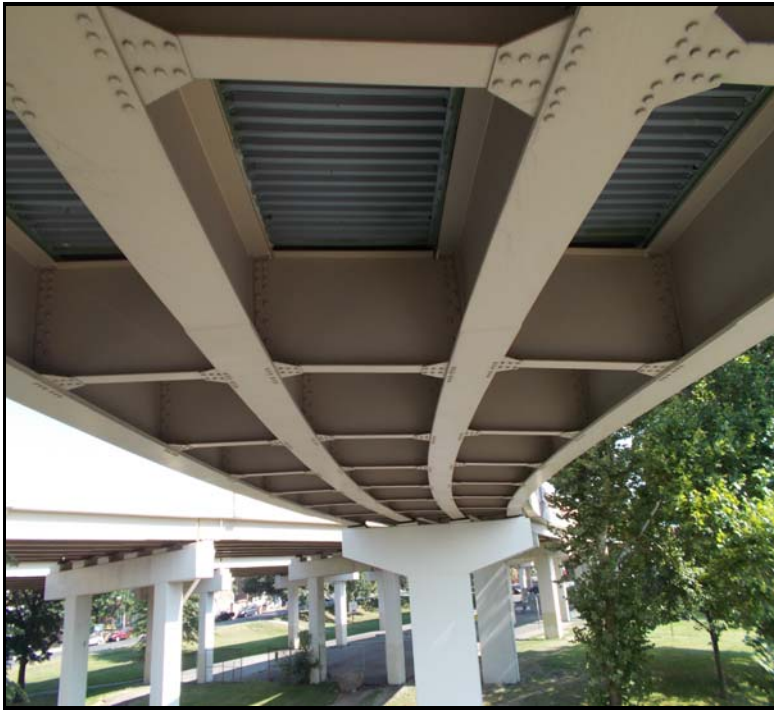
3. General view of Span 5 underside, looking northwest.

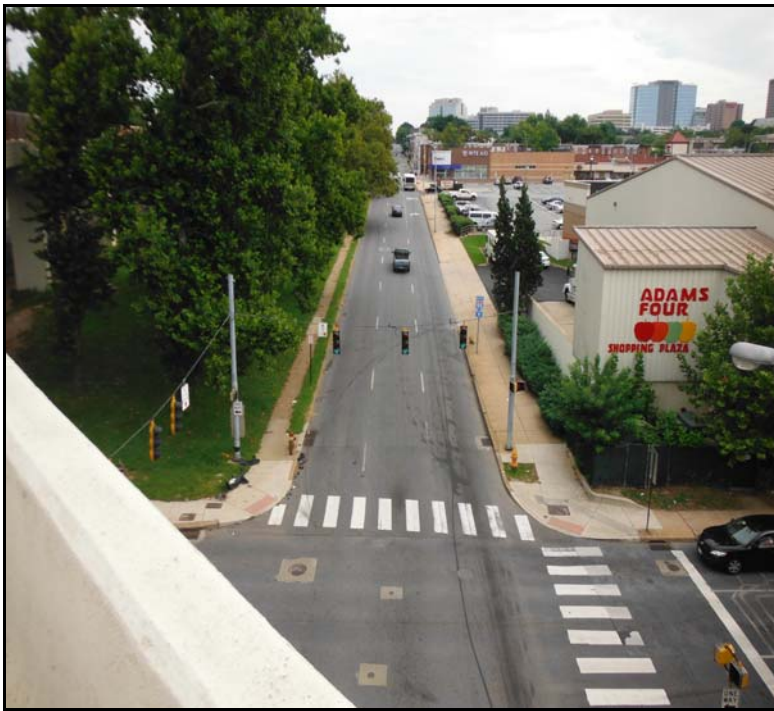
4. Under record, Span 4, Adams Ave, looking north.

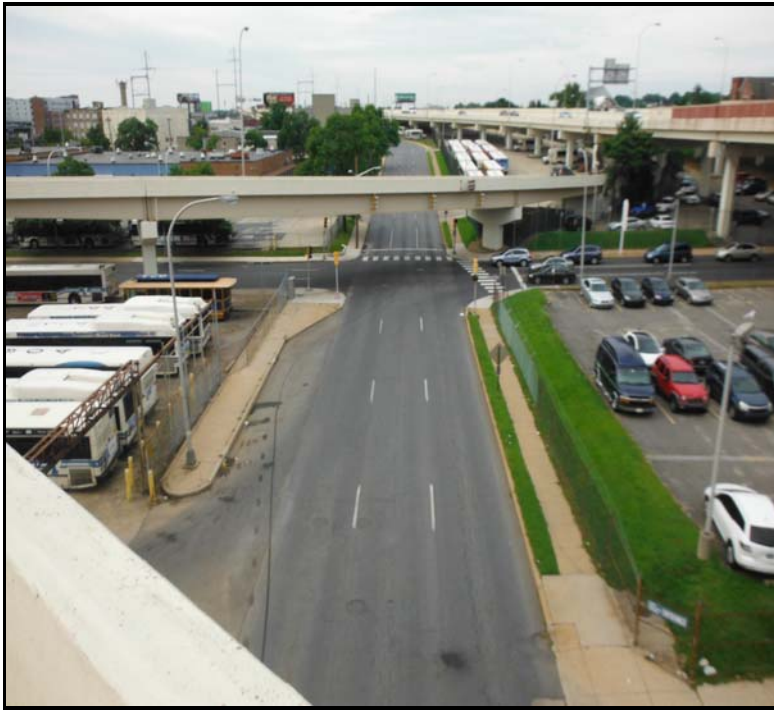
5. Under record, Span 4, Adams Ave, looking south.

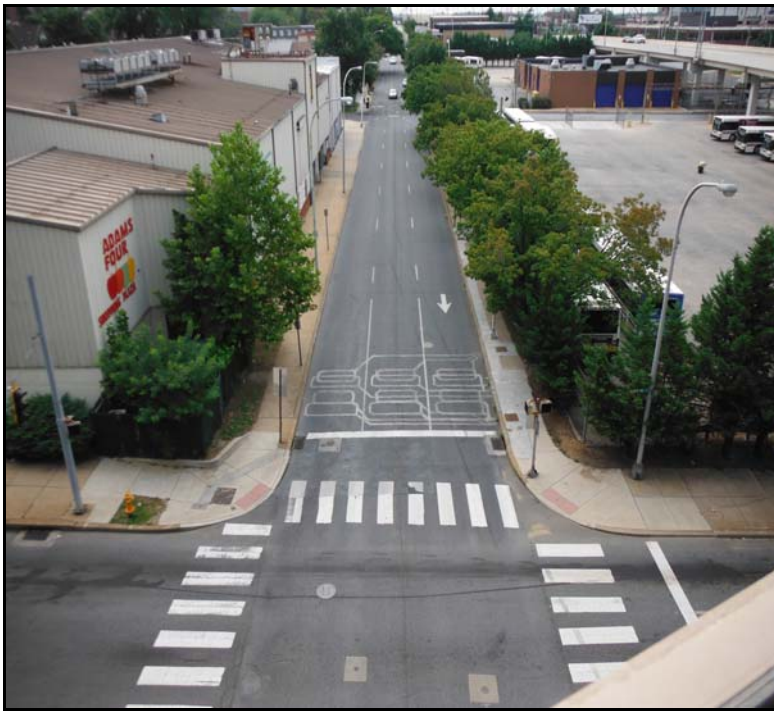
6. Under record, Span 5, 2nd Ave, looking east.

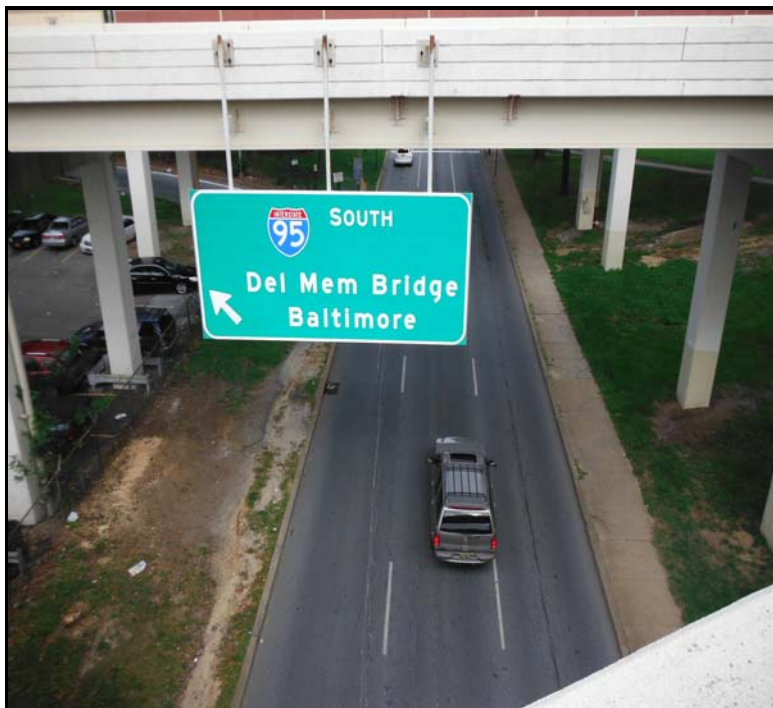
7. Under record, Span 5, 2nd Ave, looking west (Bridge 1-748N shown).

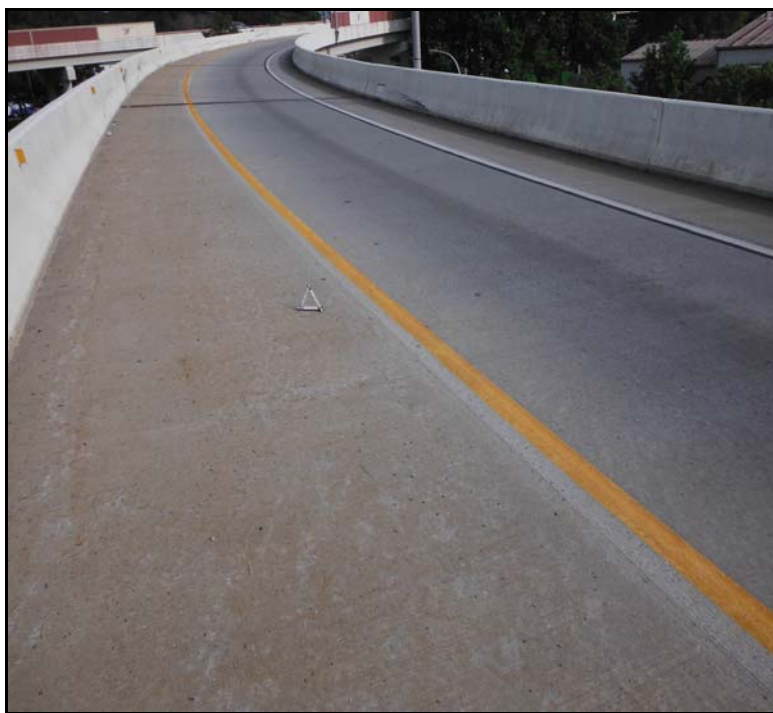
8. General view of Span 2 top of deck, looking northwest.

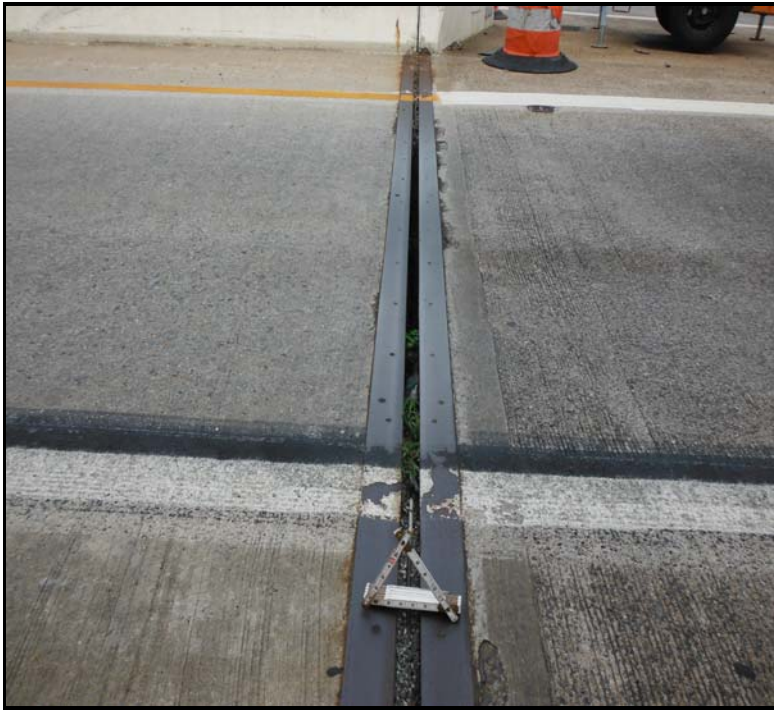
ELEM	ENV	DESCRIPTION	UNITS	TOTAL	CS1	CS2	CS3	CS4	CS5	COMMENTS
26	4	Conc Deck/Coatd Bars	(SF)	0	0	0	0	0	0	0
65	4	Drainage	(EA)	0	0	0	0	0	0	0
302	4	Compressn Joint Seal	(LF)	25	0	0	25	0	0	CS3: (25 LF) Pier E6 seal is not water tight, portion in Bay 2 & 3 hangs down (sunken up to 1.2') (Photo 9). Minor spalls in adj. conc. deck on top and filled w/ debris.
107	3	Paint Stl Opn Girder	(LF)	288	227	55	6	0	0	CS1: (227 LF) End 5' of all BMs at PE6 have previously been painted (prior to previous inspection). CS2: (55 LF) Localized light spot or freckled rust at ends and on bottom flanges. BM4 w/ light rust thruout bottom flange and BMs 1-3 w/ light freckled rust along W. half of bottom flange. CS3: (6 LF) BM4 end at PE6 and near PE6 with 1' long areas of mod. corrosion on bottom flange. BMs 1-4 at PE7 have minor corr. with exposed steel and surface rust (Photo 13).
331	4	Conc Bridge Railing	(LF)	144	142	1	1	0	0	CS2: (1 LF) Spall to outside face of S. parapet @ W. end (8"L x 19"H x 1"Dp). CS3: (1 LF) Spall and crack w/ rust stain @ NW end (outside face).

9. PE6 joint, looking southwest. Joint seal has failed.

INSPECTED BY: Pennoni Associates, Inc. - SON
 (I,P), CWM (I), KFA (TL, I, R, P), DJC (I)
 Maintenance Items: Repair all deck joints.
 Repair parapet spalls. Clean & flush deck.
 Reattach conduit for lights in Span 2.
 Securely attach mast arm on the u/side of BM 2
 in Span 1. Cover exposed wires at light post
 supports in Spans 2 & 5. Inspection Notes:
 Spans are labelled East to West (beginning
 with Span 1). Piers are labelled West to East
 beginning with Pier E6 at the West end. Span

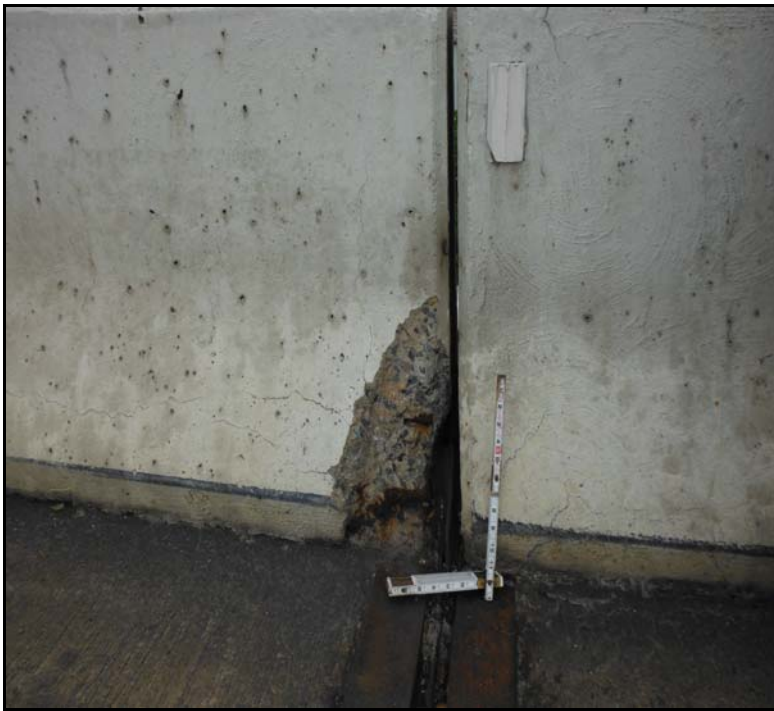
ELEM	ENV	DESCRIPTION	UNITS	TOTAL	CS1	CS2	CS3	CS4	CS5	COMMENTS
26	4	Conc Deck/Coatd Bars	(SF)	0	0	0	0	0	0	0
65	4	Drainage	(EA)	0	0	0	0	0	0	0
302	4	Compressn Joint Seal	(LF)	26	0	26	0	0	0	CS2: (26 LF) Joint material is sunken up to 1 1/2". Evidence below (rust stains) that the joint is not water tight. Some debris in the top of the joint. Spalling along jt.
107	3	Paint Stl Opn Girder	(LF)	373	319	51	3	0	0	CS2: (51 LF) Beam ends @ S. jt w/ light spot rust, BM 1 W. half w/ freckled rust, BM 2 w/ random spot & freckled rust on bott fl. BM 4 w/ light freckled rust along W. half. CS3: (3 LF) W. end of BM 4 @ top flange edge w/ chipped paint and rusted base metal @ soffit spall.
331	4	Conc Bridge Railing	(LF)	188	185	1	2	0	0	CS2: (1 LF) Cr w/ delam in NW end of barrier (4"W x 1'H) @ Pier E8. CS3: (2 LF) Large spall at the base of the NE end of barrier @ Pier E9 joint w/ exp. reinforcing (8"L x 17"H x 3"Dp) and small spall (2" diam) in top of N. parapet w/ exp steel (Photo 10).

10. Span 4, N. parapet at PE9. The parapet has an 8"L x 17"H x 3"Dp spall.

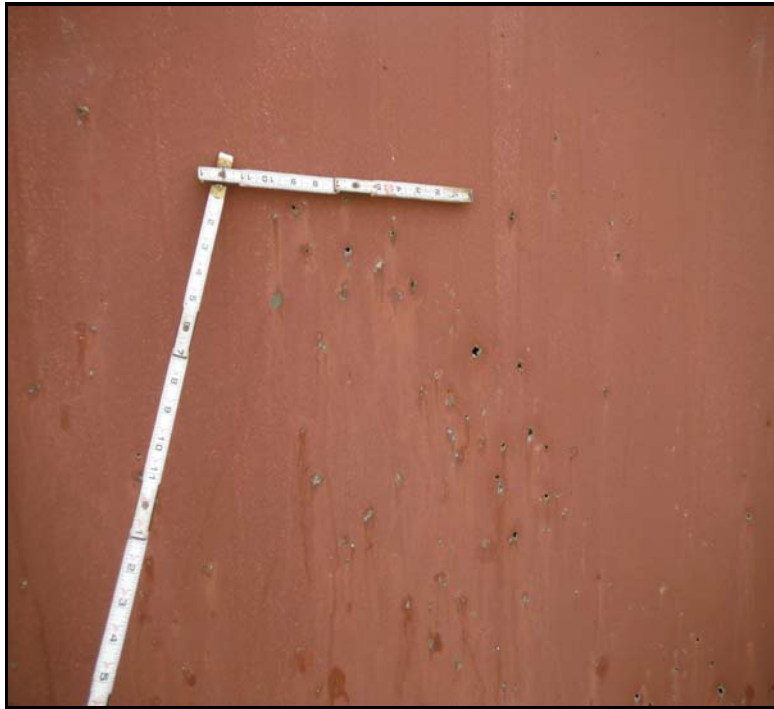
11. Span 5, N. sound wall, 4th panel from W. end. Areas of 100% SL.

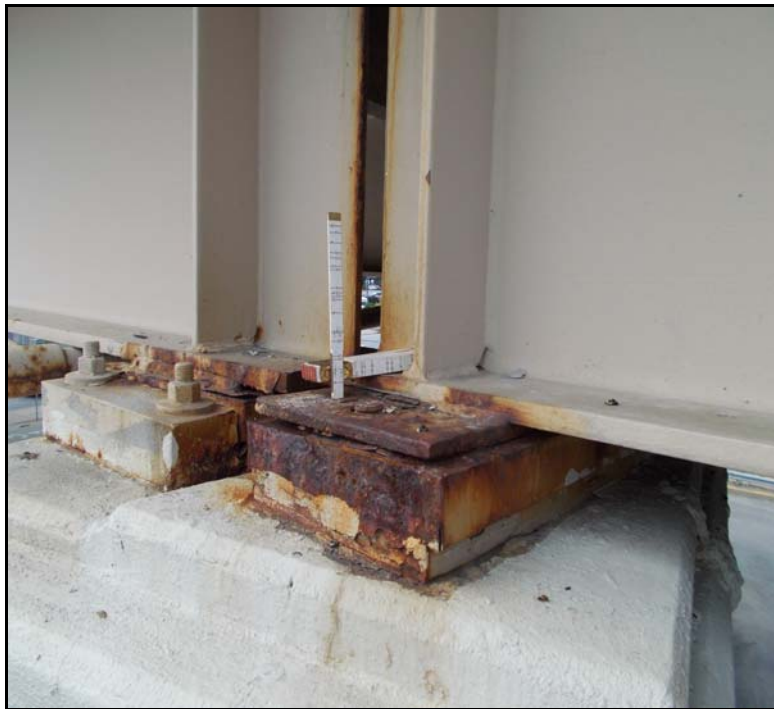
12. Span 1, Brg 5 @ PE12. N. AB sheared off and pack rust btwn plates.

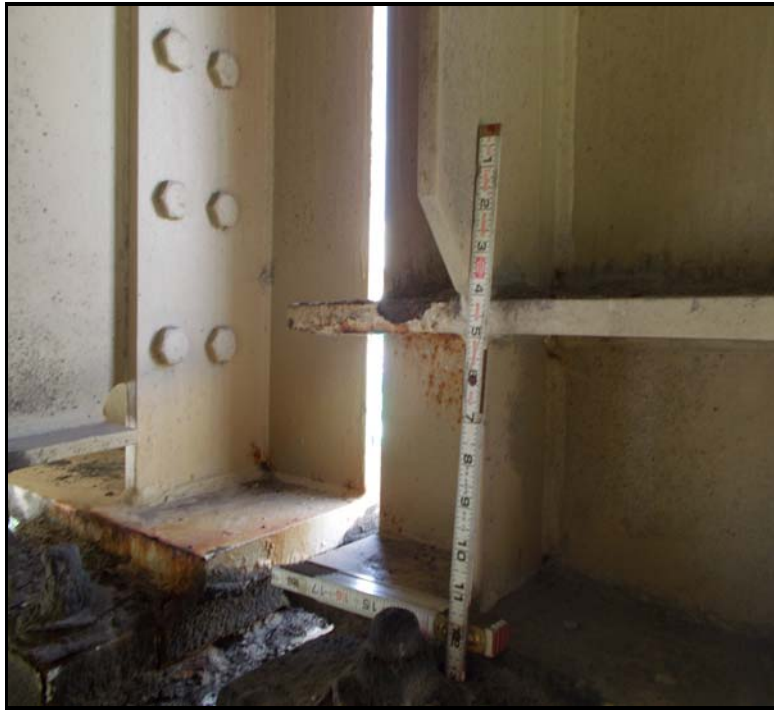
13. Span 6, BM1 at PE7 has exposed steel with surface rust.

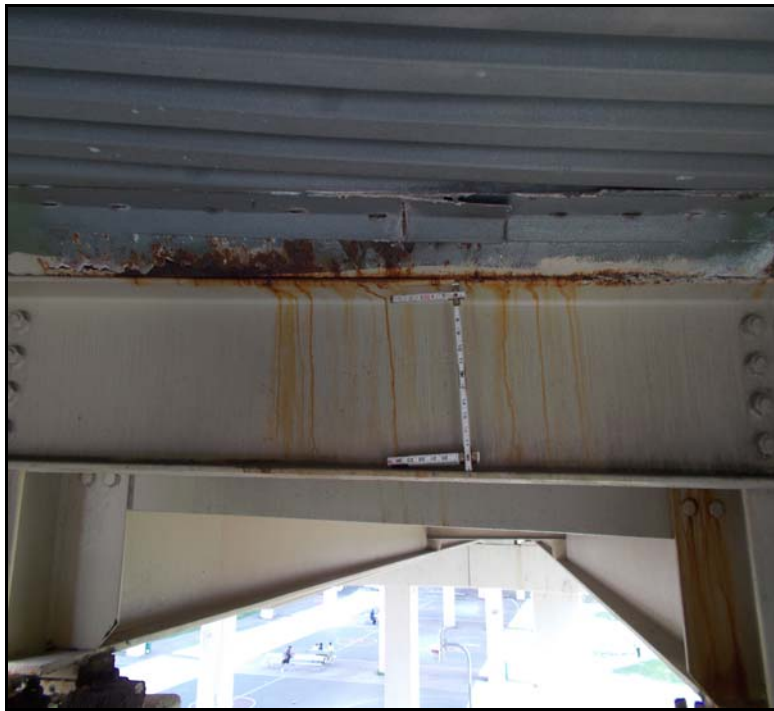
14. Span 6, Bay 1 end diaphragm at PE6 has moderate corrosion.

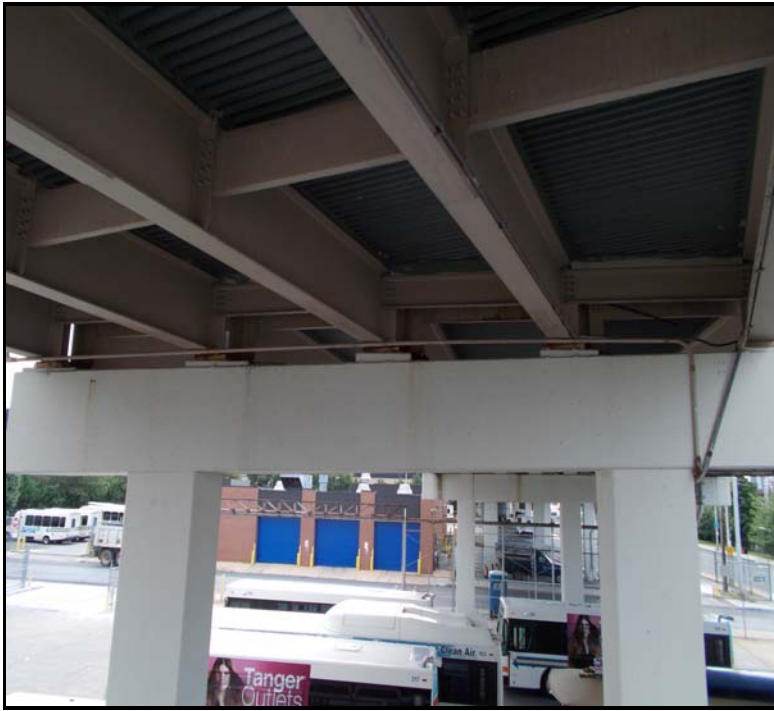
234	3	R/Conc Pier Cap	(LF)	29	28	1	0	0	0	Pier cap repaired and painted since the previous inspection (Photo 15). CS2: (1 LF) Top of cap between BM2 and BM3 has 12"L x 18"W delam.
358	1	Deck Cracking SmFlag	(EA)	1	1	0	0	0	0	CS1: (1 EA) Scattered HL to fine cracks. (NC-13)
359	1	Soffit Smart Flag	(EA)	1	1	0	0	0	0	CS1: (1 EA) Few HL to fine trans. cracks at o/hangs typ. Cracks w/ rust @ jts. Span 2 @ NE end w/ 3" dia. spall @ BM 4 top flange. Span 3 w/ 12"W x 2"L spall in exposed concrete in Bay 3 @ E. end. Span 4 @ NW end w/ 22"L x 4"W spall w/ exp. ends of steel. Ends of Spans 2 & 3 @ N. o/hang w/ long cracks up to 2'L w/ rust. Spans 5 & 6 NE o/hang w/ HL long cracks up to 2'L w/rust.

15. Span 1, PE12 has been repaired since prev. inspection (typ).

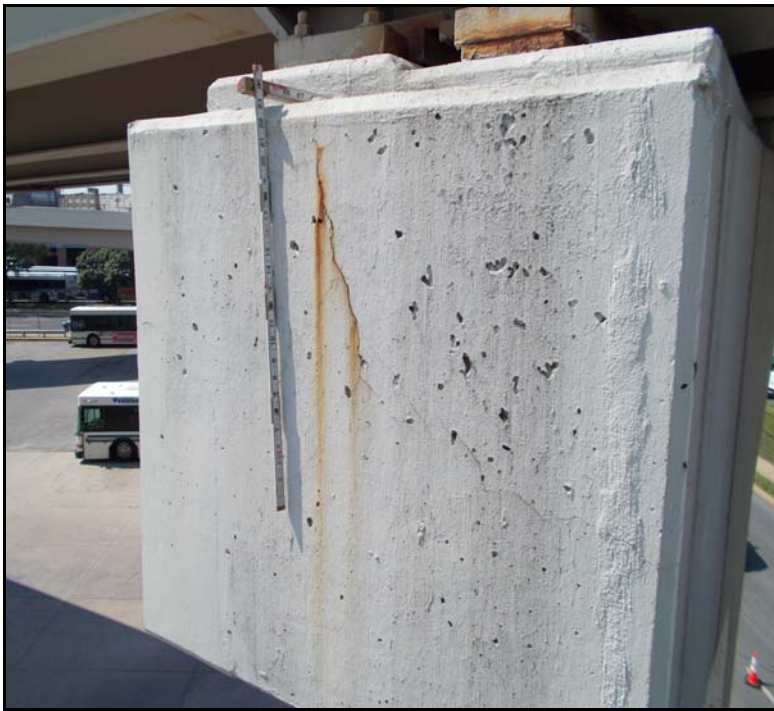
310	4	Elastomeric Bearing	(EA)	4	1	3	0	0	0	CS1: (1 EA) Pier E10 Brg 4 w/ freckled rust. CS2: (3 EA) Brg's 1 & 2 w/ pack rust between the sole & filler plates has deformed filler plates by 1/2" max (prev. 3/8") @ Brg 1 and 3/8" max @ Brg 2. Brg 3 w/ flaking paint w/ exp metal w/ lt freckles. E. anchor bolt @ Brg 3 is slightly bent.
311	4	Moveable Bearing	(EA)	4	0	4	0	0	0	CS2: (4 EA) Pier E9 Brg 1 w/ slightly bent anchor bolts on the S. side, light freckled & spot rust w/ cracking and flaking paint and laminated rust on guide plt w/ <1/16" section loss.
210	3	R/Conc Pier Wall	(LF)	8	7	1	0	0	0	Pier wall repaired and painted since the previous inspection. CS2: (1 LF) West face has two vertical cracks up to 3'L x 1/16"W.
234	3	R/Conc Pier Cap	(LF)	26	23	1	2	0	0	Pier cap repaired and painted since the previous inspection. CS2: (1 LF) Top of cap between BM 3 & BM 4 has a 1' dia. delam. CS3: (2 LF) N. end has a full-height vertical crack up to 1/16"W with rust stain (Photo 16). E. face at BM 2 has a 12"L HL horiz crack with rust.

16. PE8, N. end of cap has a crack with corrosion staining.

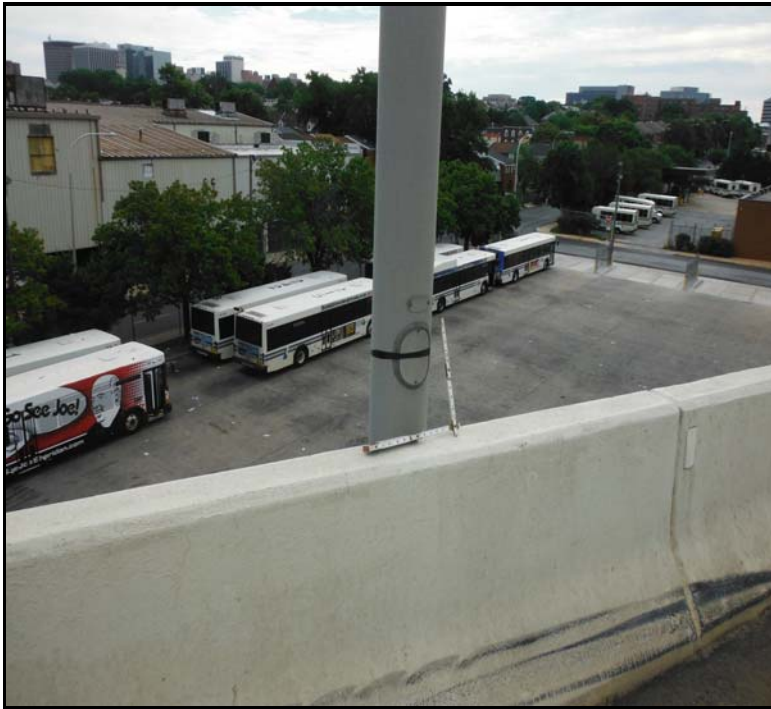
17. Span 2 light pole handhole cover has been replaced since prev. inspection.

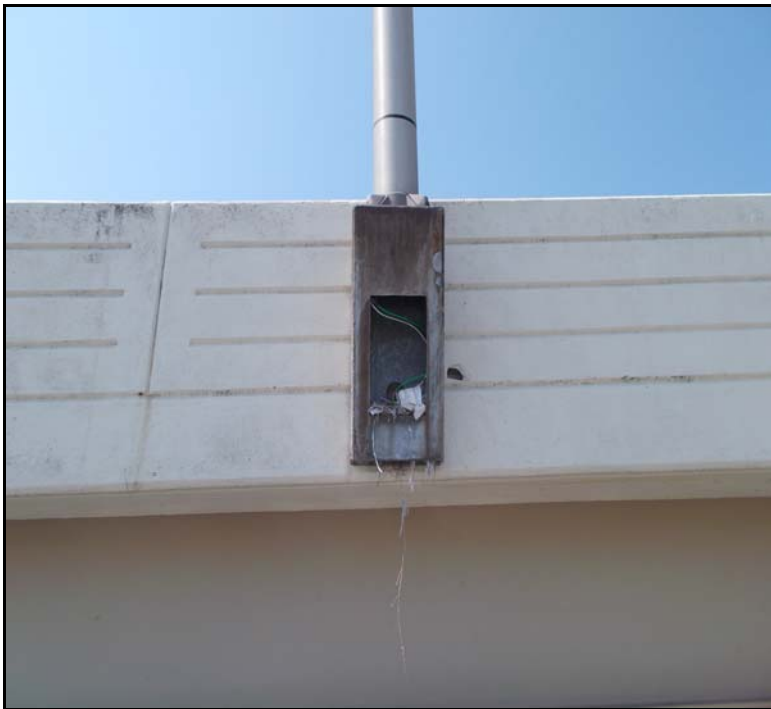
1: Light pole attached to u/side of BM 2 w/
 one u-bolt instead of two which is allowing
 more severe vibration. Span 2: Conduit
 attached to u/side of BM 2 has pulled off the
 beam @ E. end of span and is hanging down.
 Lights attached to u/side of BM 2 & 3 w/ two
 u-bolts w/ very slight vibration - NDN.
 Junction box cover in N. Parapet is missing 6
 of 10 screws; cover is secure. Previously
 noted missing handhole cover has been replaced
 (Photo 17). Light post support on the N. side
 of barrier is open with exposed wires and
 trash (Photo 18). Span 3: Bay 3 @ E. end w/
 section of missing SIP's. Lights attached to
 u/side of BM 1 & 4 w/ two u-bolts each w/
 slight vibration - NDN. Span 5: Junction box
 cover in N. Parapet is missing 8 of 10 screws;
 cover is secure. Previously noted missing
 handhole cover has been replaced. Light post
 support on the N. side of the parapet is open
 with exposed wires and trash.

18. Span 2 light pole on N. parapet. N. side open with exposed wires and trash.
