**STRUCTURAL DATA RECORD****Sufficiency Rating: 98.0****IDENTIFICATION**

Bridge ID: 1758F6149	(2) District: 01	(3) County: 3
Inventory Route:	(B) Highway Type: 1	(4) Place Code: 77580
(A) On/Under: 1	(E) Direction: 0	(C) Service Lvl: 7
(D) Route No: 00095		6B) Critical: *
6A) Features Intersected: MLK BLVD & ADAMS ST		11) Km. Point: 0.010 mi
(7) Facility Carried: RAMP TO I 95 S		
(9) Location: WILMINGTON		
16) Latitude: 39^44'29.15"	17) Longitude: 75^33'40.13"	
98) Border Bridge Code: NA	99) Border Br. Str. No.: NA

# DELAWARE DEPARTMENT OF TRANSPORTATION

## Bridge Management Section MultiSpan PONTIS Element Report for Span No. 1

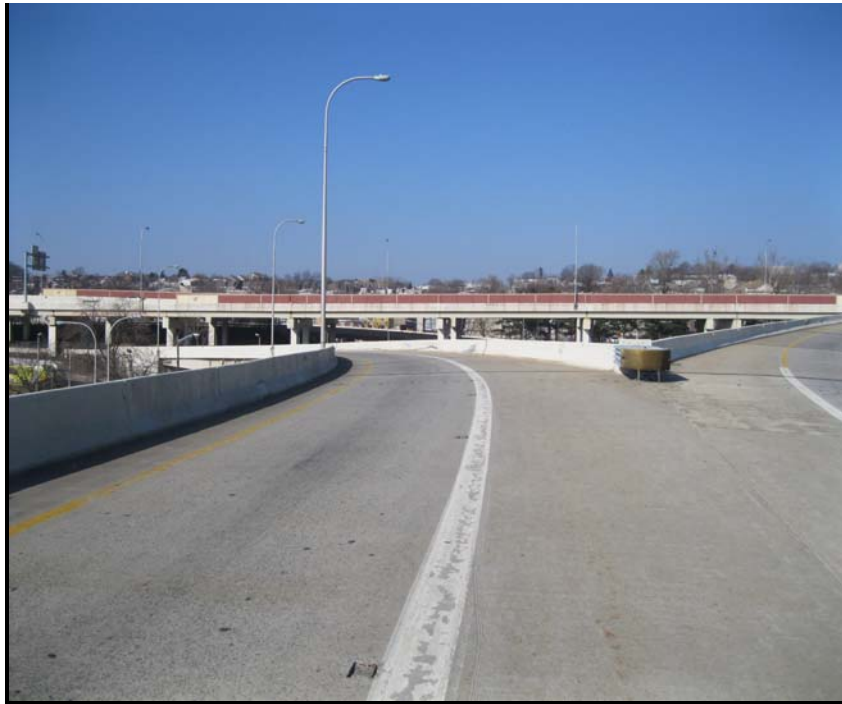
1. East approach roadway, looking West

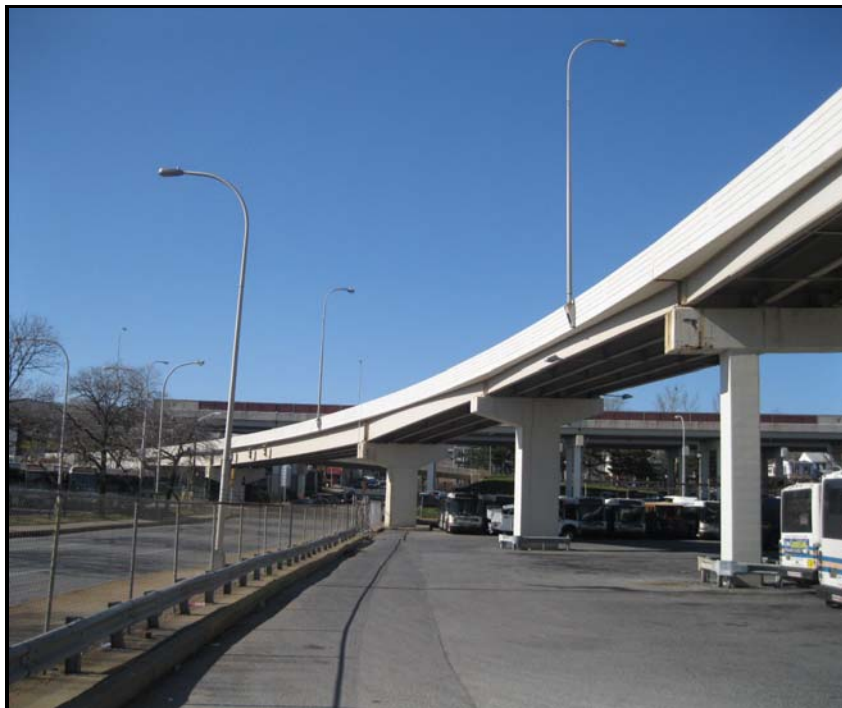
2. Southeast Elevation, looking Northwest

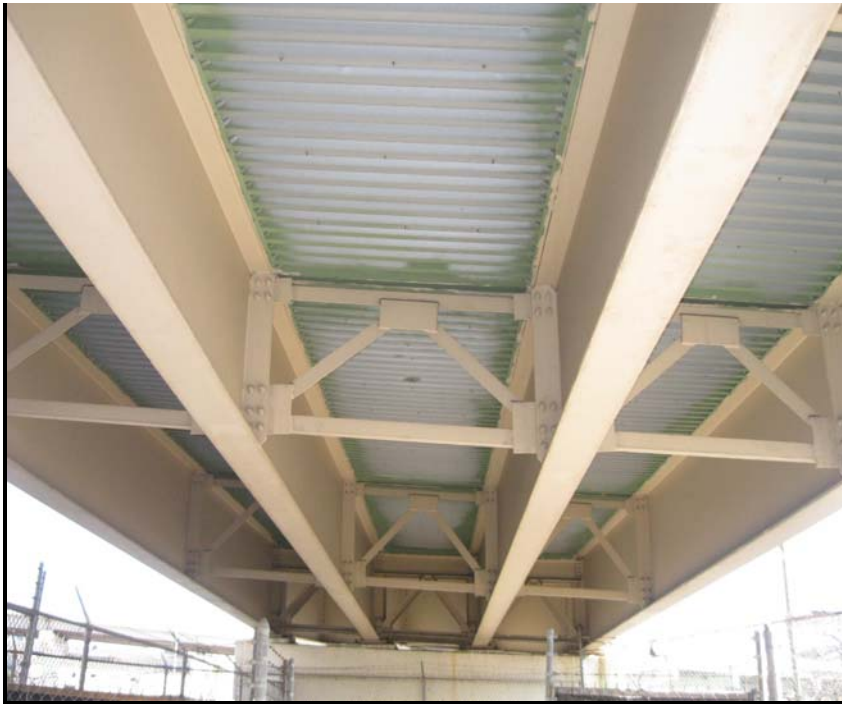
3. General view of the underside, Span 1, looking Northeast

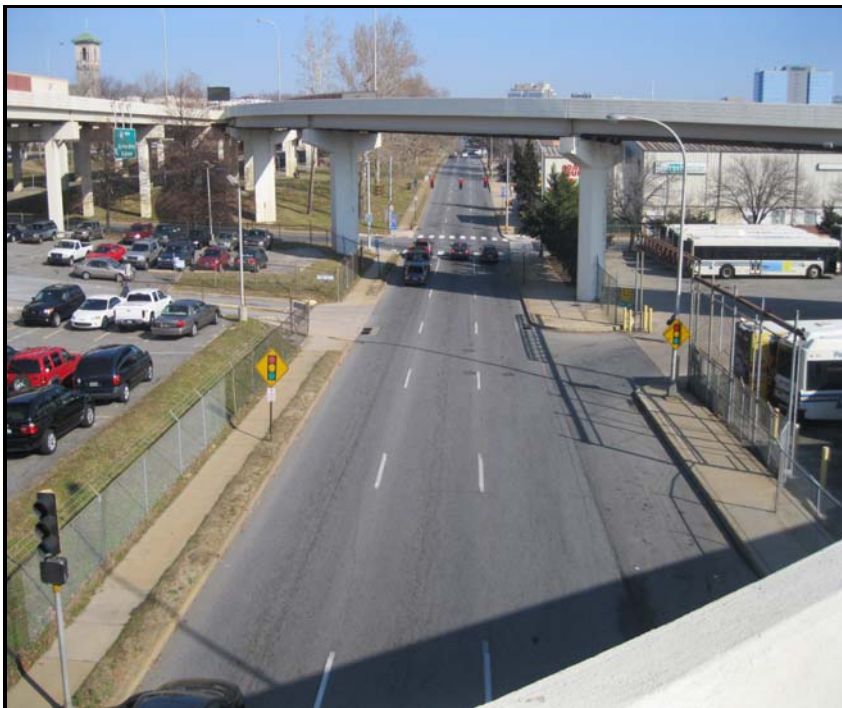
4. Under Record, Span 2 over Adams St, looking North

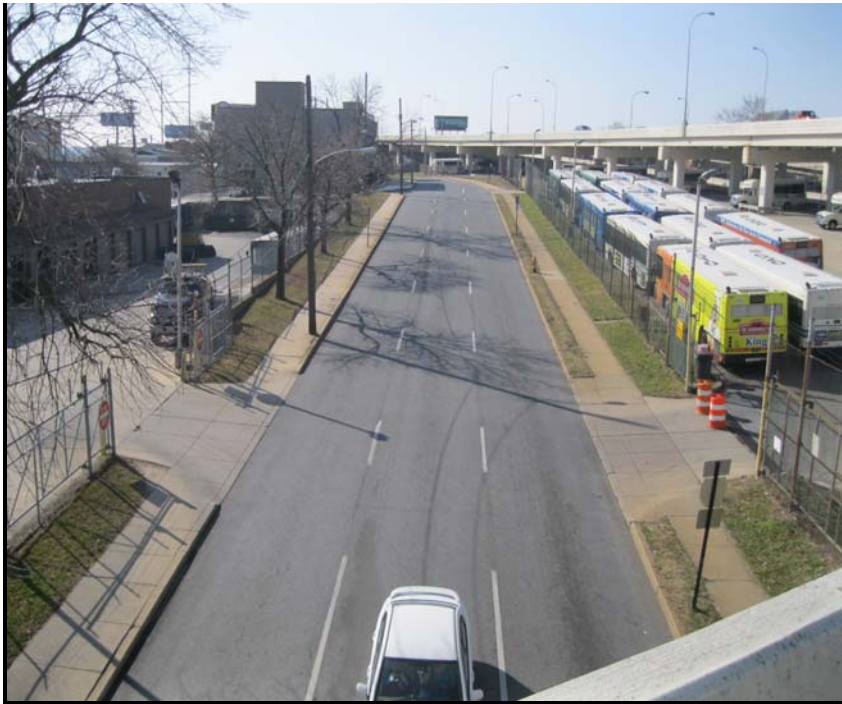
5. Under Record, Span 2 over Adams St, looking South

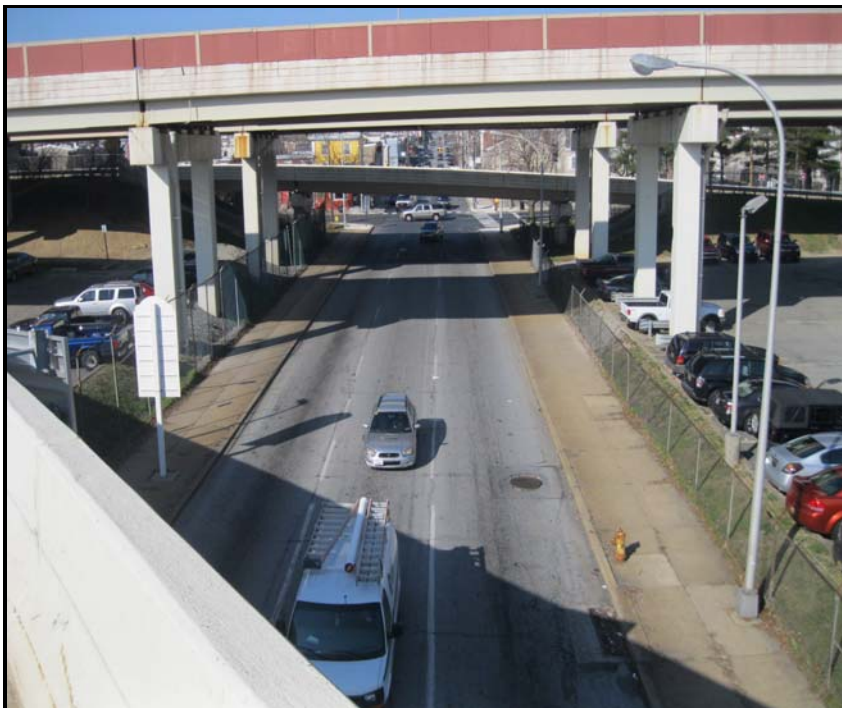
6. Under Record, Span 2 over Lancaster Ave, looking West

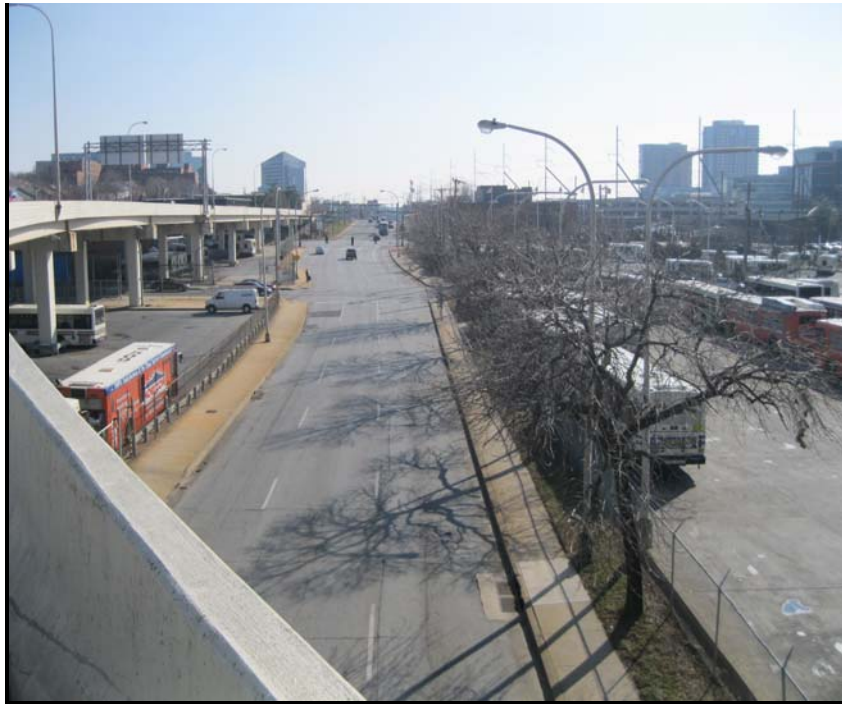
7. Under Record, Span 2 over Lancaster Ave, looking East

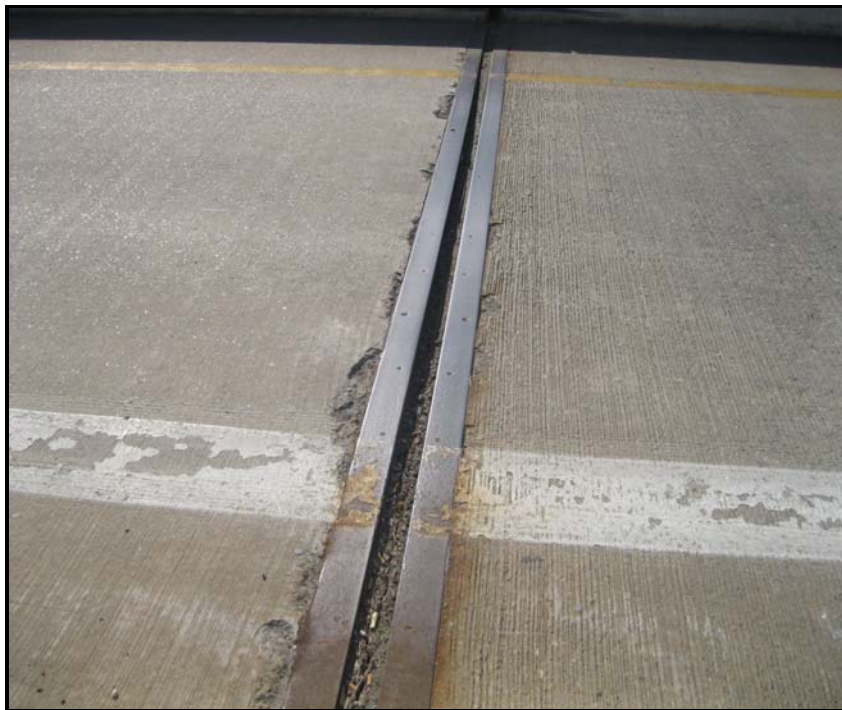
8. Typical deck joint and spalls along the adjacent deck, Pier 2, looking Southeast

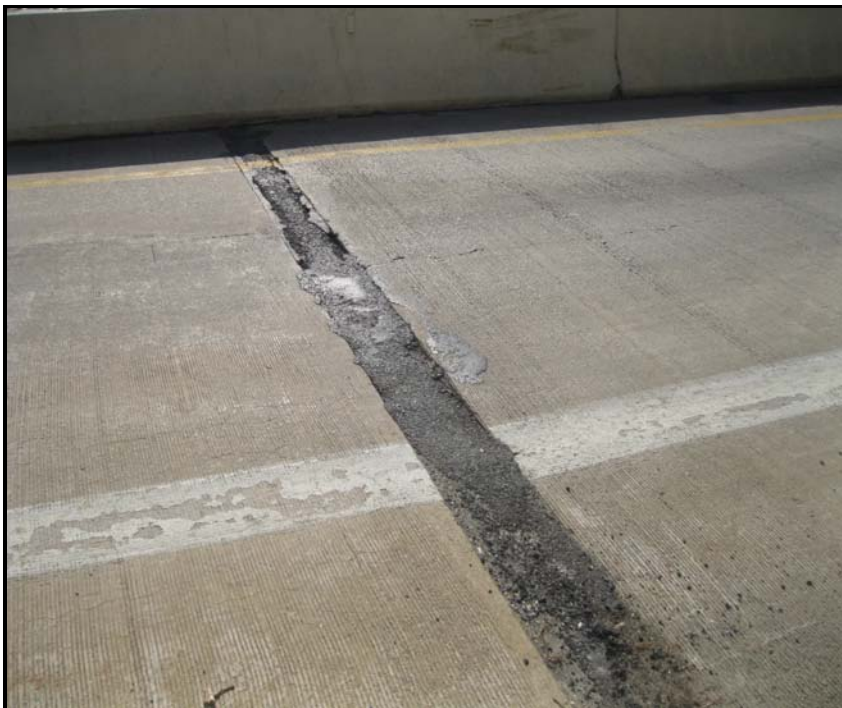
10. Deteriorated relief joint in southwest approach roadway, looking Southeast

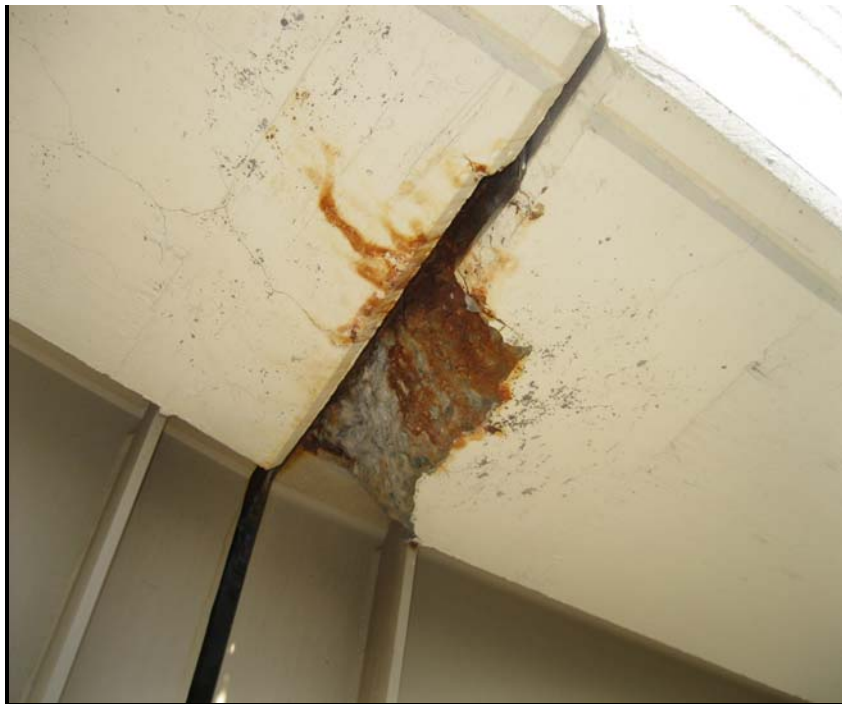
11. Typical soffit spall, South overhang at Pier 3 in Span 4

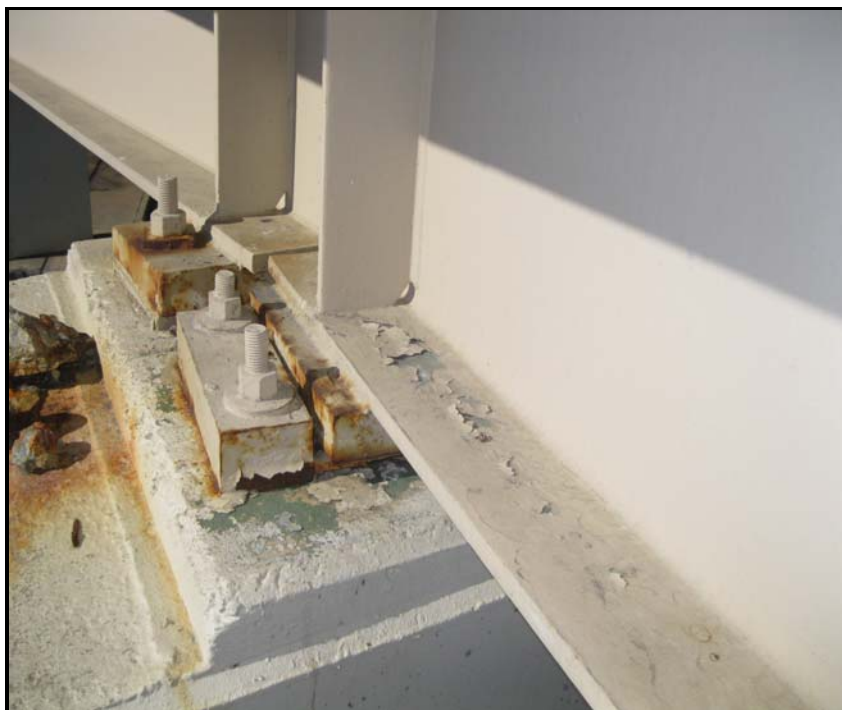
12. Peeling paint with exposed primer to the bottom flange of Beam 4, Span 4 at Pier 3

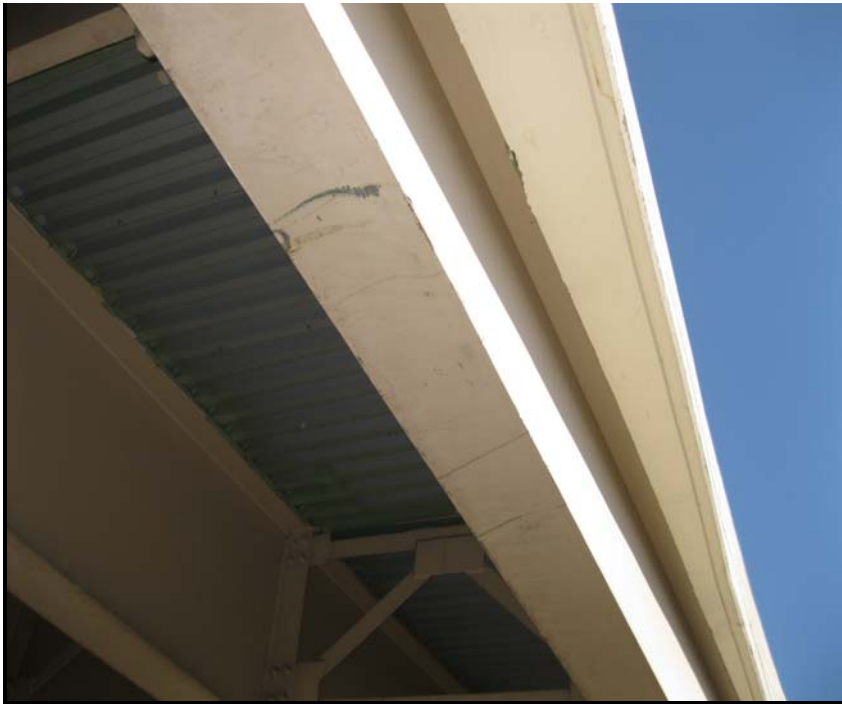
390	2	Reinf Conc Wingwalls	(LF)	141	139	1	1	0	0	CS2: (1 LF) Open/incip spall in top of E. wing @ joint w/ abut (18"h x 9"w). CS3: (1 LF) Fine cr w/ rust @ mdht of E. wing near abut joint.
358	1	Deck Cracking SmFlag	(EA)	1	1	0	0	0	0	CS1: (1 EA) Superficial cracking.
359	1	Soffit Smart Flag	(EA)	1	0	1	0	0	0	CS2: (1 EA) Span 4: Large edge spall in S. soffit @ Pier 4 deck jt (31" x 4" x 4" dp) and at Pier 3 deck jt (20" x 8" x 4"dp) (Photo 11).
362	1	Traf Impact SmFlag	(EA)	1	0	1	0	0	0	CS2: (1 EA) Minor collision scrapes exposing metal on bottom flange of BM 4 over access road in Span 1 (Photo 13).

13. Scrape marks in underside of Beam 4 in Span 4

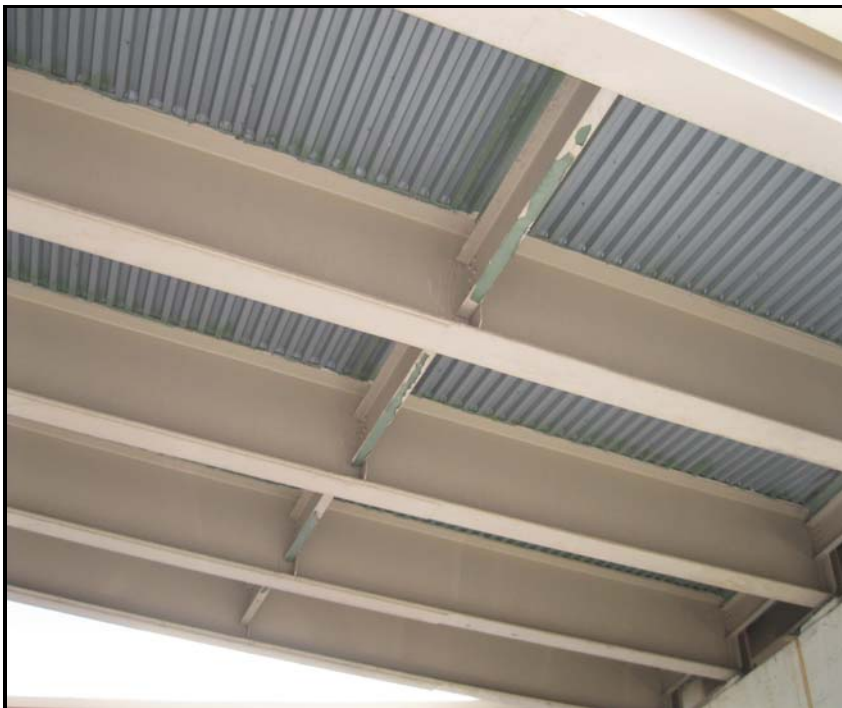
ELEM	ENV	DESCRIPTION	UNITS	TOTAL	CS1	CS2	CS3	CS4	CS5	COMMENTS
26	4	Conc Deck/Coatd Bars	(SF)	0	0	0	0	0	0	0
65	4	Drainage	(EA)	0	0	0	0	0	0	0
301	4	Pourable Joint Seal	(LF)	0	0	0	0	0	0	0
302	4	Compressn Joint Seal	(LF)	0	0	0	0	0	0	0
321	4	R/Conc Approach Slab	(EA)	0	0	0	0	0	0	0
107	4	Paint Stl Opn Girder	(LF)	253	125	125	3	0	0	CS2: (125 LF) Localized areas of light freckled rust along bottom flange of all beams for approx. 50% of length. Peeling paint w/ exp primer to bott fl of Bm 4 @ Pier 3 (Photo 12). CS3: (3 LF) Few small spots of blistering rust @ end of BM 4, u/side bott fl. Peeling paint w/ corroded steel along bott fl of BMs 2 & 5 @ Pier 4.
331	4	Conc Bridge Railing	(LF)	102	101	0	1	0	0	CS3: (1 LF) Small spall w/ exp steel on S. parapet in front of light pole.
381	3	Painted Steel Diaphr	(EA)	20	4	16	0	0	0	CS2: (16 EA) Large areas in u/sides w/ peeling paint exposing primer w/ no rust to many diaph's. Early signs of paint system distress w/ light freckled rust on most other diaph's (Photo 14).

14. Peeling paint with exposed primer to the bottom flanges of diaphragms in Span 4

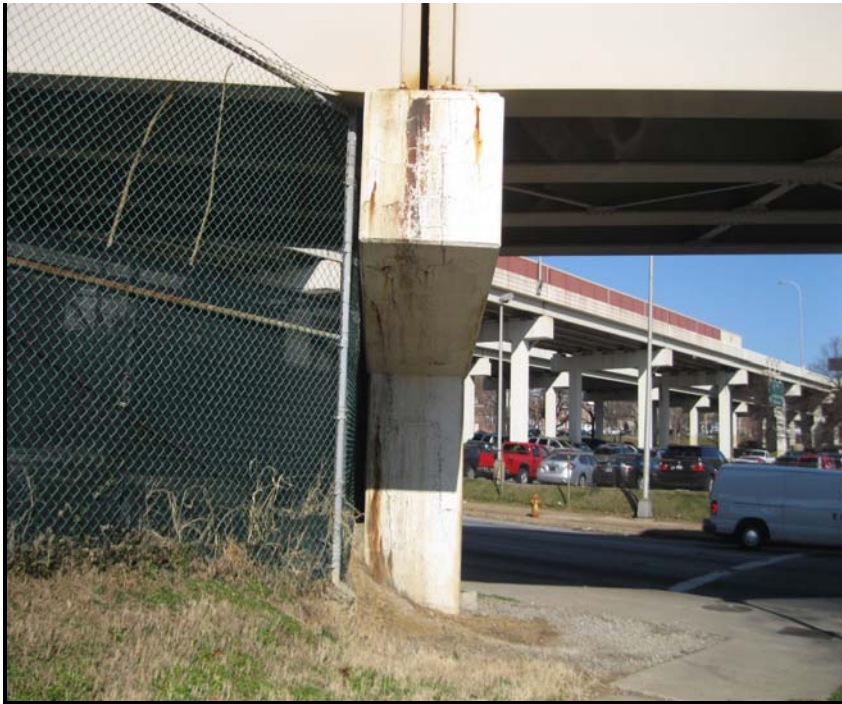
331	4	Conc Bridge Railing	(LF)	267	267	0	0	0	0	NDN
381	3	Painted Steel Diaphr	(EA)	12	5	6	1	0	0	CS2: (6 EA) Very light spot rust @ end diaph's and 1st interior @ Bay 1. Note: Channels @ abut. and K-frames @ Pier and throughout span. CS3: (1 EA) Blistering rust along top flange of Bay 1 diaph @ Pier 1.
311	3	Moveable Bearing	(EA)	4	4	0	0	0	0	CS1: (4 EA) Light surface spot rust, worst @ fascia brgs.
313	3	Fixed Bearing	(EA)	4	4	0	0	0	0	CS1: (4 EA) Light surface spot rust, worst @ fascia brgs..
205	3	R/Conc Column	(LF)	0	0	0	0	0	0	0
210	3	R/Conc Pier Wall	(LF)	8	5	0	3	0	0	CS3: (3 LF) Few cracks w/ rust @ SE end.
215	2	R/Conc Abutment	(LF)	26	20	2	4	0	0	CS2: (2 LF) 1/16" wide horiz crack @ NW corner. CS3: (4 LF) Cracks w/ rust in the E. end and E. face.
234	3	R/Conc Pier Cap	(LF)	25	18	1	6	0	0	CS2: (1 LF) N. o/hang w/ small incip spall on u/side (6 " diam). CS3: (6 LF) Several cracks w/ rust in S. o/hang, W & S faces and u/side (Photo 15).

15. Cracks with rust stains in the Southeast face of Pier 1, looking North

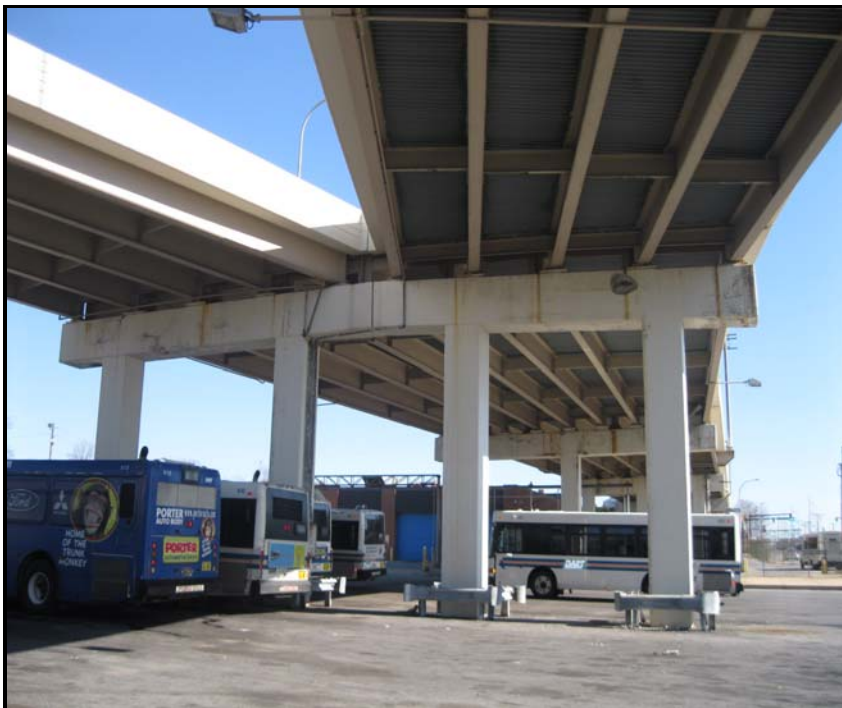
16. Span 4, general view of the shared pier with Bridge 1758H057, looking East
