STRUCTURAL DATA RECORD**Sufficiency Rating: 92.5****IDENTIFICATION**

Bridge ID: 1758G6149	(2) District: 01	(3) County: 3
Inventory Route:	(B) Highway Type: 3	(4) Place Code: 77540
(A) On/Under: 1	(E) Direction: 0	(C) Service Lvl: 7
(D) Route No: 06149		6B) Critical: *
6A) Features Intersected: SR 4, MARYLAND AVE.		11) Km. Point: 0.020 mi
(7) Facility Carried: MLK BLD TO I 95 S		
(9) Location: WILMINGTON		
16) Latitude: 39^44'27.47"	17) Longitude: 75^33'44.04"	
98) Border Bridge Code: NA	99) Border Br. Str. No.: NA

DELAWARE DEPARTMENT OF TRANSPORTATION

Bridge Management Section MultiSpan PONTIS Element Report for Span No. 1

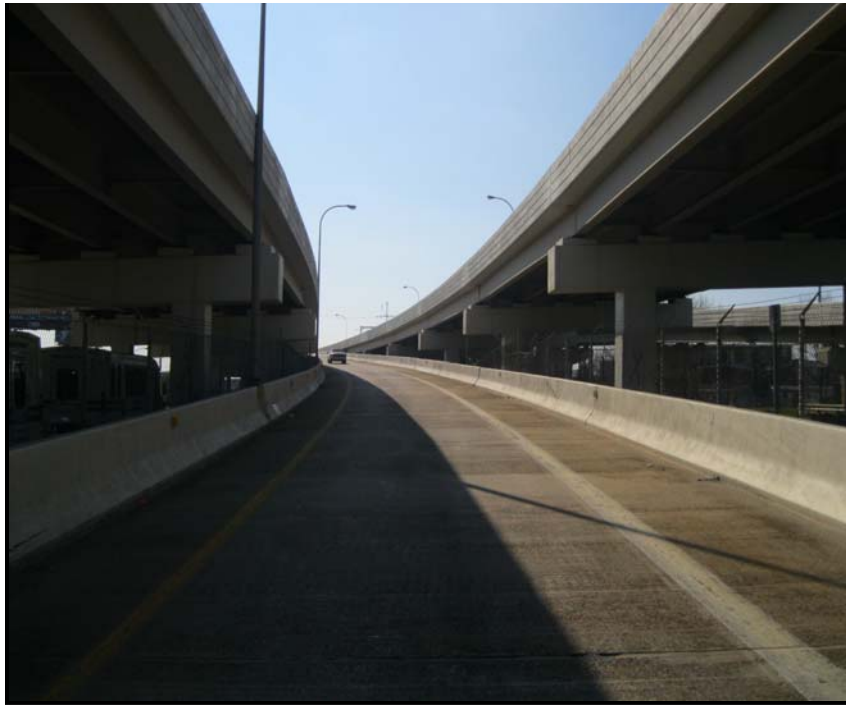
1. North Approach, looking South

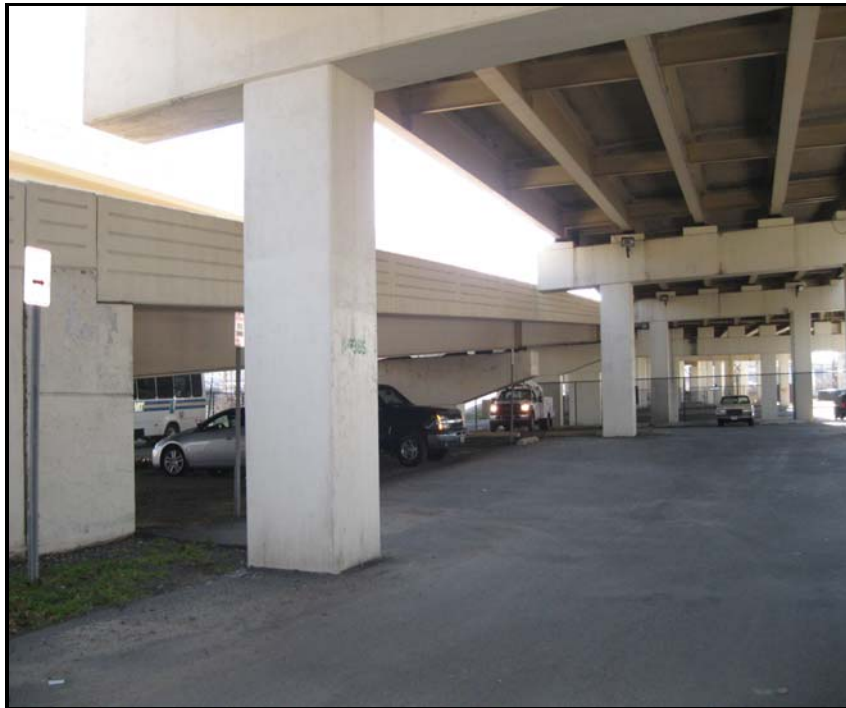
2. West Elevation

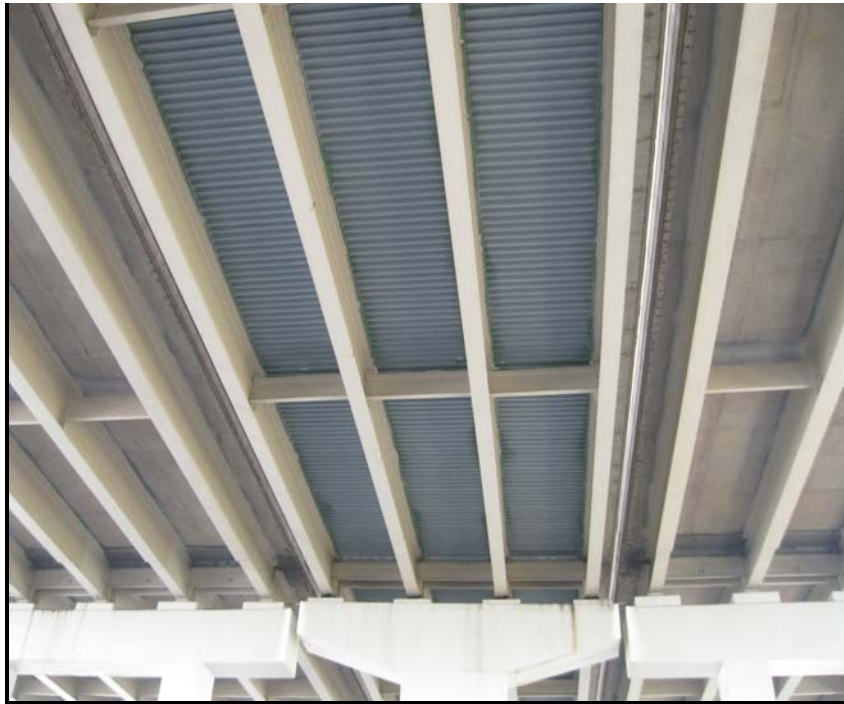
3. General view of the underside, Span 4, looking North

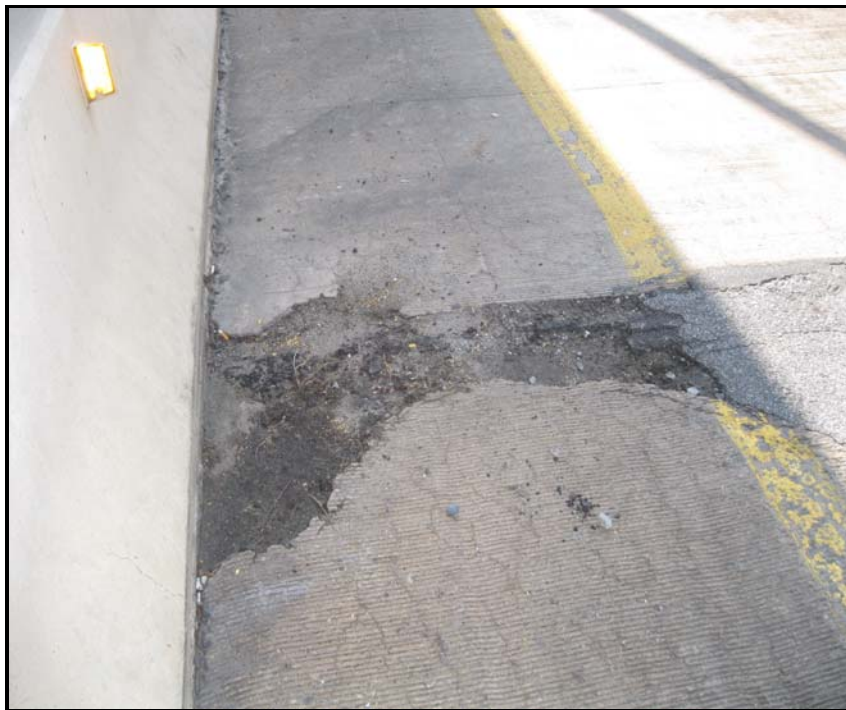
8. Spall in the North approach slab along the east shoulder

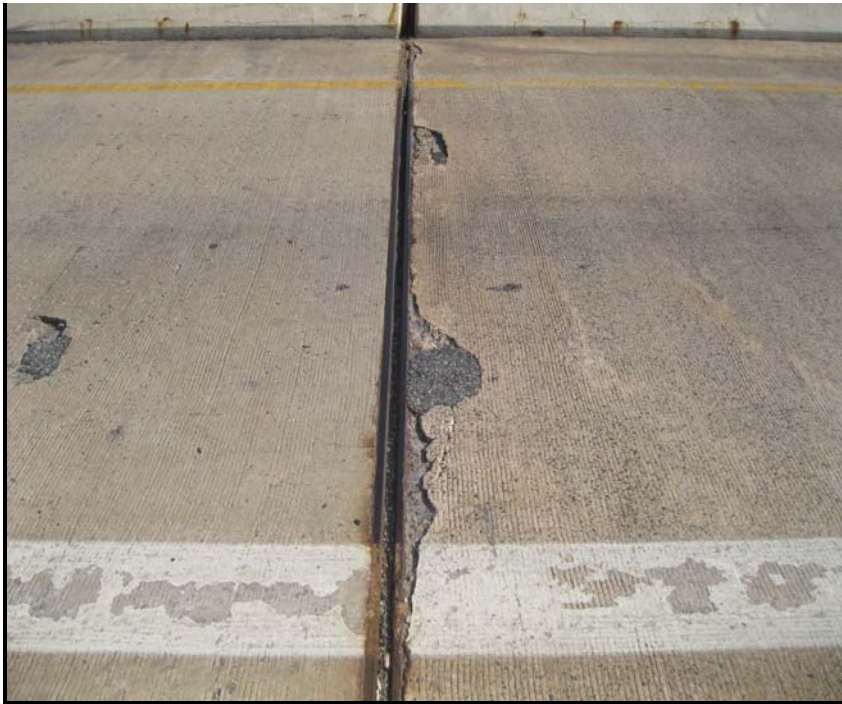
9. Spalls along the joint at Pier 4, looking East

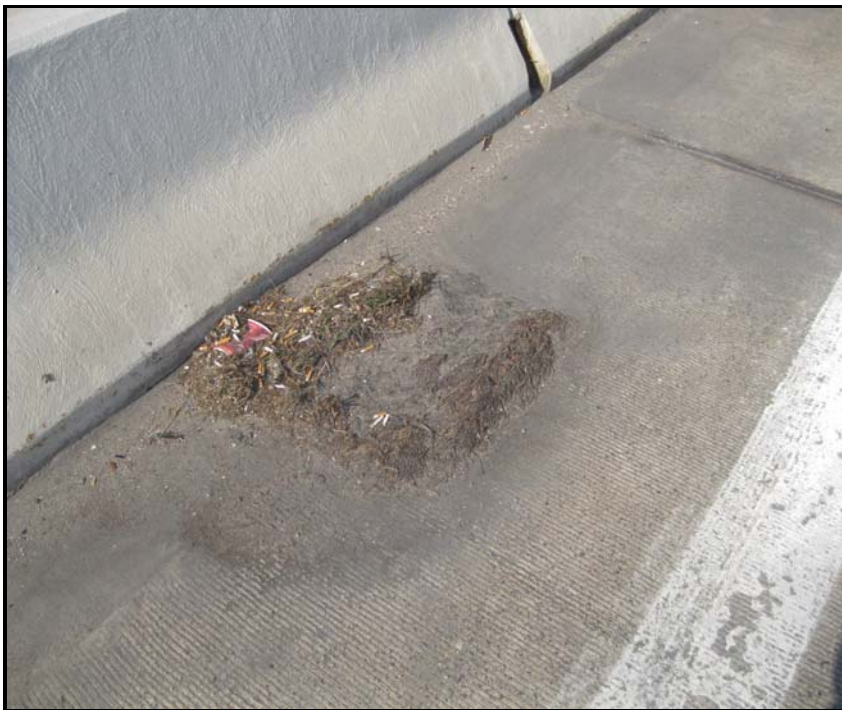
ELEM	ENV	DESCRIPTION	UNITS	TOTAL	CS1	CS2	CS3	CS4	CS5	COMMENTS
26	4	Conc Deck/Coatd Bars	(SF)	0	0	0	0	0	0	0
65	4	Drainage	(EA)	1	0	0	1	0	0	CS3: (1 EA) Scupper is completely clogged (Photo 10).
300	4	Strip Seal Exp Joint	(LF)	23	0	23	0	0	0	CS2: (23 LF) Filled w/ debris over shoulders and evidence of leakage.
301	4	Pourable Joint Seal	(LF)	0	0	0	0	0	0	0
302	4	Compressn Joint Seal	(LF)	0	0	0	0	0	0	0
321	4	R/Conc Approach Slab	(EA)	0	0	0	0	0	0	0
107	3	Paint Stl Opn Girder	(LF)	291	254	35	2	0	0	CS2: (35 LF) Light corrosion to all beam ends @ Piers, few areas of light freckled rust in bott fl & lower part of fascia webs and pigeon debris on bott flanges of BMs 1 & 2 @ Pier 2 (Photo 14). CS3: (2 LF) Blistering with rust @ ends of fascia beams @ Pier 2, mostly on flanges.
331	4	Conc Bridge Railing	(LF)	148	133	0	15	0	0	CS3: (15 LF) W. & E. parapets w/ shallow spalls w/ exp steel and horiz cracks w/ rust stains.

10. Clogged scupper at the NW corner of Span 2

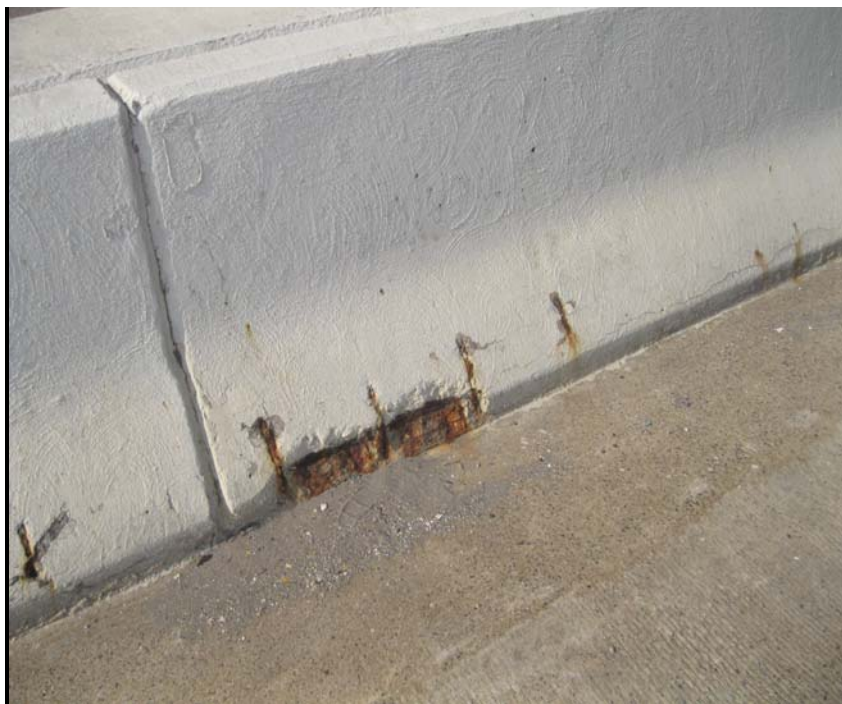
ELEM	ENV	DESCRIPTION	UNITS	TOTAL	CS1	CS2	CS3	CS4	CS5	COMMENTS
26	4	Conc Deck/Coatd Bars	(SF)	0	0	0	0	0	0	0
65	4	Drainage	(EA)	0	0	0	0	0	0	0
300	4	Strip Seal Exp Joint	(LF)	23	0	23	0	0	0	CS2: (23 LF) Seal packed w/ debris over shoulders and active leakage prev. noted near BM 4. Two large spalls adj to joint w/ assoc. delam (64"w x 9"l and 36"w x 7"l) (Photo 9).
301	4	Pourable Joint Seal	(LF)	0	0	0	0	0	0	0
302	4	Compressn Joint Seal	(LF)	0	0	0	0	0	0	0
321	4	R/Conc Approach Slab	(EA)	0	0	0	0	0	0	0
107	3	Paint Stl Opn Girder	(LF)	290	276	10	4	0	0	CS2: (10 LF) Light corrosion @ end of BM 4 @ Pier 4 due to leaking jt. CS3: (4 LF) Mod. corrosion along edge of top flange of BM 1 @ Pier 4 and all beams @ Pier 3.
331	4	Conc Bridge Railing	(LF)	148	72	0	76	0	0	CS3: (76 LF) Both E & W parapets w/ few full length horiz. cracks w/ random rust stains along the length. W. parapet w/ several small spalls w/ exp steel. Spall with exp steel near midspan to E. barrier (12"l x 2"h) and W. barrier (23"l x 5"h) (Photo 11).

11. Spall with exposed steel at the base of the West parapet in Span 4

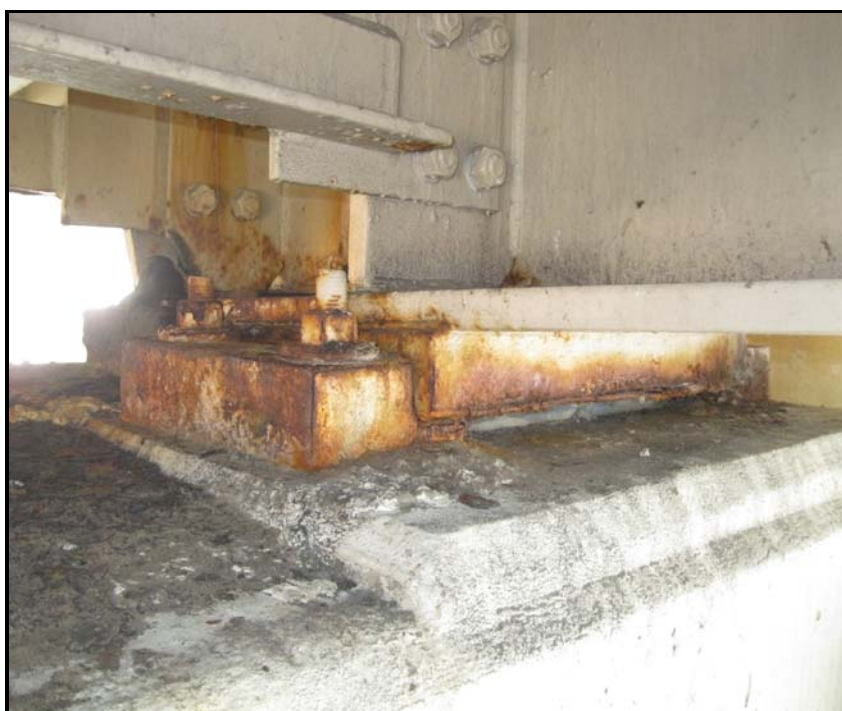
310	4	Elastomeric Bearing	(EA)	4	4	0	0	0	0	CS1: (4 EA) Light surface rust w/ blistering and peeling paint to plates (Photo 12).
311	4	Moveable Bearing	(EA)	0	0	0	0	0	0	0
313	4	Fixed Bearing	(EA)	4	4	0	0	0	0	CS1: (4 EA) No defects noted, greased.
210	2	R/Conc Pier Wall	(LF)	8	7	1	0	0	0	CS2: (1 LF) Small shallow spall (4" diam) on S. face. CS3: (1 LF) Short HL horiz cr w/ rust in E. face.
215	2	R/Conc Abutment	(LF)	0	0	0	0	0	0	0
234	2	R/Conc Pier Cap	(LF)	26	26	0	0	0	0	NDN
390	2	Reinf Conc Wingwalls	(LF)	0	0	0	0	0	0	0
359	1	Soffit Smart Flag	(EA)	0	0	0	0	0	0	0
362	1	Traf Impact SmFlag	(EA)	0	0	0	0	0	0	0

12. Rust to Bearing 4, Span 7 at Pier 7 shown

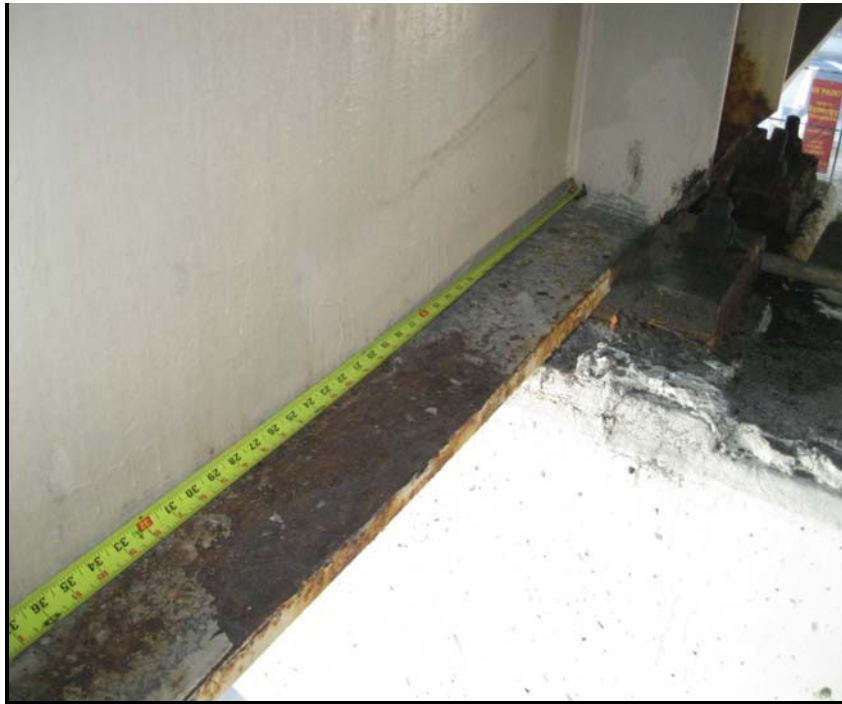
13. Rust along the bottom flange of Beam 4 in Span 9 at Pier 8

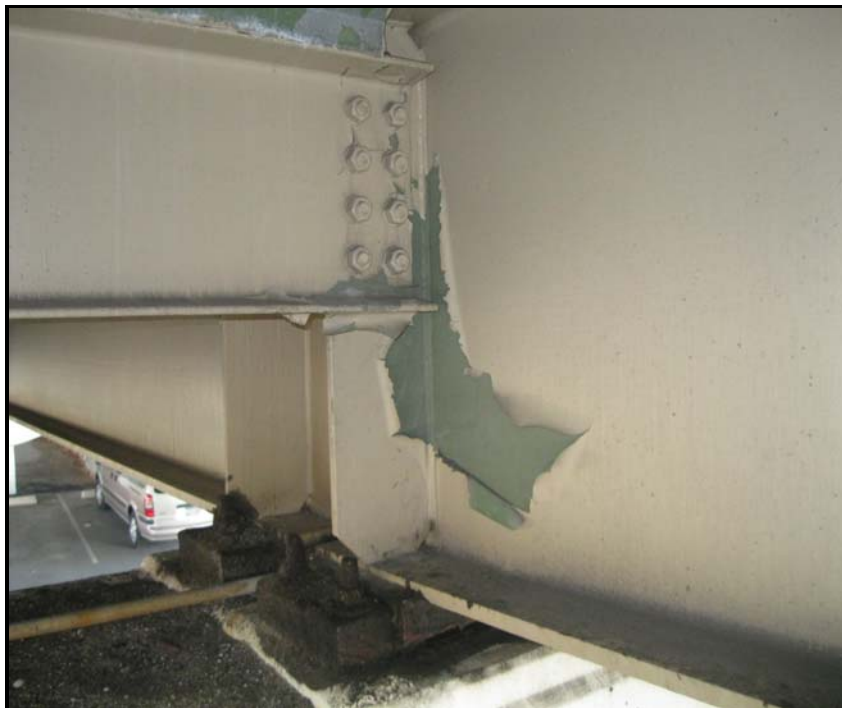
14. Peeling paint w/ exposed primer to the end of Beam 2 and Bay 2 diaphragm in Span 8 at Pier 8

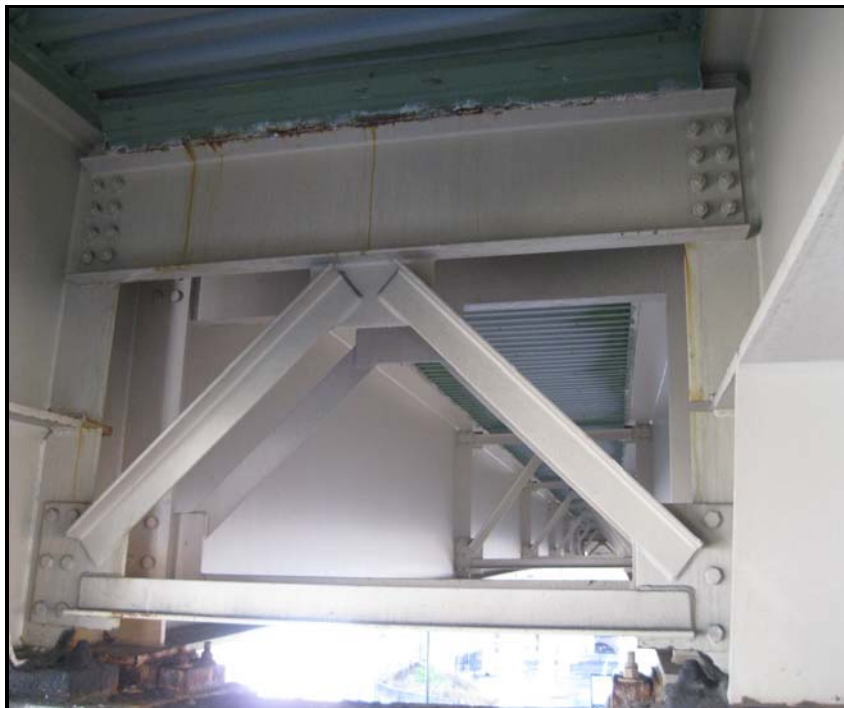
ELEM	ENV	DESCRIPTION	UNITS	TOTAL	CS1	CS2	CS3	CS4	CS5	COMMENTS
26	4	Conc Deck/Coatd Bars	(SF)	0	0	0	0	0	0	0
65	4	Drainage	(EA)	0	0	0	0	0	0	0
300	4	Strip Seal Exp Joint	(LF)	0	0	0	0	0	0	0
301	4	Pourable Joint Seal	(LF)	0	0	0	0	0	0	0
302	4	Compressn Joint Seal	(LF)	23	0	23	0	0	0	CS2: (23 LF) Spalls along edges and active leakage in Bays 1 & 3. Completely filled w/ debris.
321	4	R/Conc Approach Slab	(EA)	0	0	0	0	0	0	0
107	3	Paint Stl Opn Girder	(LF)	256	172	52	32	0	0	CS2: (52 LF) Random areas of light spot rust on BMs 1, 2, 3 and on most of BM 4. Large area of peeled paint w/ exp primer @ N. end of BM 2. CS3: (32 LF) Peeled/blistered paint w/ rusted base metal along ext edge & top side of BM 4 bott fl along S. half.
331	4	Conc Bridge Railing	(LF)	129	127	2	0	0	0	CS2: (2LF) Open spall in top of W. parapet near midspan (19"l x 7"w x 3"dp).
381	3	Painted Steel Diaphr	(EA)	12	4	7	1	0	0	CS2: (7 EA) Several end and interior diaph's w/ light freckled rust or peeling paint with exp primer. CS3: (1 EA) Rust along top fl of Bay 3 diaph @ Pier 7 (Photo 16).

16. Rust along the top flange edge of Bay 3 diaphragm in Span 8 at Pier 7

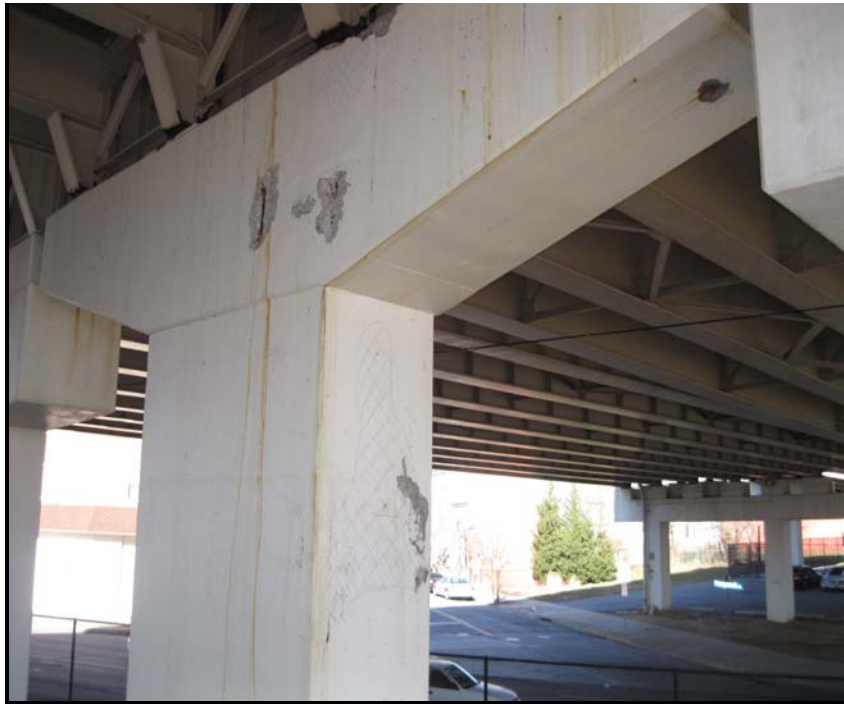
310	4	Elastomeric Bearing	(EA)	4	4	0	0	0	0	CS1: (4 EA) Bearings are greased w/ no defects noted.
311	4	Moveable Bearing	(EA)	0	0	0	0	0	0	0
313	4	Fixed Bearing	(EA)	4	4	0	0	0	0	CS1: (4 EA) Bearings are greased w/ no defects noted. Peeling paint w/ rusted steel to Brg 4.
210	2	R/Conc Pier Wall	(LF)	8	7	1	0	0	0	CS2: (1 LF) Large delam in E. face (60"h x 28"w) (Photo 17). CS3: (1 LF) Open/incip spall w/ exp steel (66"h x 33"w) @ bott E. face.
215	2	R/Conc Abutment	(LF)	0	0	0	0	0	0	0
234	2	R/Conc Pier Cap	(LF)	25	19	0	6	0	0	CS3: (6 LF) Large open/incip edge spall w/exp steel in top of cap, S. face under BM 3 (36"w x 22"h x 4"dp). Spall w/ exp steel (8" diam) in u/side of E. end; open/incip spall w/ exp steel in S. face @ Bay 2 (40"h x 16"w); and open/incip spall w/ exp steel in S. face under BM 3 @ bott of cap (28"w x 18"h). (Photo 17)
390	2	Reinf Conc Wingwalls	(LF)	0	0	0	0	0	0	0
359	1	Soffit Smart Flag	(EA)	0	0	0	0	0	0	0

17. Large open and incipient spalls in the cap and stem of Pier 6, looking Northwest

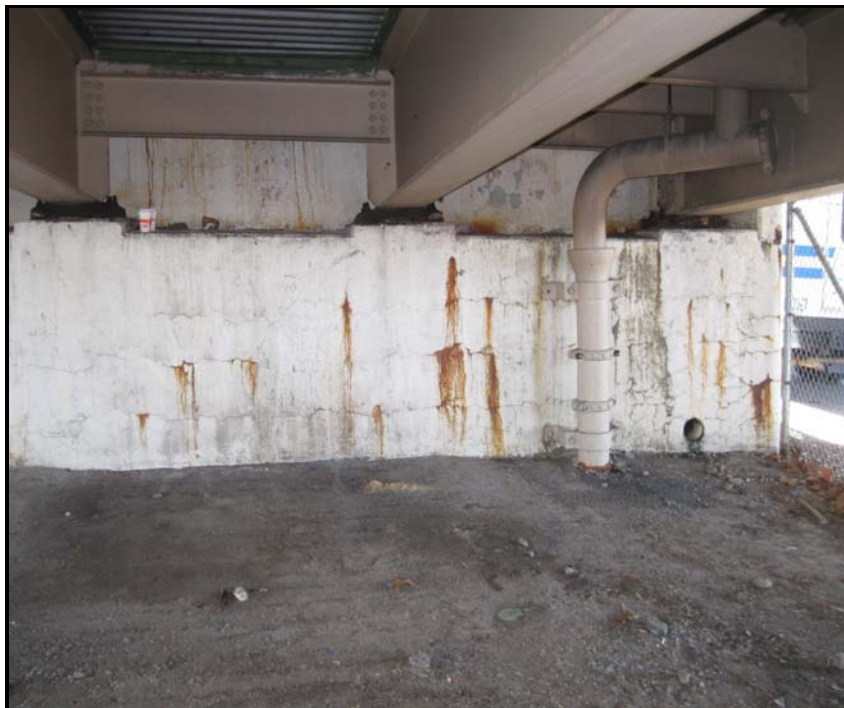
18. General view of cracks with rust in the stem of the abutment
