STRUCTURAL DATA RECORD**Sufficiency Rating: 84.0****IDENTIFICATION**

Bridge ID: 1758H057 (2) District: 01 (3) County: 3
 Inventory Route: (4) Place Code: 77580
 (A) On/Under: 1 (B) Highway Type: 1 (C) Service Lvl: 7
 (D) Route No: 00095 (E) Direction: 0
 6A) Features Intersected: MONROE ST & MADISON ST 6B) Critical: *
 (7) Facility Carried: MLK BLVD 11) Km. Point: 0.010 mi
 (9) Location: WILMINGTON
 16) Latitude: 39^44'27.58" 17) Longitude: 75^33'34.24"
 98) Border Bridge Code: NA 99) Border Br. Str. No.: NA

Bridge Management Section MultiSpan PONTIS Element Report for Span No. 1

Inspection Date: 1/31/2012

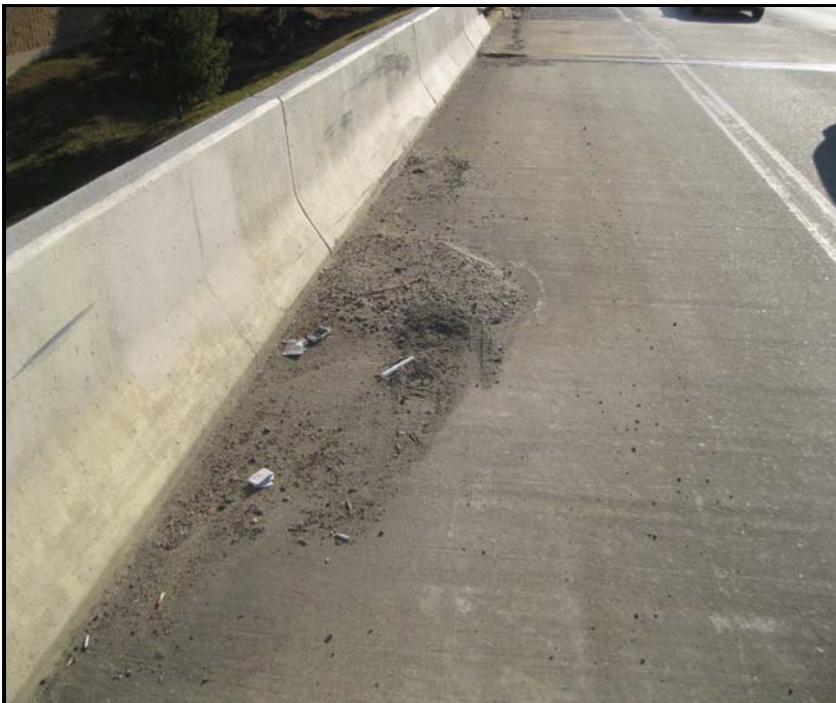
8. Accumulation of dirt and debris along the North shoulder of Span 7, looking East

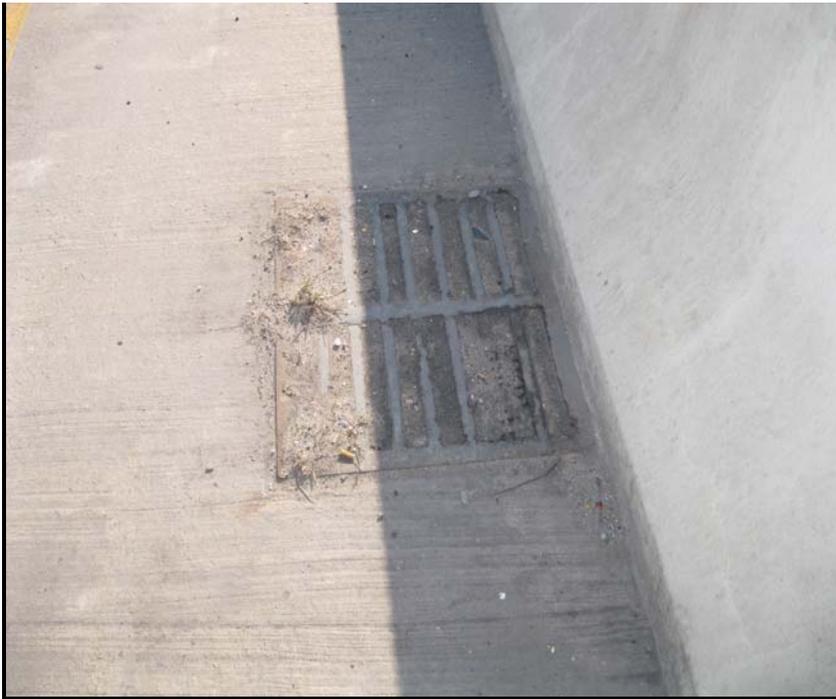
9. Clogged scupper in the South shoulder of Span 3

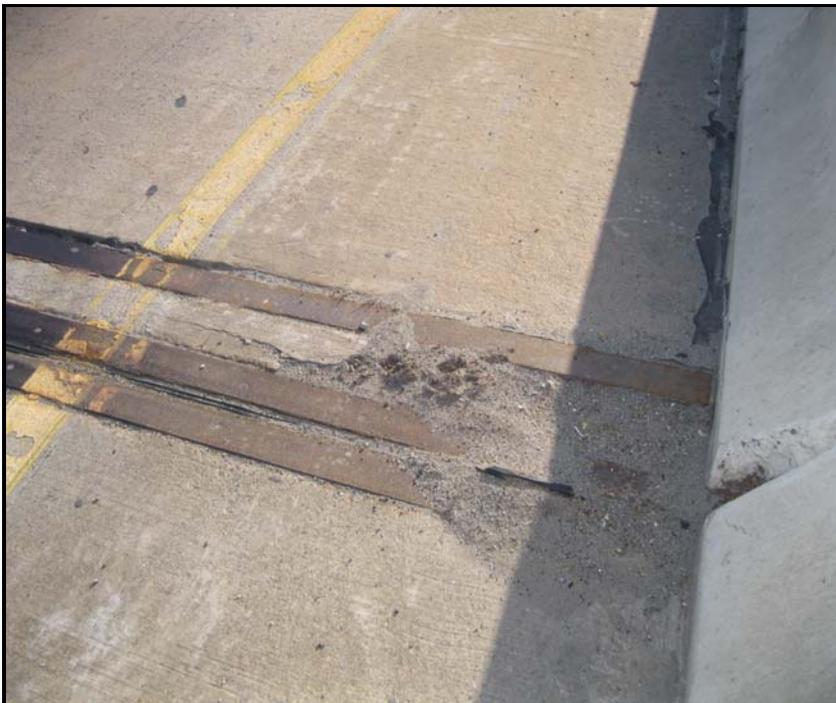
10. Large and deep spall, filled with dirt, in the West Abutment header in the South shoulder

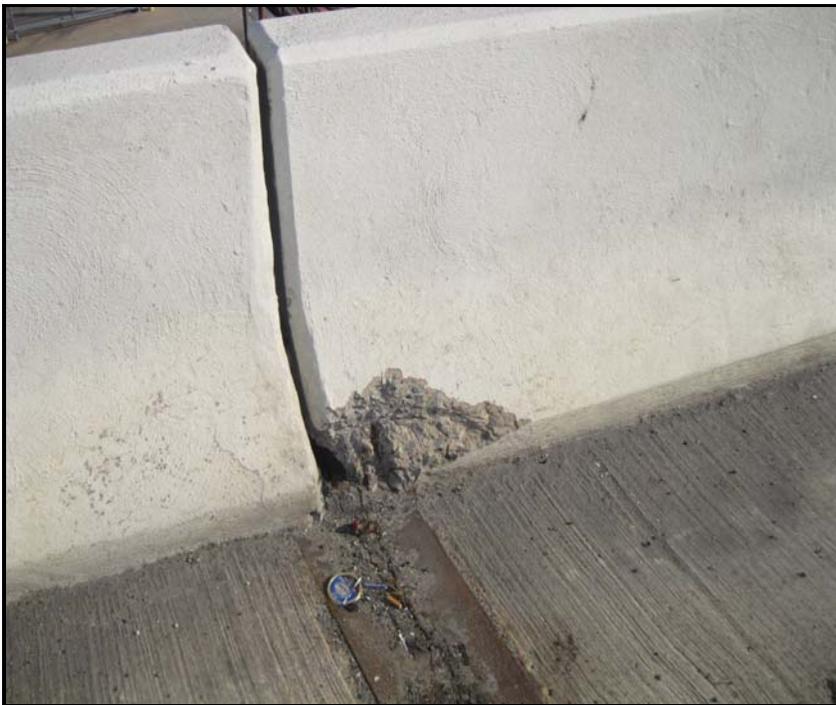
12. Spall with exposed steel in the base of the North barrier, Span 2 at Pier 2

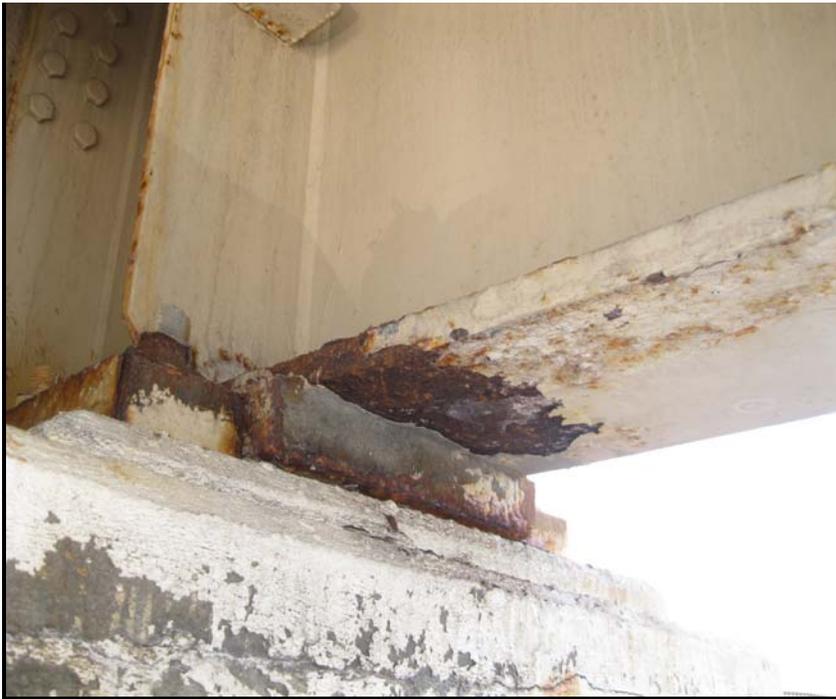
13. Area of blistering and rusted steel to the bottom flange of Beam 1, Span 4 at Pier 4

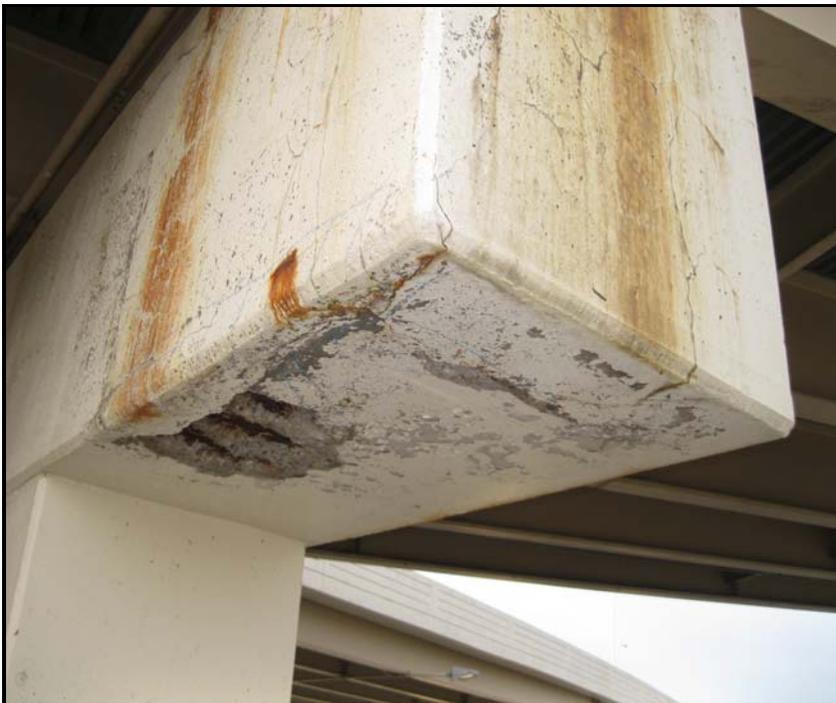
215	2	R/Conc Abutment	(LF)	0	0	0	0	0	0	0
234	3	R/Conc Pier Cap	(LF)	125	0	45	80	0	0	CS2: (45 LF) 1/16" to 1/8" wide cracks thruout Piers 1 & 2, some w/ efflo, some w/ assoc delams or open spalls. Pier 1 w/ delam/unsound patch to E. face below BM 1 (22"w x 26"h), delams w/ assoc 1/16" to 1/8" wide cracks on S. o/hang u/side (21"l x 4"w) and delams on W. face under BM 1 (18" diam) and (20"w x 6"h) along top under BM 2, Bay 4 @ top (24"l x 4"h), Bay 6 @ top (24"l x 4"h). Pier 2 w/ delams, some w/ assoc cracks found in W. face under BM 2 (12"w x 10"h), Bay 4 (12" diam) and (6'w x 12"h), Bay 5 (8"h x 44"w) @ top and (31"w x 8"h x 9"dp) @ bott, Bay 6 (46"w x 12"h) and (46"w x 24"h), Bay 8 (25"w x 4"h) and (18" diam) w/ assoc spall (14"h x 3"w) then E. face @ bott in Bay 2 (53"w x 6"h) and Bay 4 (53"w x 4"h) and mdht (4'w x 12"h). Large unsound patch (4' x 4') under Bay 1, W. face of Pier 2. CS3: (80 LF) HL cracks w/ rust stains thruout piers 1 & 2 (Photo 16). Pier 1 w/ spall w/ exp steel and assoc. delams @ bott E. edge of N. o/hang (54"l x 21"w x 4"h) (Photo 14) and W. face under BM 8 (28" x 24" x 2"dp). Pier 1, Bay 2

14. Spall with exposed steel and associated delaminations, Pier 1, North overhang, looking South

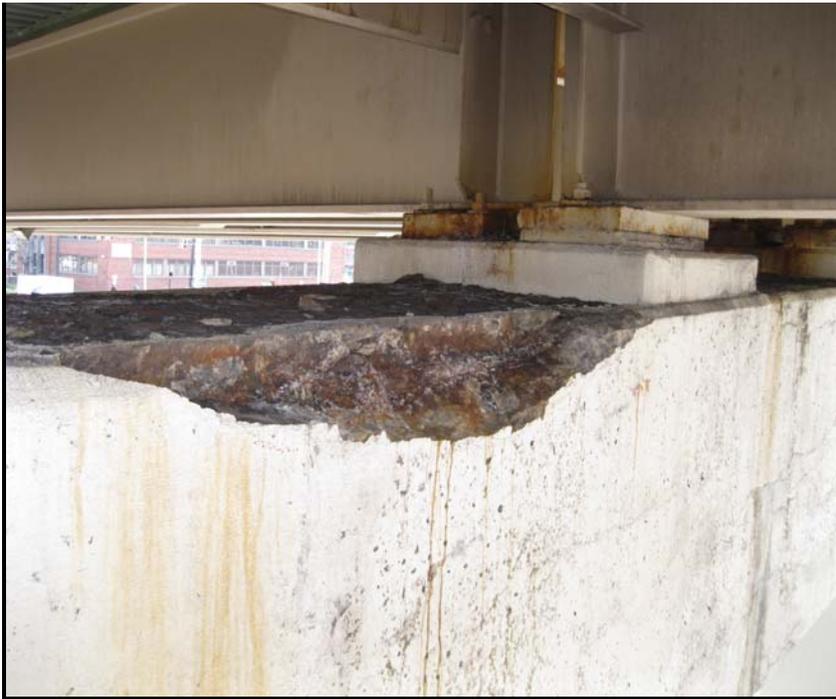
15. Large spall along the top west edge of Pier 4 under Bay 2, looking Southeast

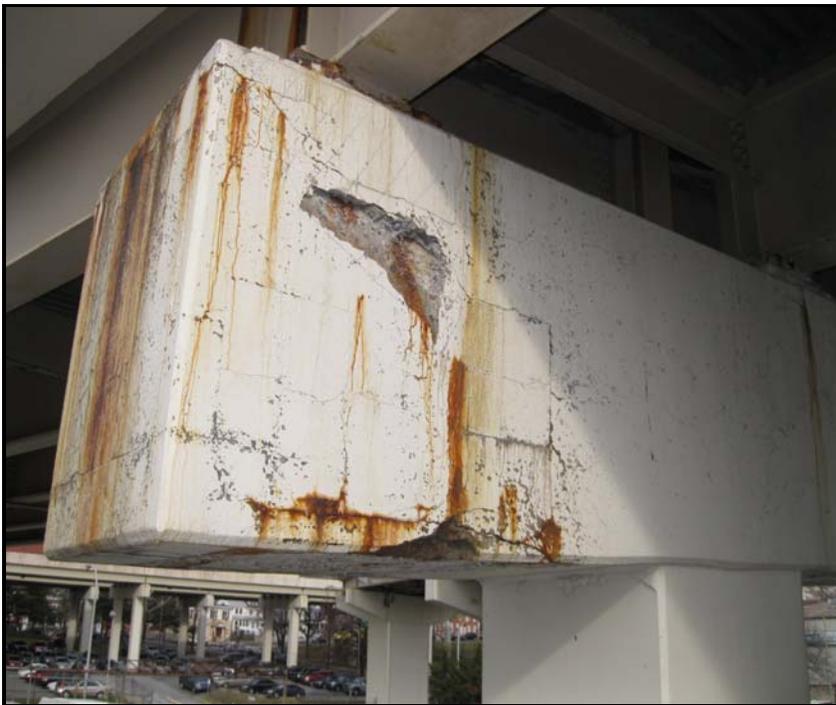
16. Cracks with rust and spalls in the East face of Pier 1, South overhang

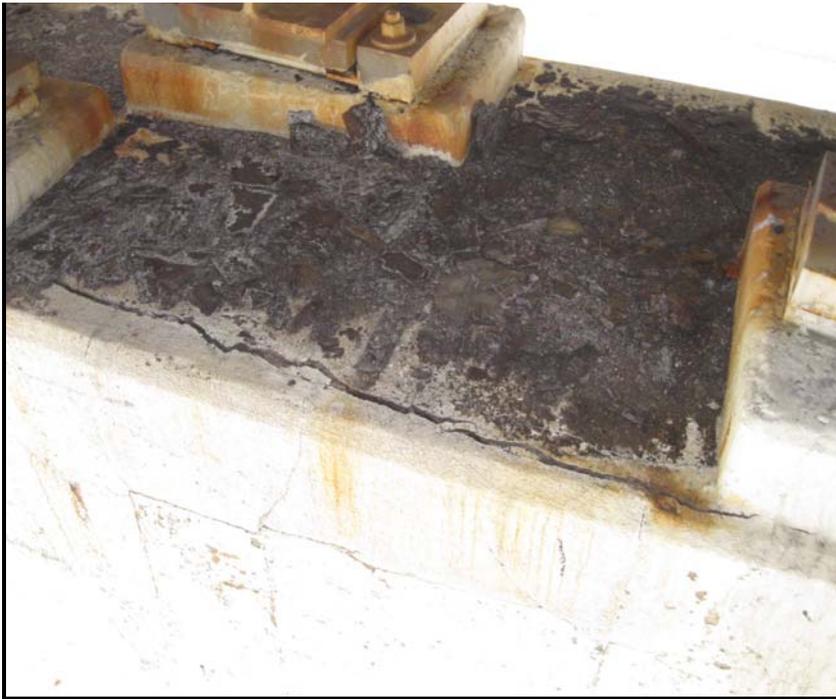
17. Typical wide cracks along the top edge of Pier 2 cap

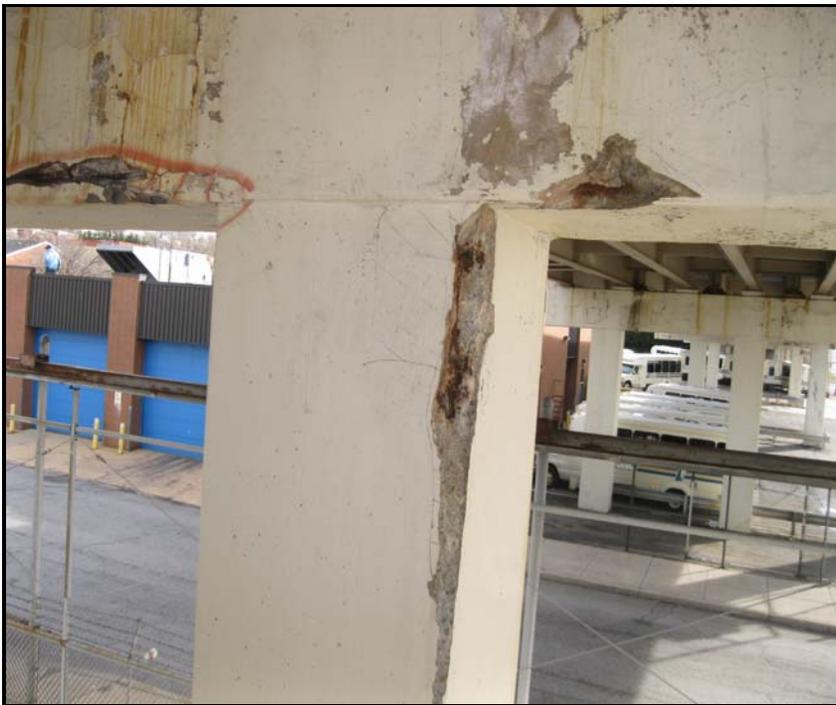
<p>w/ 1/8" wide horiz cr w/ assoc delams (20"l x 20"w x 3"h) and (32"l x 16w x 3"h) on the W. face and u/side as well as S. o/hang u/side w/ assoc spall (18"w x 3"l) and unsound patch (24" x 6"h x 6"w) (Photo 18) and E. face (42"l). Pier 1, bott W. face btwn Col's 3 & 4 w/ cracked and unsound patch w/ rust (28"l x 8"w x 6"h) and E. face under BM 9 w/ cracks w/ rust w/ assoc delam (34"l x 28"h) and spall (20"w x 12"h x 2"dp). Pier 2 w/ Cracks, up to 1/4" wide, some w/ rust along top of cap or seat w/ assoc delams on W. face Bay 1 (72"w x 25"h), Bay 2 (66"w x 44"h x 25"l) w/ assoc unsound patch (52"w x 24"h), Bay 3 (5'w x 2'l x 41"h) & Bay 7 (66"w x 26"h x 4"dp) and E. face delams w/ assoc cracks w/ rust found @ bott in Bay 5 (6'w x 4"h) and mdht Bay 3 (14"h x 10"w), Bay 5 (19"h x 15"w) and Bay 6 (6'w x 12"h). W. face spall w/ exp steel that extends into u/side of Bay 4 (58"w x 8"h x 4"dp) and under Bay 5 spall w/ exp steel (28"l x 7"</p>

18. Large corner spall with exposed steel in the West face of South column at Pier2

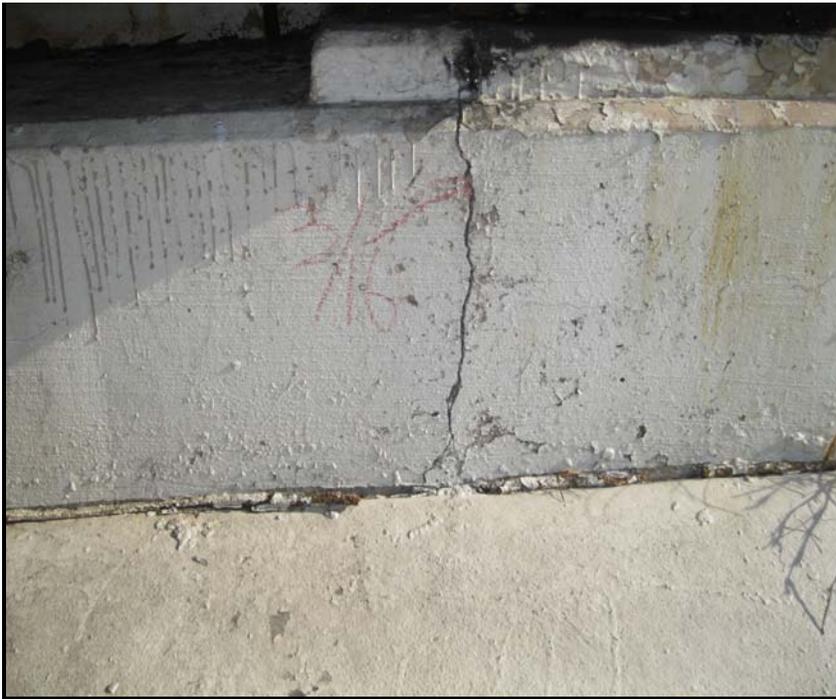
19. 3/16" wide vertical crack in East Abutment below Bay 5
