**STRUCTURAL DATA RECORD****Sufficiency Rating: 83.3****IDENTIFICATION**

Bridge ID: 1758 6143	(2) District: 01	(3) County: 3
Inventory Route:	(B) Highway Type: 3	(4) Place Code: 77580
(A) On/Under: 1	(E) Direction: 0	(C) Service Lvl: 7
(D) Route No: 00048		6B) Critical: *
6A) Features Intersected: SR 4,MARYLAND AVE		11) Km. Point: 0.170 mi
(7) Facility Carried: SR 48 TO I 95 SB		
(9) Location: SOUTH WILMINGTON		
16) Latitude: 39^44'23.99"	17) Longitude: 75^33'45.98"	
98) Border Bridge Code: NA	99) Border Br. Str. No.: NA

# DELAWARE DEPARTMENT OF TRANSPORTATION

## Bridge Management Section MultiSpan PONTIS Element Report for Span No. 1

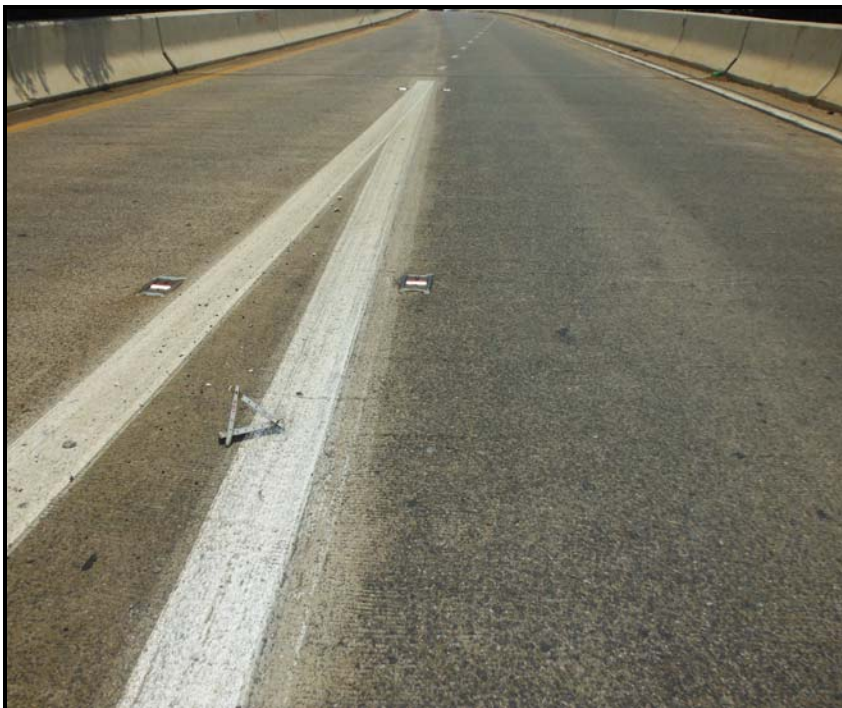
6. Typical condition of deck with moderate wear (Span 2B shown).

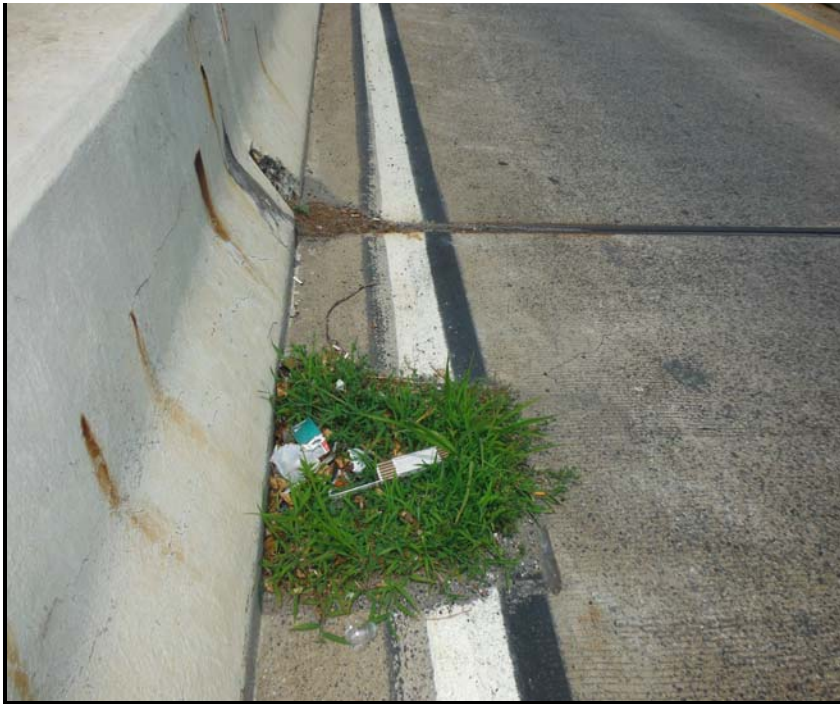
ELEM	ENV	DESCRIPTION	UNITS	TOTAL	CS1	CS2	CS3	CS4	CS5	COMMENTS
22	4	P Conc Deck/Rigid Ov	(SF)	0	0	0	0	0	0	0
65	4	Drainage	(EA)	1	0	0	1	0	0	CS3: (1 EA) Scupper on Pier 5B completely clogged with vegetation growth and 2' high portion of downspout missing. See Photo 7.
300	4	Strip Seal Exp Joint	(LF)	22	0	22	0	0	0	CS2: (22 LF) Filled with debris and heavy delamination and corrosion to east end of armor.
321	4	R/Conc Approach Slab	(EA)	0	0	0	0	0	0	0
107	3	Paint Stl Opn Girder	(LF)	280	246	26	8	0	0	CS2: (26 LF) Random minor spots or scattered freckled rust on beams. CS3: (8 LF) Exposed and rusted steel, mostly on top flanges at ends of beams. Corrosion throughout the length of Beam 4 was not found.
331	4	Conc Bridge Railing	(LF)	140	0	0	140	0	0	CS3: (140 LF) Wide horizontal cracks on back face of both parapets and cracks with rust stains and 1/16" wide cracks at southeast and northwest corners of span, a few small corner spalls with rust and northwest end with 1/16" to 1/8" wide vertical crack at joint with efflorescence and rust. Exterior face with horizontal cracks on west side 1/16" to 1/8" at south end but 2 LF with rust stains. 1/8" wide for 60 LF with rust stains with small spalls or incipient spalls. Typical areas with map cracking with light efflorescence. East exterior face with 1/16" to 1/8" horizontal crack throughout length with rust stains.

7. Span 5B, scupper is completely clogged with vegetation.

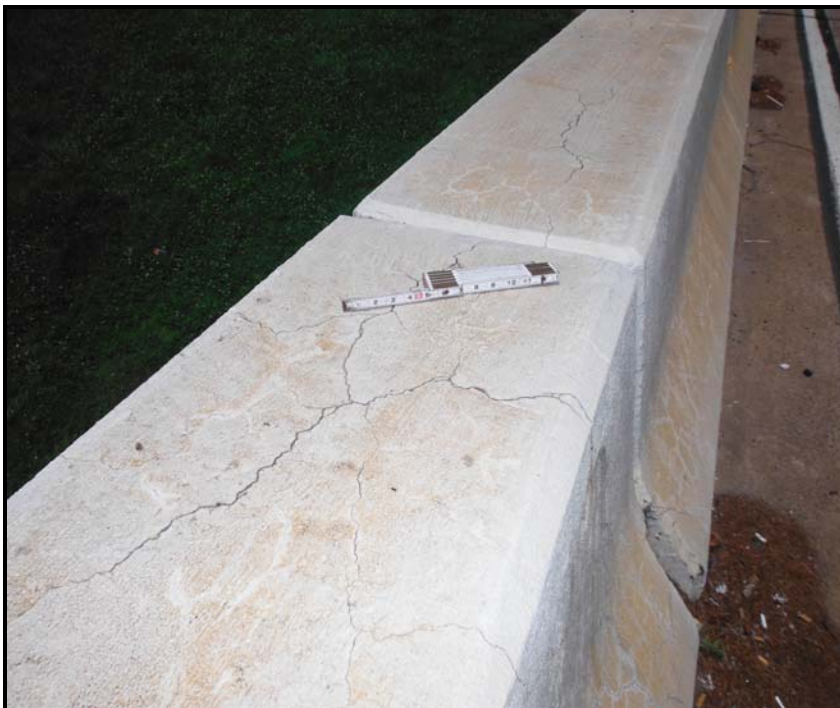
ELEM	ENV	DESCRIPTION	UNITS	TOTAL	CS1	CS2	CS3	CS4	CS5	COMMENTS
22	4	P Conc Deck/Rigid Ov	(SF)	0	0	0	0	0	0	0
65	4	Drainage	(EA)	1	0	0	1	0	0	CS3: (1 EA) Scupper filled with debris and vegetation and downspout clogged with debris.
300	4	Strip Seal Exp Joint	(LF)	35	35	0	0	0	0	CS1: (35 LF) Filled with debris.
321	4	R/Conc Approach Slab	(EA)	0	0	0	0	0	0	0
107	3	Paint Stl Opn Girder	(LF)	360	356	4	0	0	0	CS2: (4 LF) Freckled rust to top flange at Beam 1 on south and north end and bottom flange at Beam 3 south end. Beam 5 at north end with peeling paint with exposed primer to underside of bottom flange.
331	4	Conc Bridge Railing	(LF)	120	0	0	120	0	0	CS3: (120 LF) Inside faces with hairline horizontal cracks with rust stains for full length of East and West Parapets and 1/16" wide horizontal cracks on back face of both parapets. Top surface with hairline to 1/16" longitudinal cracks with few areas of rust. See Photo 8.

8. Span 2, West Parapet - HL to 1/16" wide map cracking.

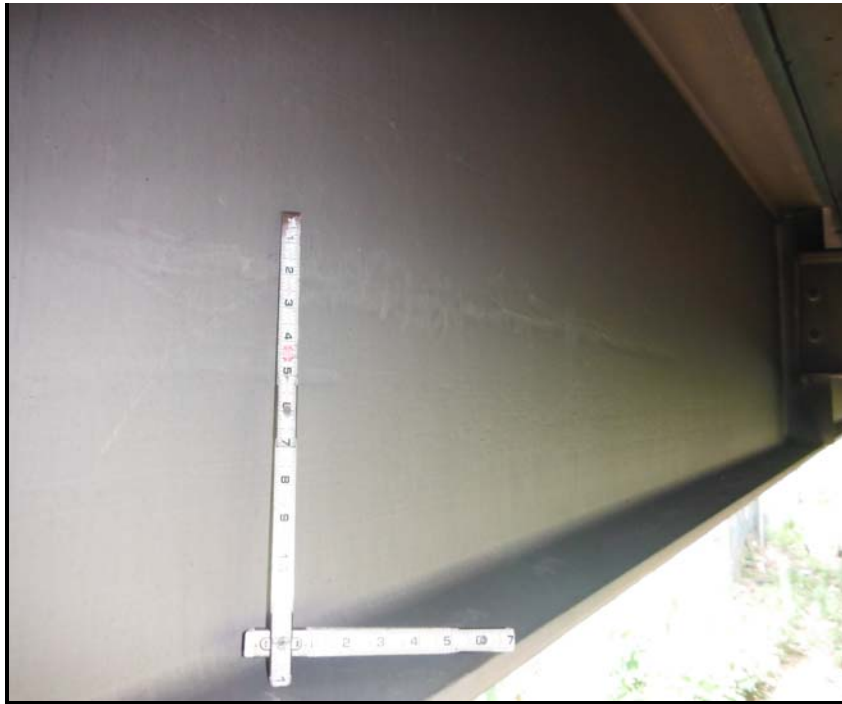
359	1	Soffit Smart Flag	(EA)	1	0	1	0	0	0	1" D). Span 4B: Incipient spall in East Overhang at Pier 5B (1' diameter) and in Bay 3 at north end (6" diameter), several shallow small incipient spalls in Bays 1 and 3 1 at Pier 4B with longitudinal crack with rust and associated incipient spall (18" L x 8" W). Bay 1 with incipient spalls along beam haunch, and two (2) spalls with exposed steel near South interim diaphragm (6" L x 12" W x 1" D). Span 5B: Bay 1, midspan, delamination with rust bleeding (1' diameter). Span 6B: Transverse crack with efflorescence and minor corrosion, center bay above 1st diaphragm from Pier 6. Bay 3 at south interim diaphragm with open/incipient spall and delaminated haunch with rust stains.
363	1	Section Loss SmFlag	(EA)	1	1	0	0	0	0	CS1: (1 EA) Area of section loss below paint at north end of Beam 1 in Span 1B on west face of web (6' L x 2" H x 1/16" D). West face of web of Beam 1 in Span 1B at north bearing is an area of section loss 2' L x 2" H x 1/16" D. See Photo 9.

9. Span 1B, Beam 1 @ N. End - 6' L x 2" H x 1/16" D SL in web.

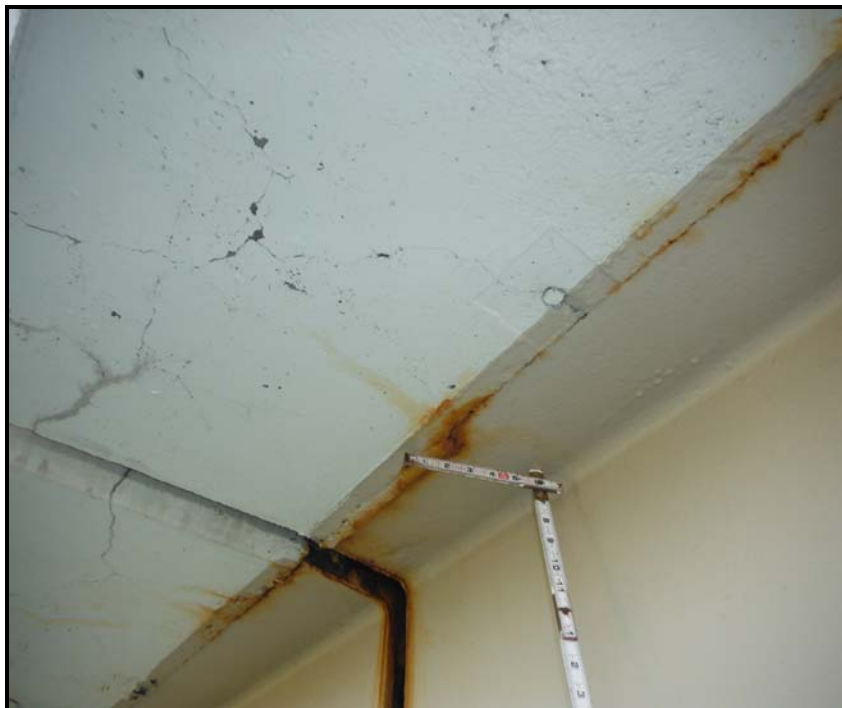
10. Span 6B, Beam 1, TF at N. End - Exp. and rusted steel.

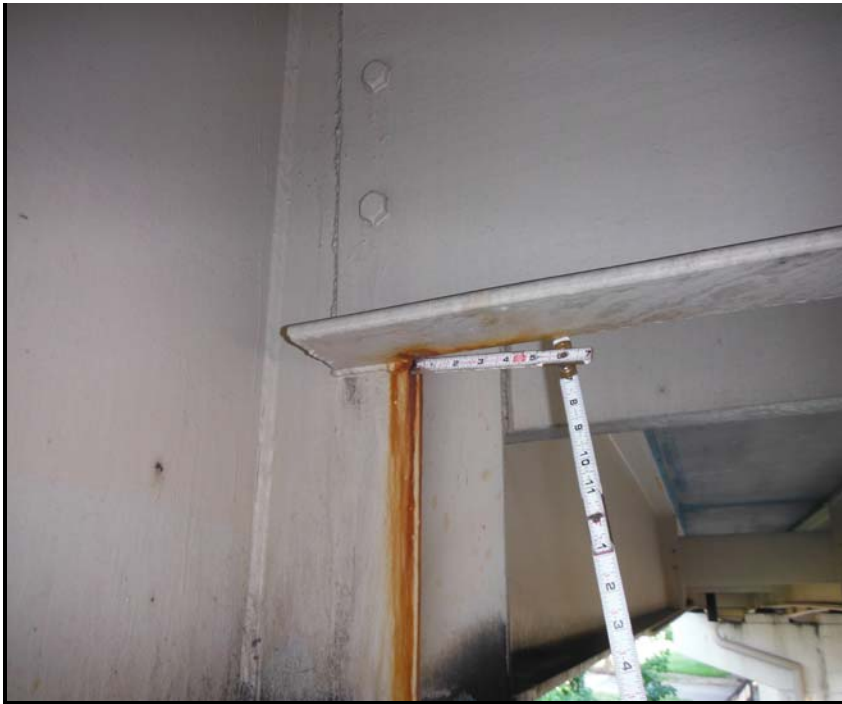
ELEM	ENV	DESCRIPTION	UNITS	TOTAL	CS1	CS2	CS3	CS4	CS5	COMMENTS
22	4	P Conc Deck/Rigid Ov	(SF)	0	0	0	0	0	0	0
65	4	Drainage	(EA)	0	0	0	0	0	0	0
300	4	Strip Seal Exp Joint	(LF)	0	0	0	0	0	0	0
321	4	R/Conc Approach Slab	(EA)	0	0	0	0	0	0	0
107	3	Paint Stl Opn Girder	(LF)	260	247	6	7	0	0	CS2: (6 LF) Very light spot rust along top flange of Beam 2 at 2/3 span. Few spots of minor rust on Beams 1 and 4. CS3: (7 LF) Beams 1 and 4 with exposed and rusted steel, mostly on the top flange at ends. See Photo 10.
331	4	Conc Bridge Railing	(LF)	130	0	0	130	0	0	CS3: (130 LF) 1/16" wide horizontal cracks on inside and top of both parapets. East and West Parapet exterior face with 1/16" to 1/8" wide horizontal crack with light rust.
381	3	Painted Steel Diaphr	(EA)	12	5	6	1	0	0	CS2: (6 EA) Random with minor spot or freckled rust. CS3: (1 EA) Bay 3 at Pier 6B with exposed rusted steel. See Photo 11.
311	4	Moveable Bearing	(EA)	4	4	0	0	0	0	CS1: (4 EA) Pier 33S bearings are greased with NDN.

11. Span 6B, diaphragm over Pier 6B - Exposed and rusted steel.

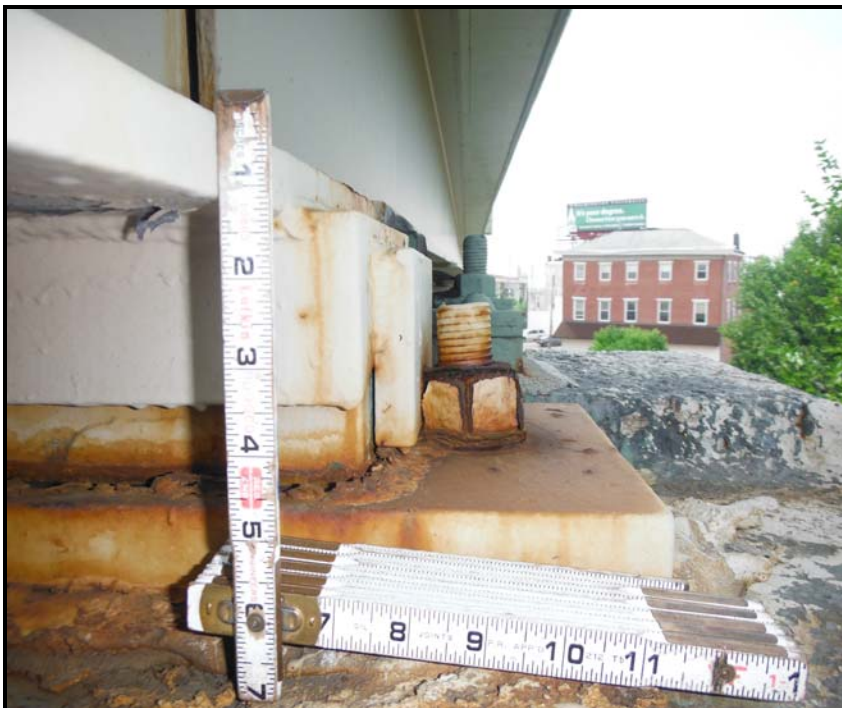
12. Pier 5B, Bearing 1 - W. Anchor Bolt is rubbing against bearing.

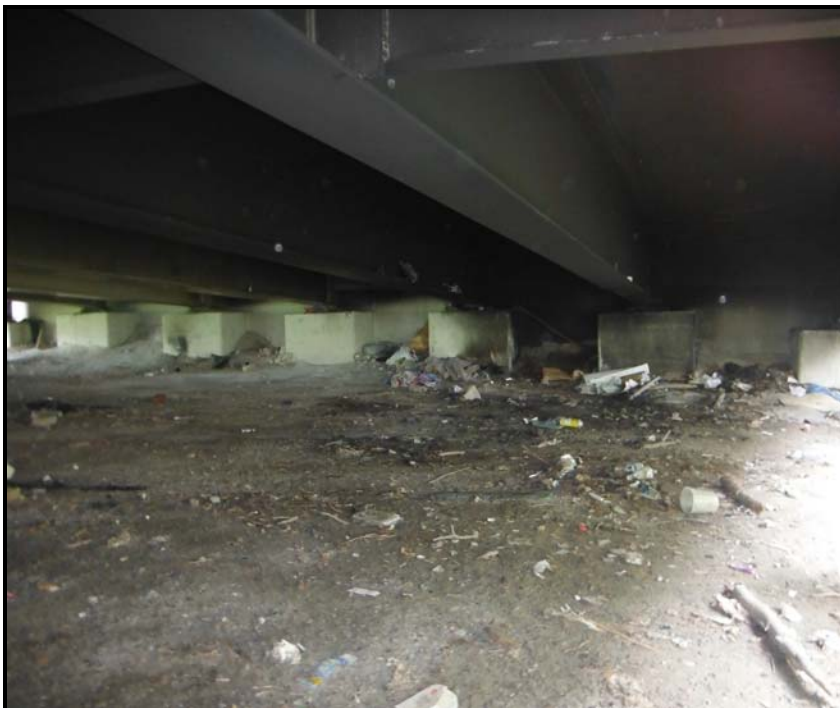
14. North Abutment Elevation. Note evidence of vagrants inhabiting area.

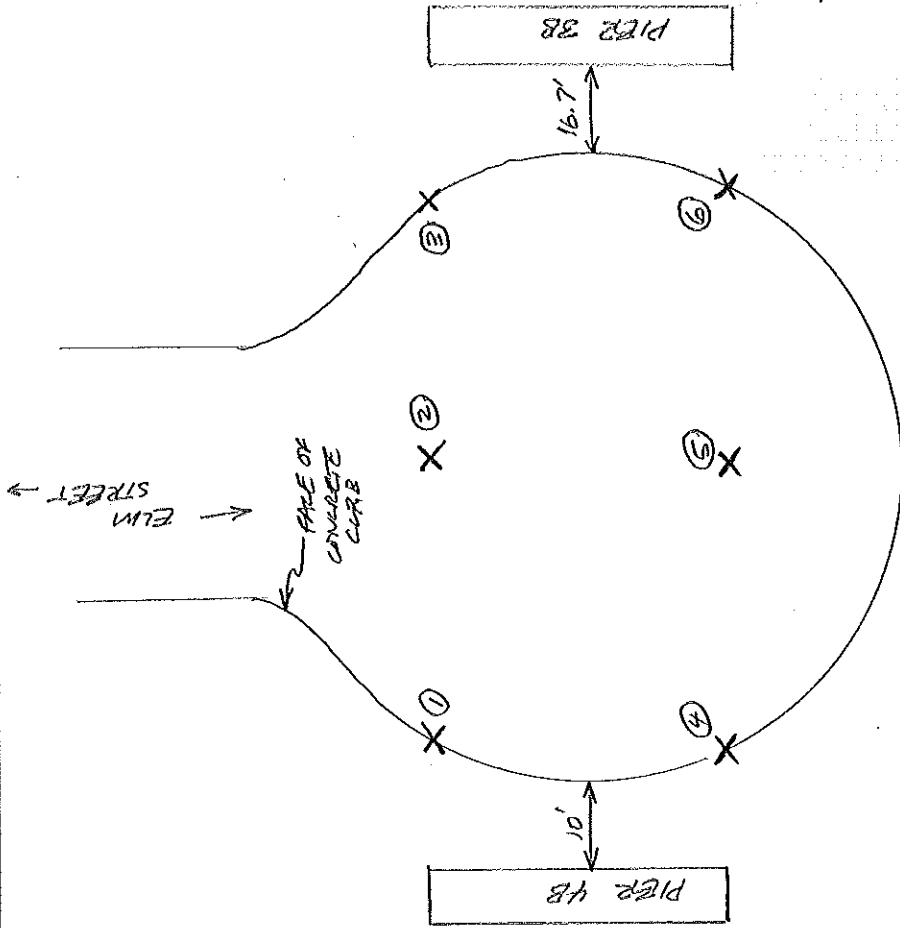
# Under Record Sketch Sheet

- ① 16.23'
  - ② 15.01'
  - ③ 13.95'
  - ④ 16.91'
  - ⑤ 15.05'
  - ⑥ 13.45'
- MINIMUM VERTICAL CLEARANCE = 13'-5 1/4"
- MINIMUM LATERAL CLEARANCE = 10' RIGHT
