## INSPECTION REPORT

White Clay Creek State Park

Inspection Report

71 Nine Foot Road Niven House, Newark, Delaware 19711

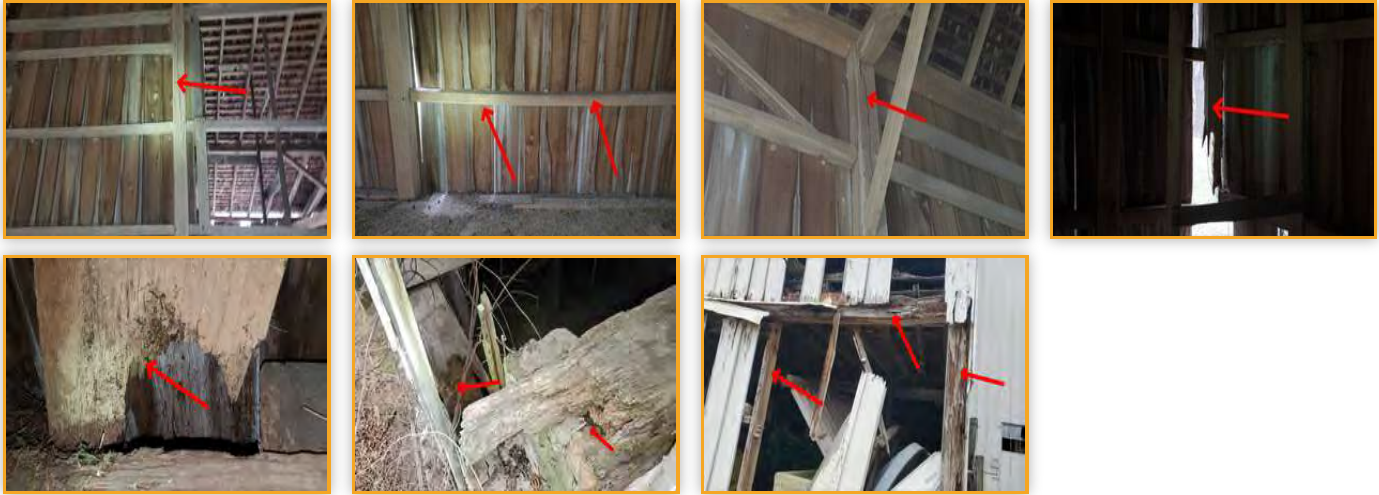
### 1.5.2 Bowed/Heavily Damaged/Leaning/Split/Termite Damage

Framing members/posts were heavily damaged/bowed/split/leaning at multiple areas throughout the barn. Heavy termite damage was present at multiple framing members. A licensed structural engineer is recommended for overall evaluation and repair as needed.

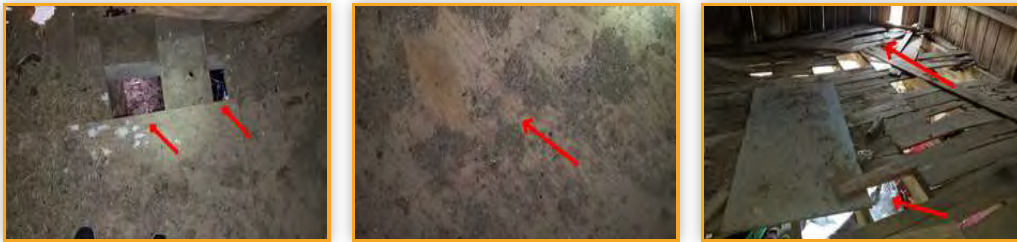
### 1.6.1 Large Gaps/Soft Spots/Heavily Damaged

Large gaps/soft spots were present at areas of flooring in barn. Sections of flooring were heavily damaged/missing creating a safety concern. A qualified contractor is recommended for evaluation and repair as needed.

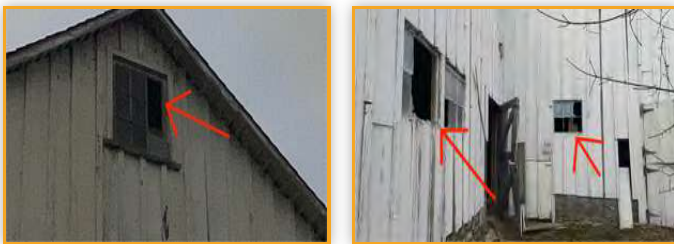
### 1.7.1 Broken glass

Broken glass was present at various locations. A qualified contractor is recommended for evaluation and repair as needed.

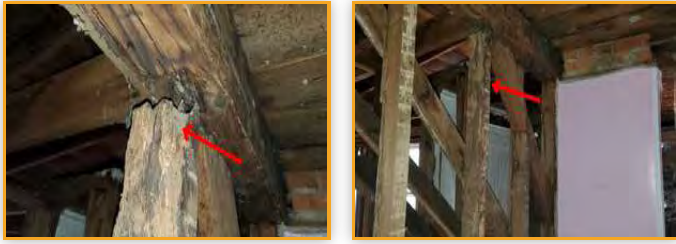
### 6.3.2 Not Secured

Wood stud was not secured/attached to framing member. A qualified contractor is recommended for evaluation and repair as needed.

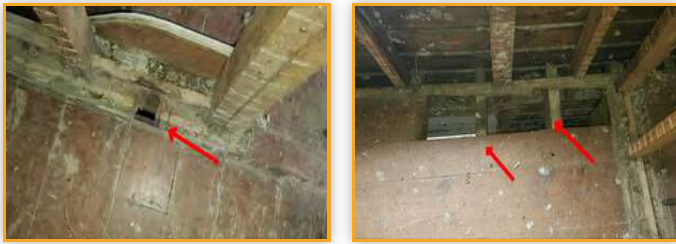
### 6.4.1 Large Gaps

Large gaps were present at areas of floor, this was creating a safety concern. A licensed electrician is recommended for evaluation and repair as needed.

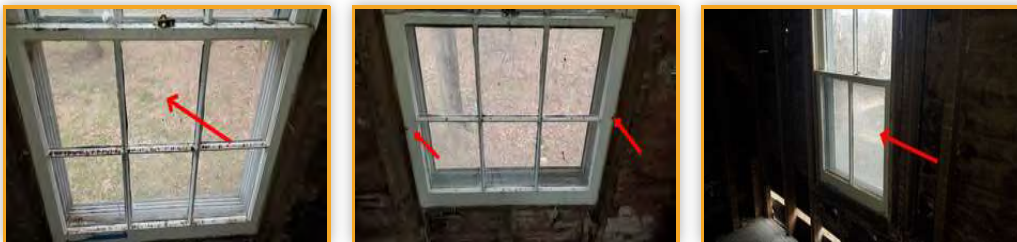
### 6.5.1 Window fell freely/Secured Shut/Heavily Damaged

Window would not stay open and fell freely when tested. Multiple windows were secured shut/heavily damaged and unable to be opened. A qualified contractor is recommended for evaluation and repair.

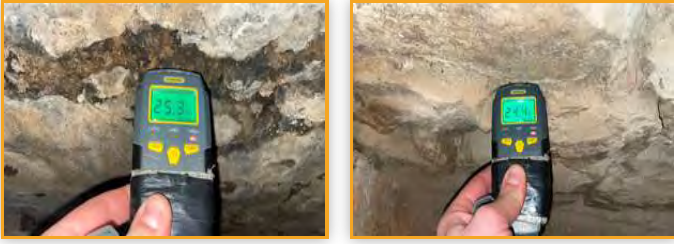
### 9.10.1 Moisture: Staining/High Readings

There were indications of moisture penetration made evident by staining and high moisture readings in basement and crawlspaces. When there is high moisture present, further evaluation by a qualified contractor is recommended.

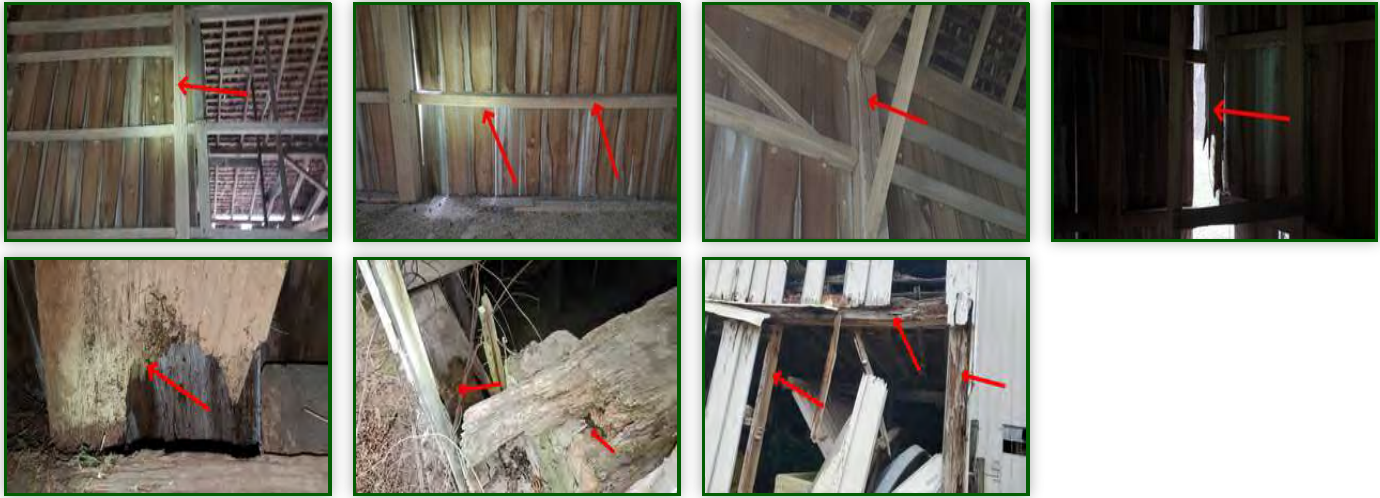
### 1.5.2 Bowed/Heavily Damaged/Leaning/Split/Termite Damage

Framing members/posts were heavily damaged/bowed/split/leaning at multiple areas throughout the barn. Heavy termite damage was present at multiple framing members. A licensed structural engineer is recommended for overall evaluation and repair as needed.

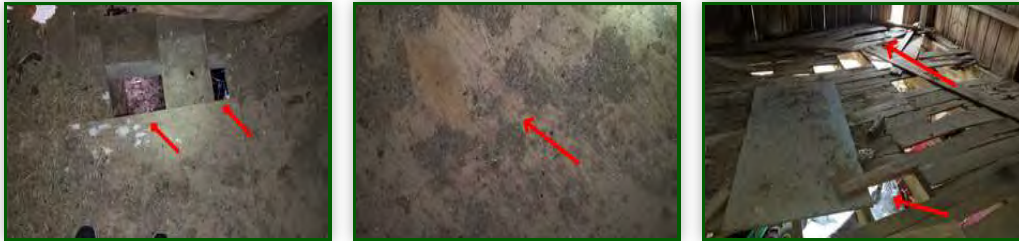
### 1.6.1 Large Gaps/Soft Spots/Heavily Damaged

Large gaps/soft spots were present at areas of flooring in barn. Sections of flooring were heavily damaged/missing creating a safety concern. A qualified contractor is recommended for evaluation and repair as needed.

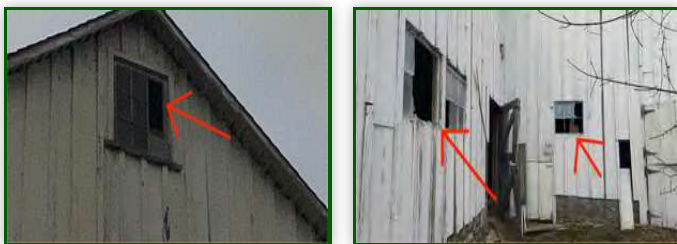
### 1.7.1 Broken glass

Broken glass was present at various locations. A qualified contractor is recommended for evaluation and repair as needed.

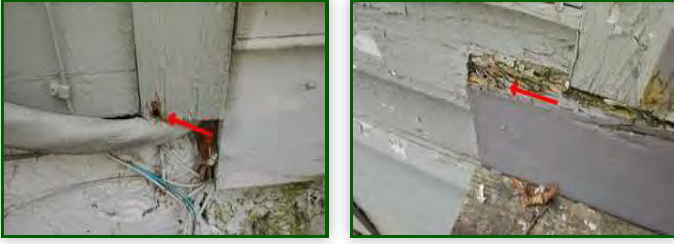
Severe wood rot was noted on trim at areas. A qualified contractor is recommended for evaluation and repair.

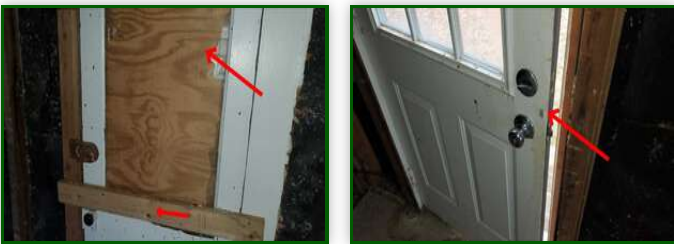
Rear exterior door had broken glass present and was secured shut making it unusable. Side door was unable to be secured shut/locked creating a safety concern. A qualified contractor is recommended for evaluation and repair as needed.

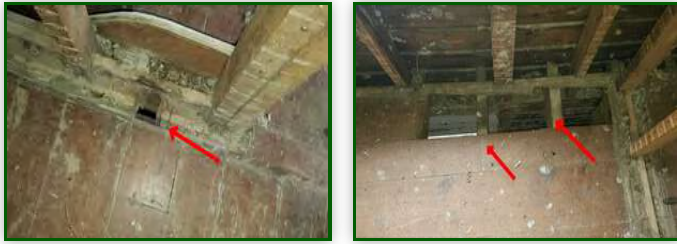
Large gaps were present at areas of floor, this was creating a safety concern. A licensed electrician is recommended for evaluation and repair as needed.

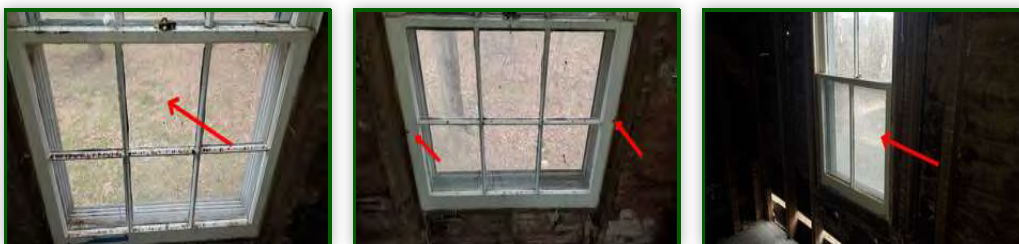
Window would not stay open and fell freely when tested. Multiple windows were secured shut/heavily damaged and unable to be opened. A qualified contractor is recommended for evaluation and repair.

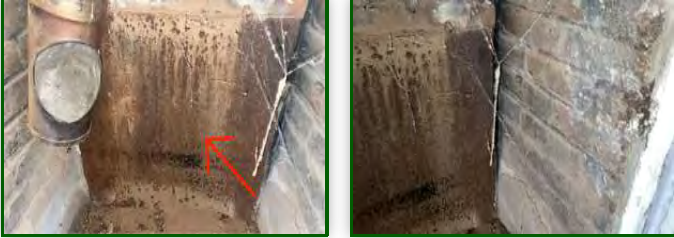
#### 3. CRACKING

Firebox surround had cracks, recommend repair

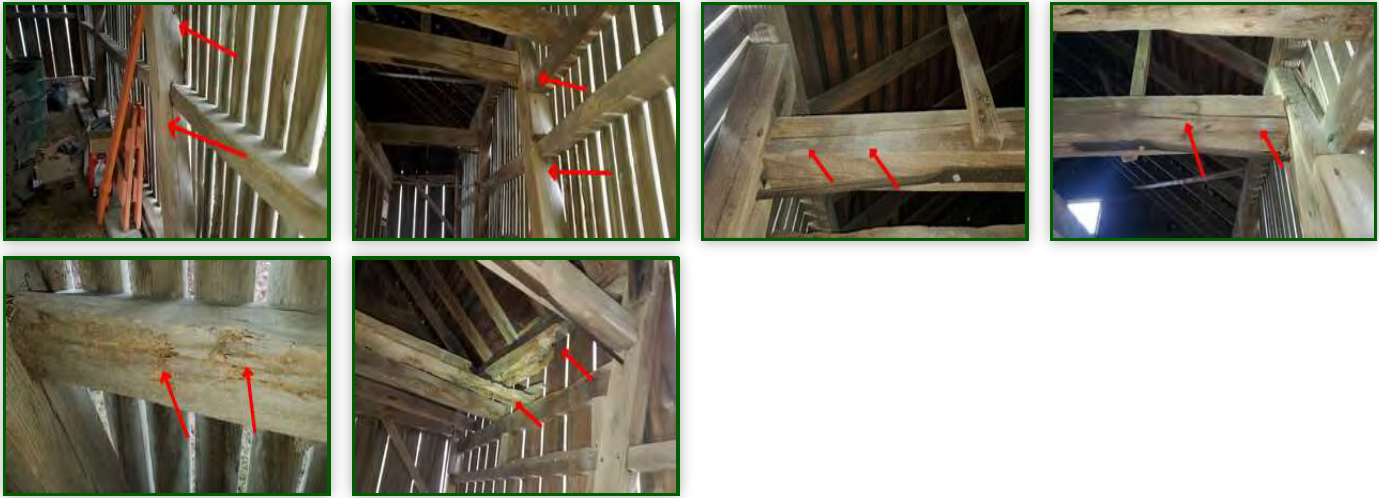
Walls/framing members for detached garage were heavily damaged/bowed at areas. Termite damage was present at framing members. Joists were splits. A qualified contractor is recommended for evaluation and repair as needed.

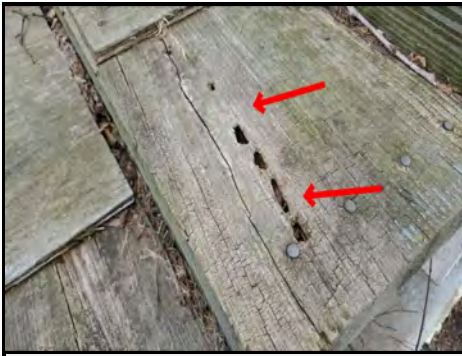
Carpenter Bee Damage

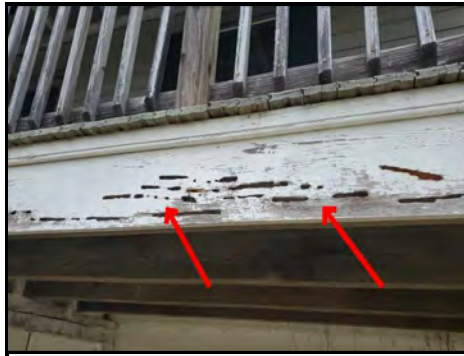
Carpenter Bee Damage

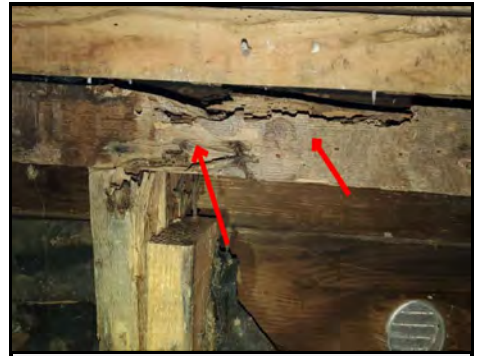
Termite Damage

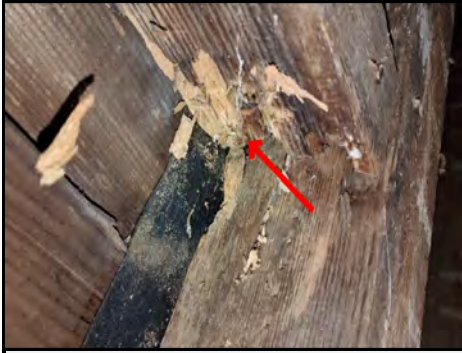
Termite Damage

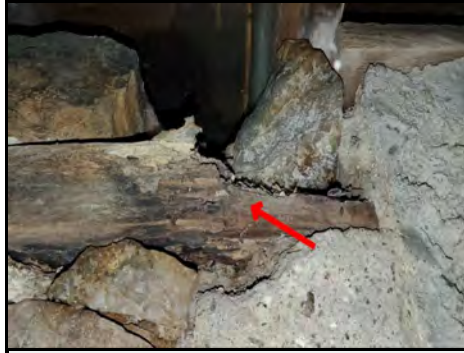
Termite Damage

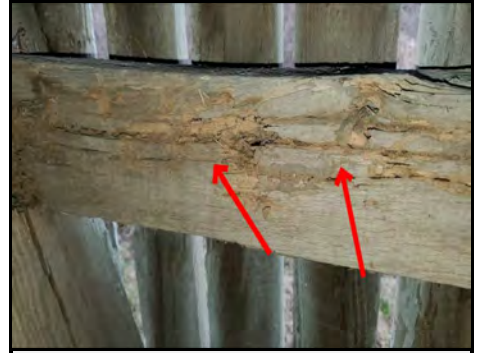
Termite Damage

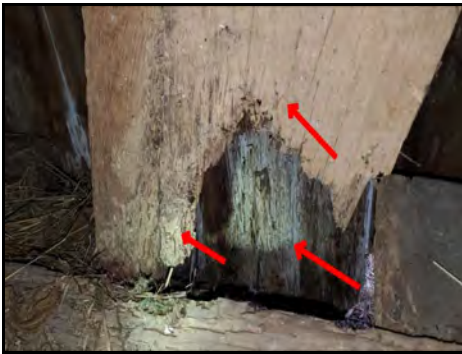
Termite Damage

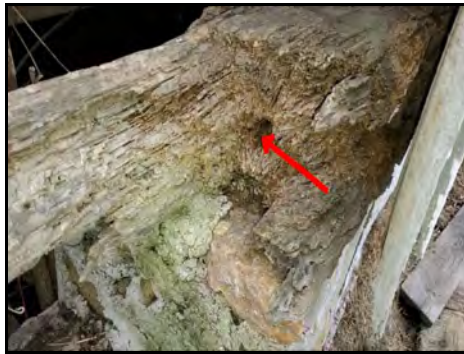
Termite Damage
