INSPECTION REPORT

White Clay Creek State Park

951 Pleasant Hill Rd Lamborn Estates , Newark, Delaware 19711

February 28, 2023 at 09:00 AM

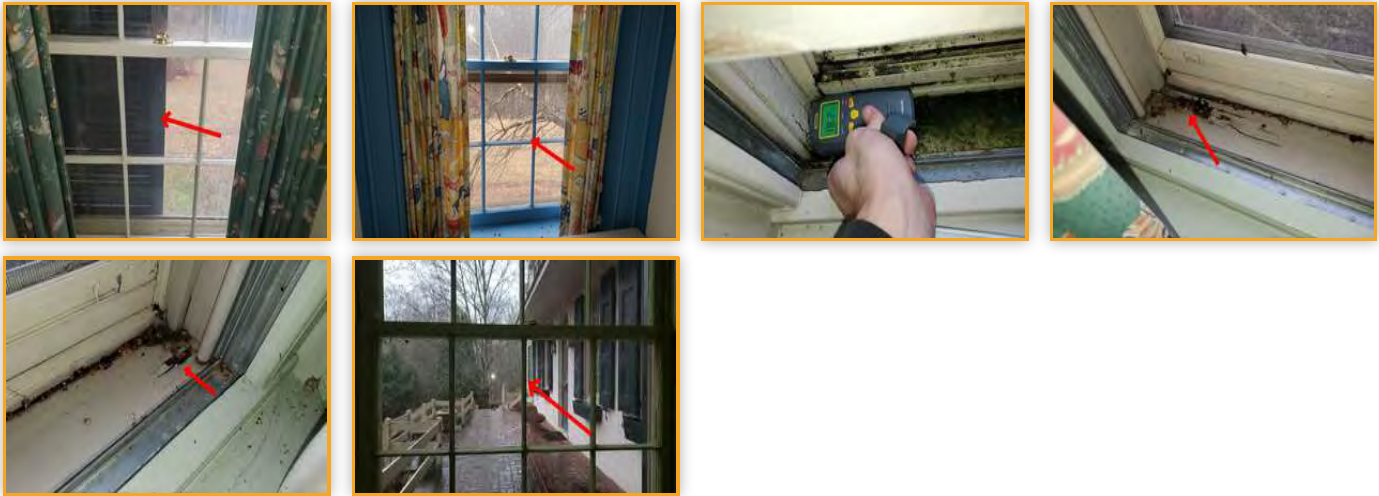
3. HEAVY ROT

Heavy wood rot was present at multiple windows throughout residence. A qualified contractor is recommended for evaluation and repair.

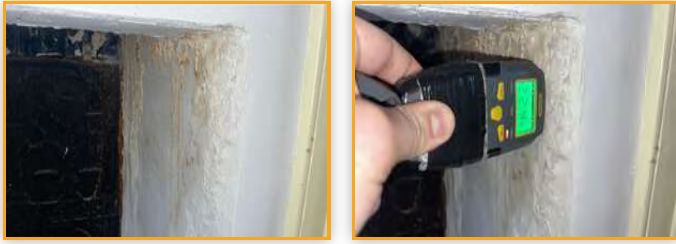
23.2.2 Moisture

Staining/high moisture readings were present at fireplace in front right bedroom indicating moisture intrusion. A qualified contractor is recommended for evaluation and repair as needed.

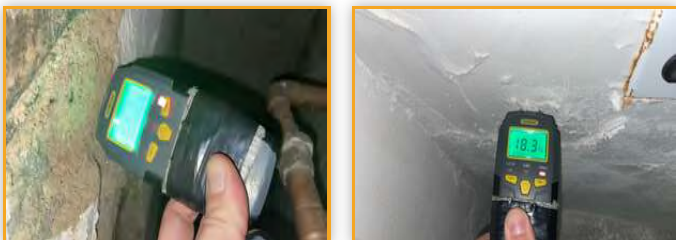
24.9.2 Moisture: Staining/High Readings

There were indications of moisture penetration made evident by staining and high moisture readings. When there is high moisture present, further evaluation by a qualified contractor is recommended.

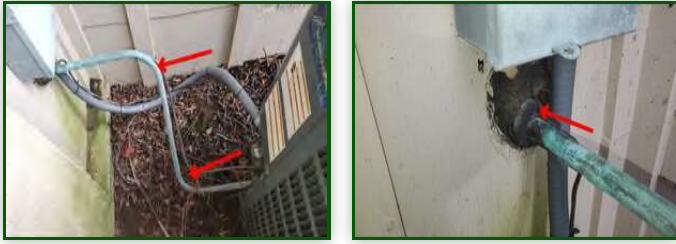
4.10.2 Gaps/Not Sealed

Refrigerant lines had gaps in the insulation. Entry point was not sealed.

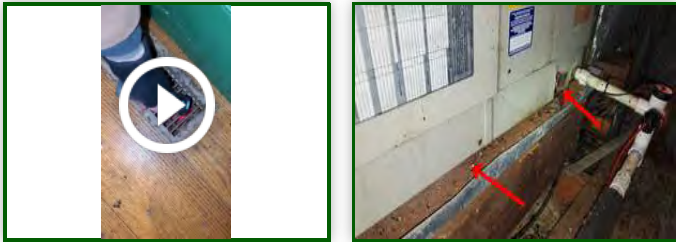
4.10.3 Uneven flow/Staining

There was a noticeable difference in temperature and airflow at the registers when tested. Balancing ductwork is beyond scope of this inspection, if desired recommend evaluation by a qualified HVAC contractor. Staining was present at heat pump in attic recommend monitoring.

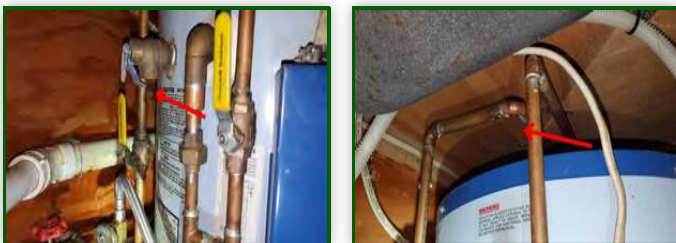
4.13.2 Missing/Not Installed

Water heater was missing tprv discharge pipe. Expansion tank was not installed. Recommend repair.

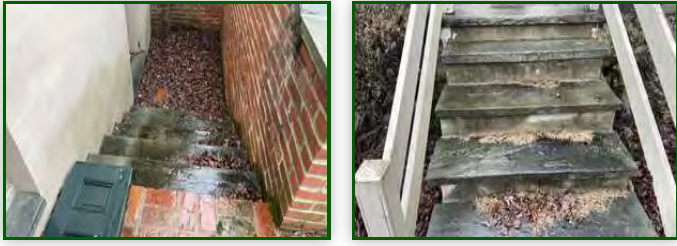
12.12.1 Handrails/treads

Handrails were not installed at areas. Client should consider installing handrails to improve safety. Treads were loose.

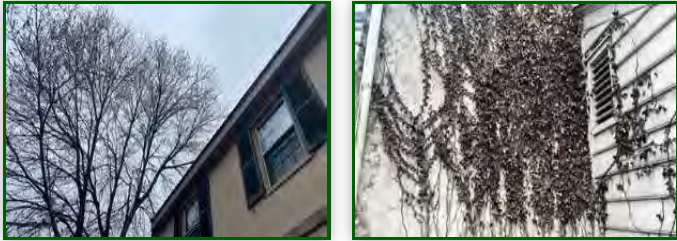
2. VEGETATION IN CONTACT

Vegetation was in contact with residence, which may lead to moisture intrusion and potential pest entry. Client may wish to trim vegetation.

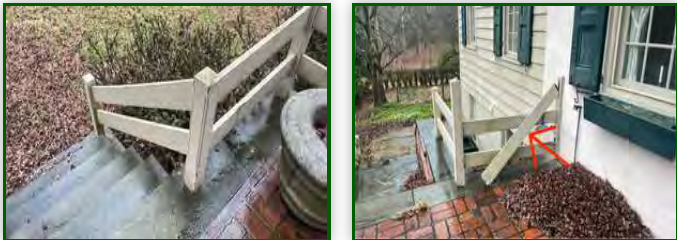
12.16.1 Loose/damaged

Handrails were loose. Guardrail was damaged.

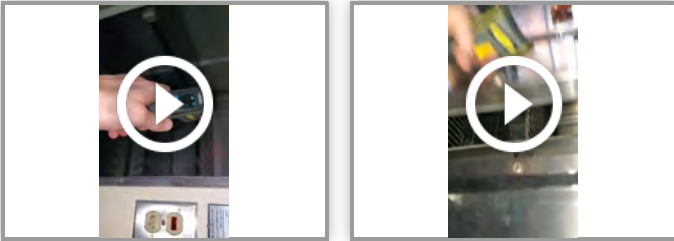
19.9.1 Not Cooling/Turned Off

The mini-fridge/walk-in freezer/freezer were not cooling and appeared to be turned off at the time of inspection. Recommend plugging in and verifying operation prior to settlement if client is concerned.

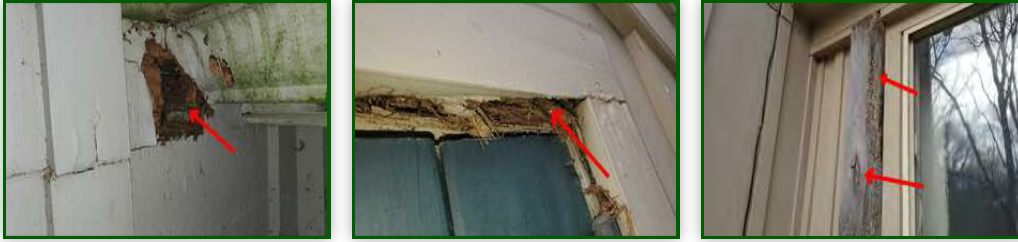
4.2.1 Heavy Wood Rot/Damage/Exposed

Heavy wood rot/damage was present at areas around the exterior. Wood was exposed at the exterior. A qualified contractor is recommended for evaluation and repair as needed.

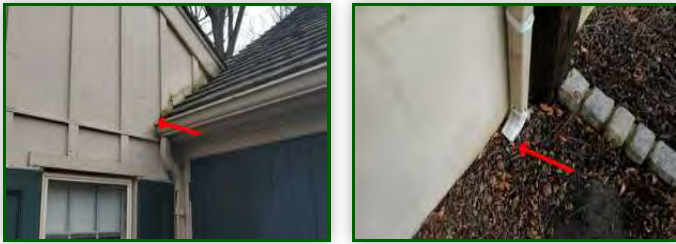
4.2.2 Exterior (Multiple Defects)

1. Kickout flashing was missing at areas. Client may want to consider installing.
2. Downspouts were draining at the foundation.

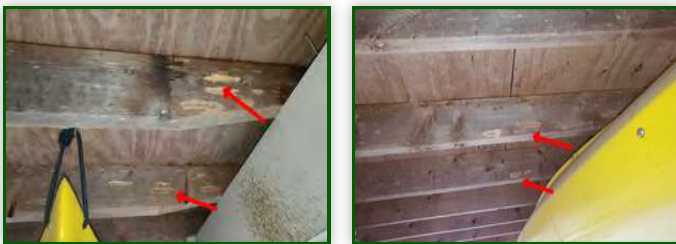
4.2.3 Heavy Carpenter Bee Damage

Heavy carpenter bee damage was present at areas of rear carport overhang. A qualified contractor is recommended for evaluation and repair as needed.

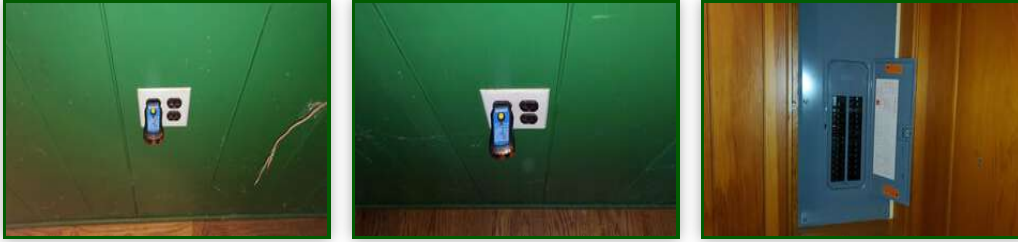
Several outlets in lower office area did not have power at the time of inspection. All breakers/switches/gfci's that were accessible were set to the on position. A licensed electrician is recommended for evaluation and repair as needed.

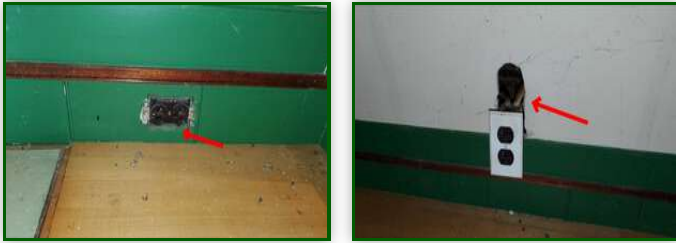
4.4.2 Missing covers/Loose

Cover plates were not installed at outlets or switches. Outlet were loose, recommend securing.

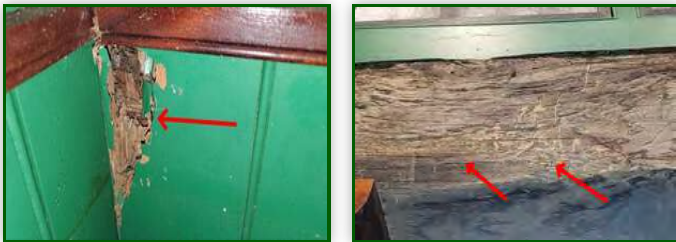
4.6.1 Heavy Termite Damage

Heavy termite damage was present at wall in lower office area/wood beam going across foyer. A qualified contractor is recommended for evaluation and repair as needed.

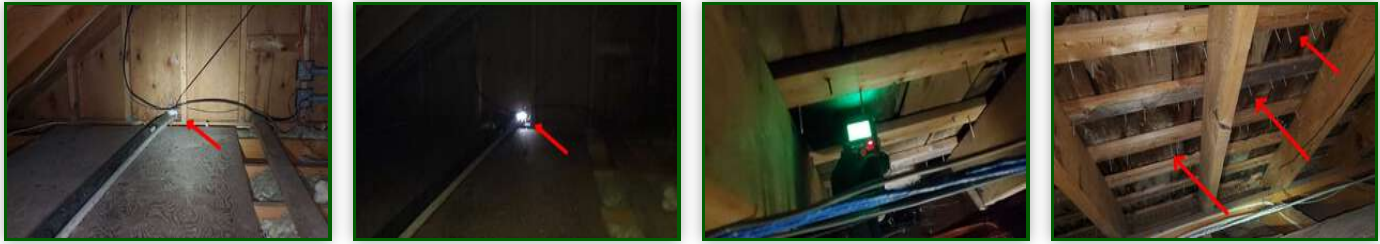
4.14.1 Open/Daylight Visible/Elevated Moisture Readings

Gap was present in attic area with daylight visible from the exterior. Staining was present at areas in attic with elevated moisture readings present. A qualified contractor is recommended for evaluation and repair as needed.

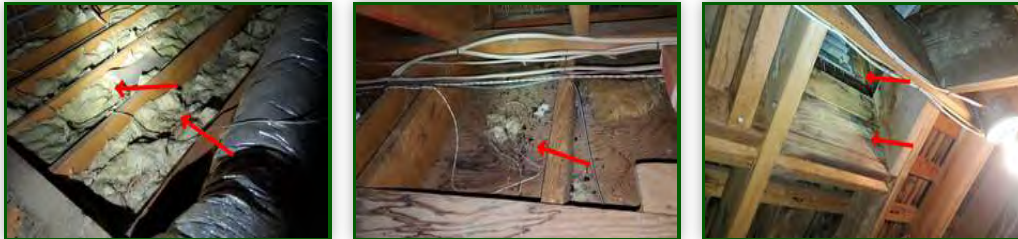
4.14.2 Compressed/Droppings/Microbial Growth

Insulation was compressed at areas, this affects the R-value. Rodent droppings/snake-skins were present in attic area. Recommend consulting a qualified exterminator if client is concerned. Microbial growth was visible at areas in attic.

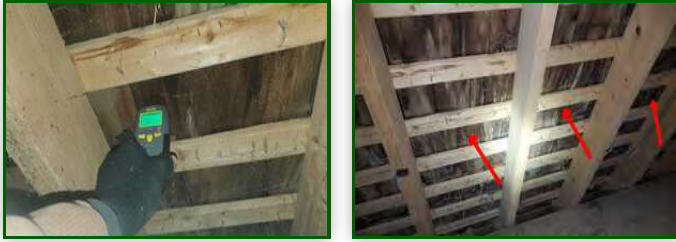
5.12.1 Staining (Elevated Moisture Readings)

Staining was present in attic area of the small animal barn. Moisture readings were taken and were elevated at the time of inspection. A qualified contractor is recommended for evaluation and repair as needed.

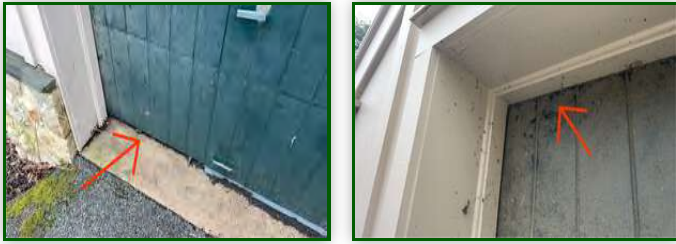
Seal was damaged. Weather stripping was not installed.

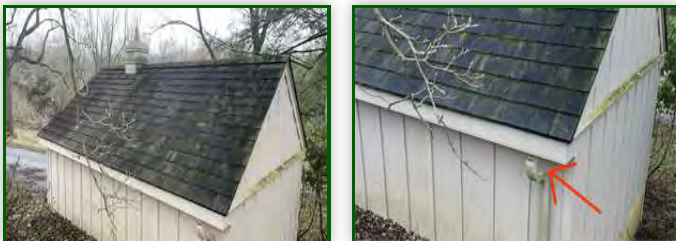
Roof was worn. Recommend monitoring. Gutters were not present.

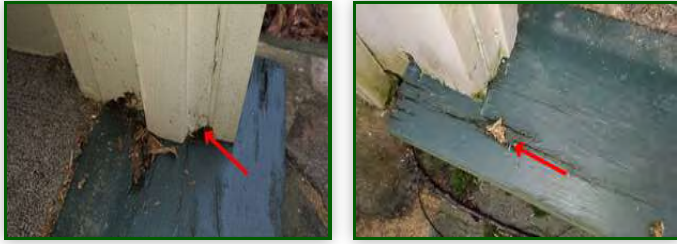
10.2.4 Heavy Rot

Heavy rot was present at door/door frame to apartment area. A qualified contractor is recommended for evaluation and repair as needed.

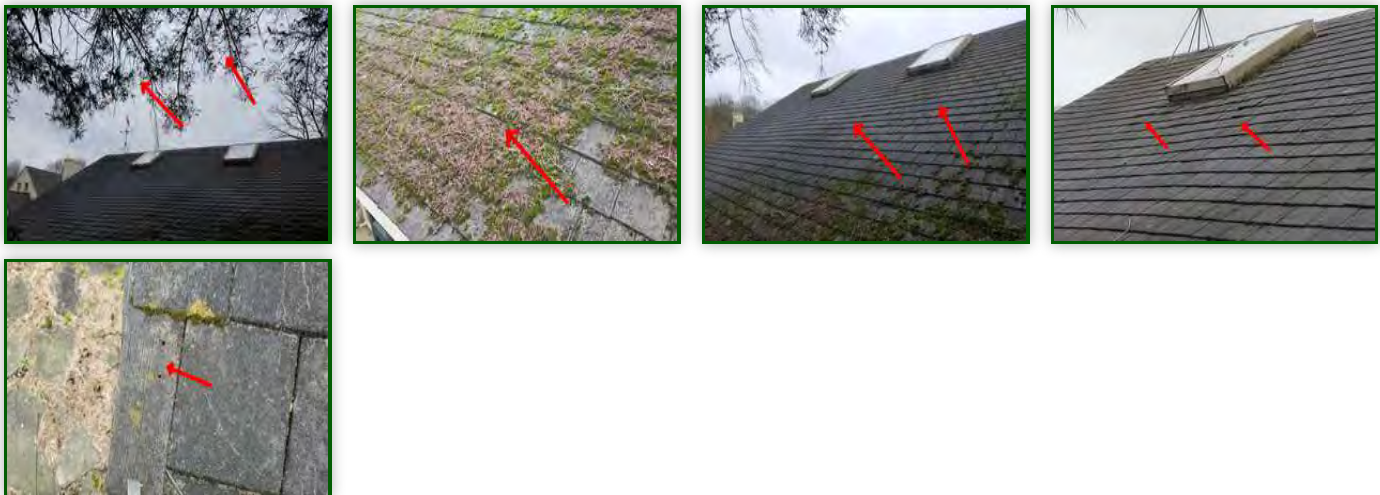
Tree limbs were overhanging roof, recommend cutting back. Moss growth was present on roof, this can accelerate deterioration. Shingles had wear/minor damage present. Shingles were not laying flat at areas, however, no issues were present resulting from this condition at time of inspection.

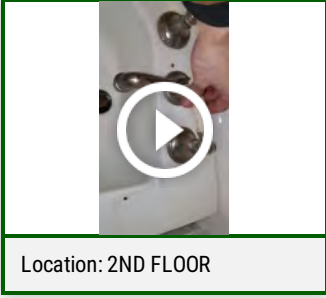
No cold water pressure was present at any fixtures in 2nd floor right side hallway bathroom. A qualified plumber is recommended for evaluation and repair as needed.

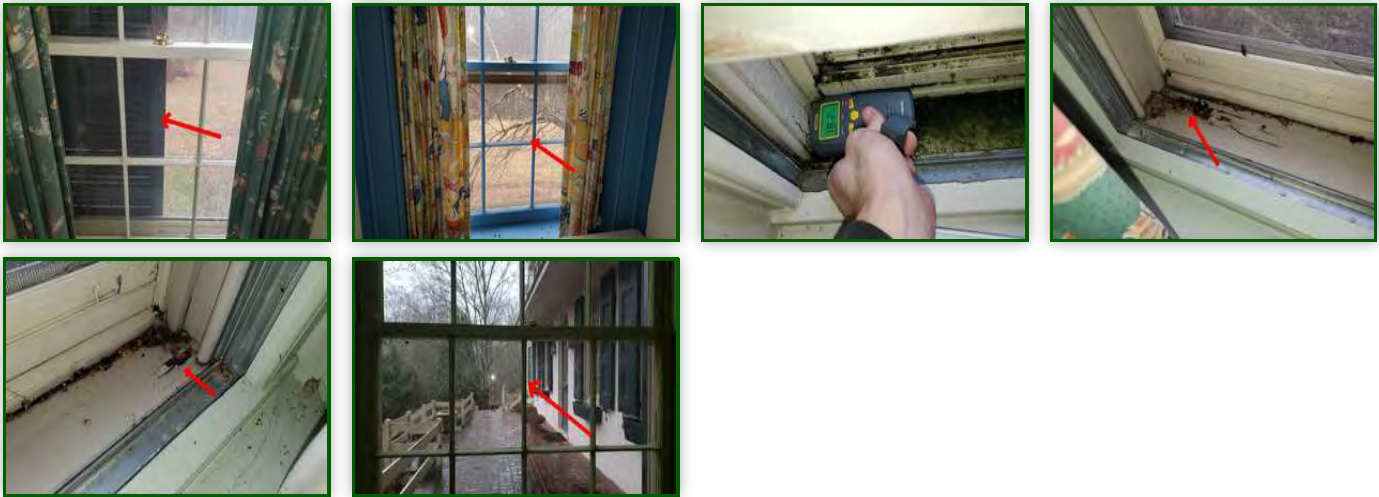
3. HEAVY ROT

Heavy wood rot was present at multiple windows throughout residence. A qualified contractor is recommended for evaluation and repair.

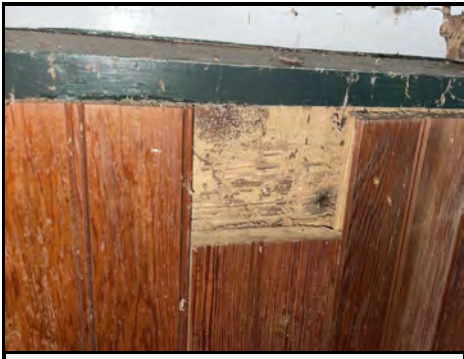
Termite damage

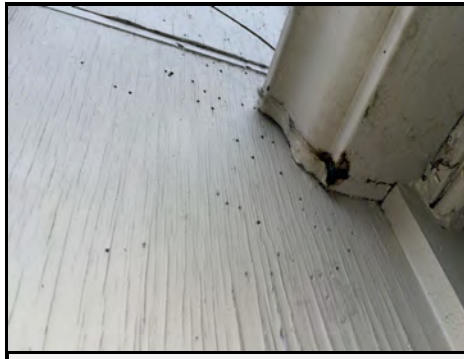
Powder post beetle damage

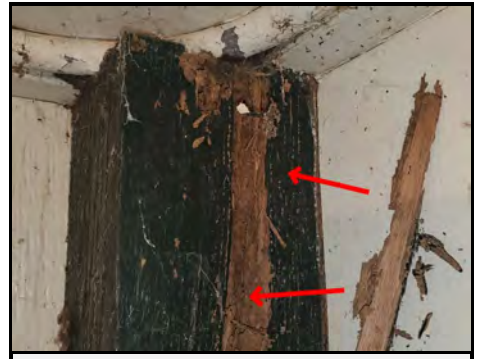
Termite Damage

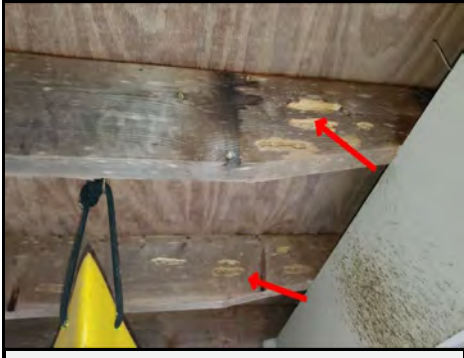
Carpenter Bee Damage

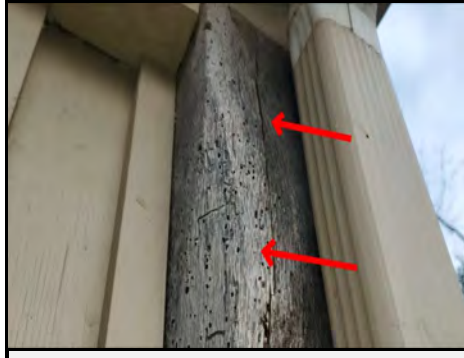
Wood boring beetle damage

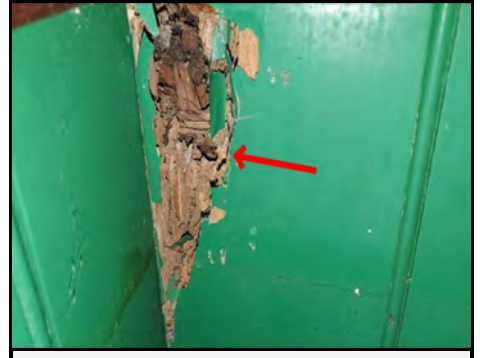
Termite Damage
