INSPECTION REPORT

White Clay Creek State Park

Inspection Report

1035 Creek Road Krapf House, Newark, Delaware 19711

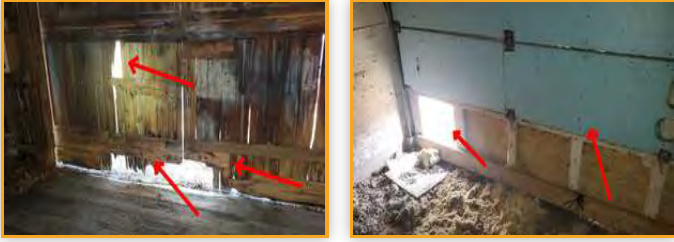
1.1.1 Heavy Damage/Wood Rot

Heavy damage/wood rot was present at outbuilding doors. Garage doors in basement area would not open when testing. A qualified contractor is recommended for evaluation and repair as needed.

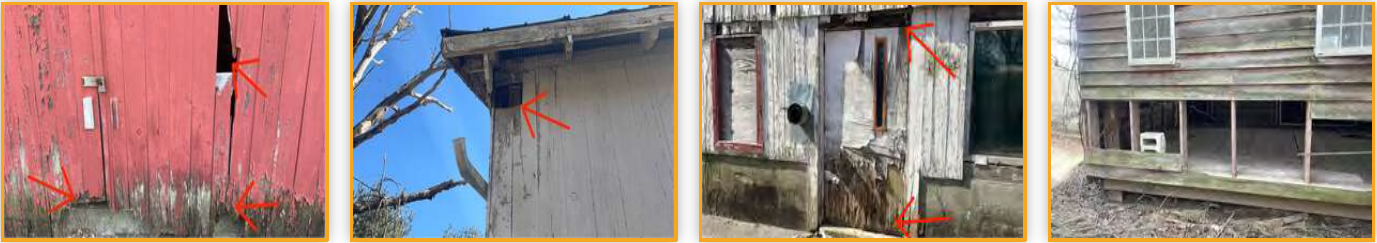
1.2.1 Damage/wood rot

Heavy wood rot/damage was present at various locations around barn. Large portions of siding were missing. A qualified contractor is recommended for evaluation and repair as needed.

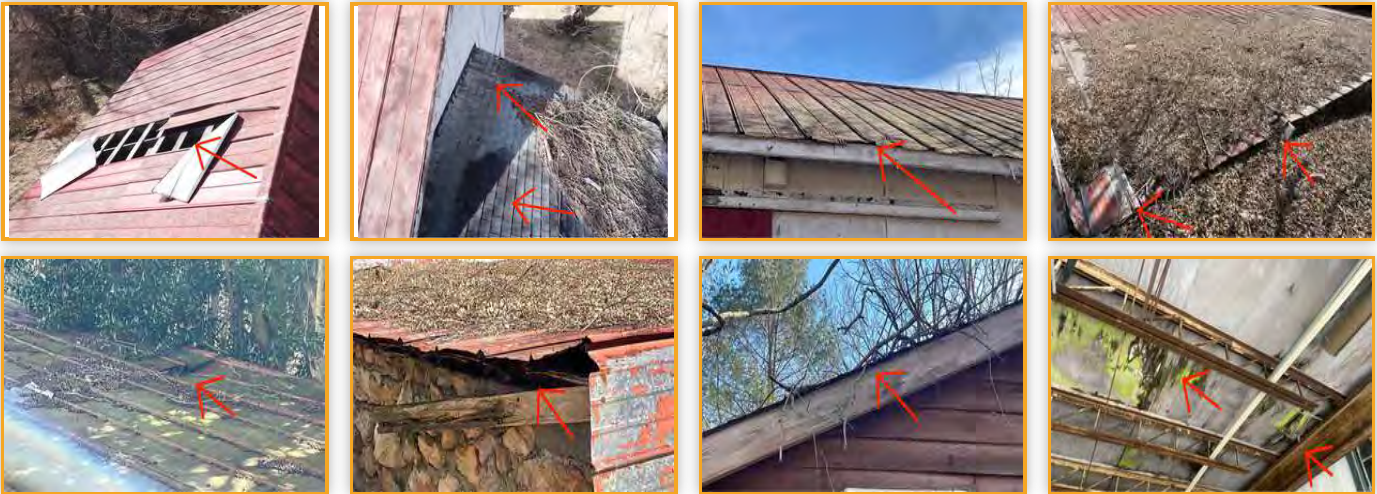
1.3.2 Damaged/worn

Roof coverings were heavily damaged/worn with moisture intrusion present inside. Heavy wood rot was present at sheathing. Drip edge was missing. A qualified contractor is recommended for evaluation of roof and repair as needed.

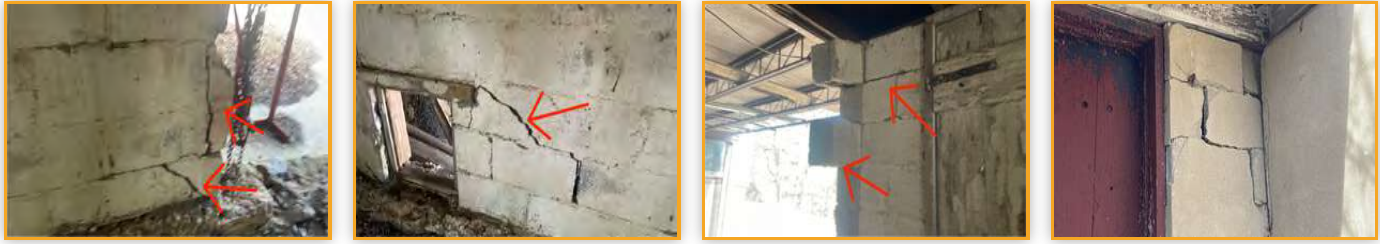
1.5.4 Blocks

Blocks were heavily damaged/loose with large cracking present. A qualified contractor is recommended for evaluation and repair as needed.

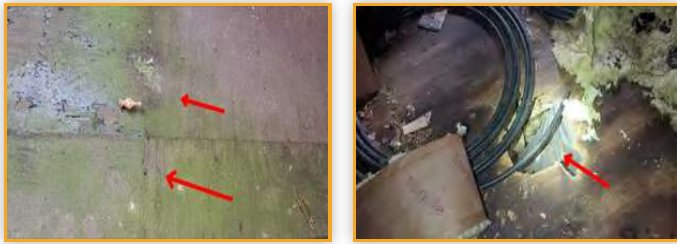
1.6.1 Soft Spots/Large Gaps

Soft spots were present at areas of flooring in outbuilding. Large gaps were present in floor creating a safety concern. A qualified contractor is recommended for evaluation and repair as needed.

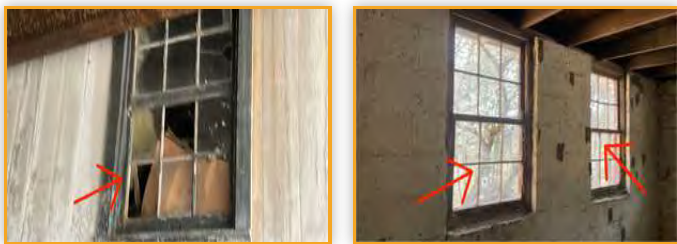
1.7.1 Broken glass

Broken glass was present at various windows/doors. A qualified contractor is recommended for evaluation and repair as needed.

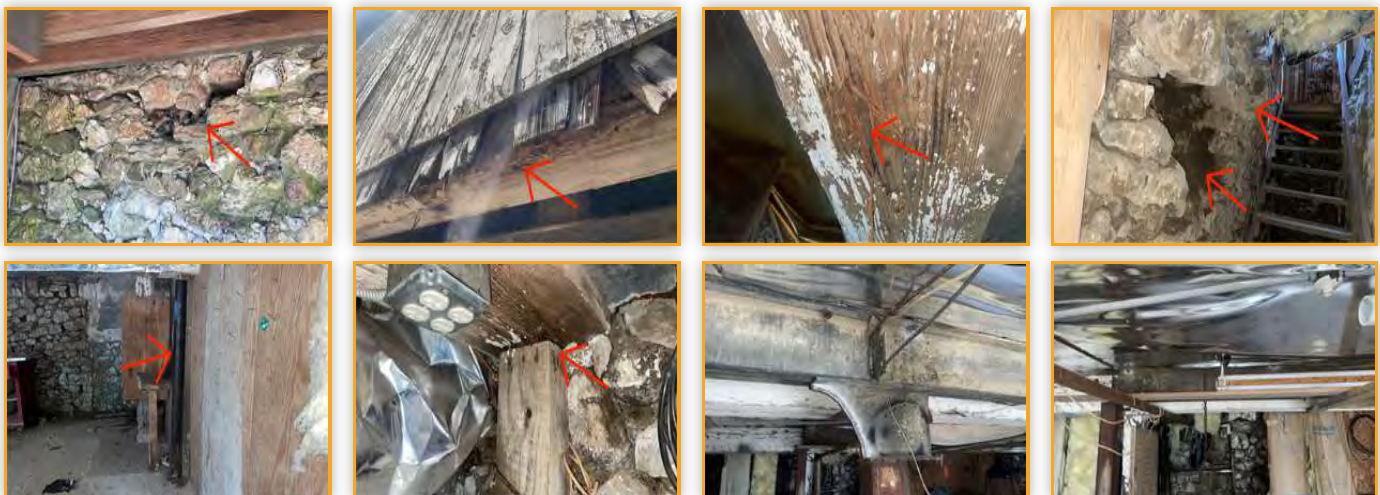
1.9.1 Foundation

Stones were missing at various locations. Heavy damage was present at beams. Bowing was present at stone foundation wall. Posts were leaning. Posts were damaged/no longer in contact with beams. Sagging/damage were present at steel beams. A licensed structural engineer is recommended for evaluation and repair as needed.

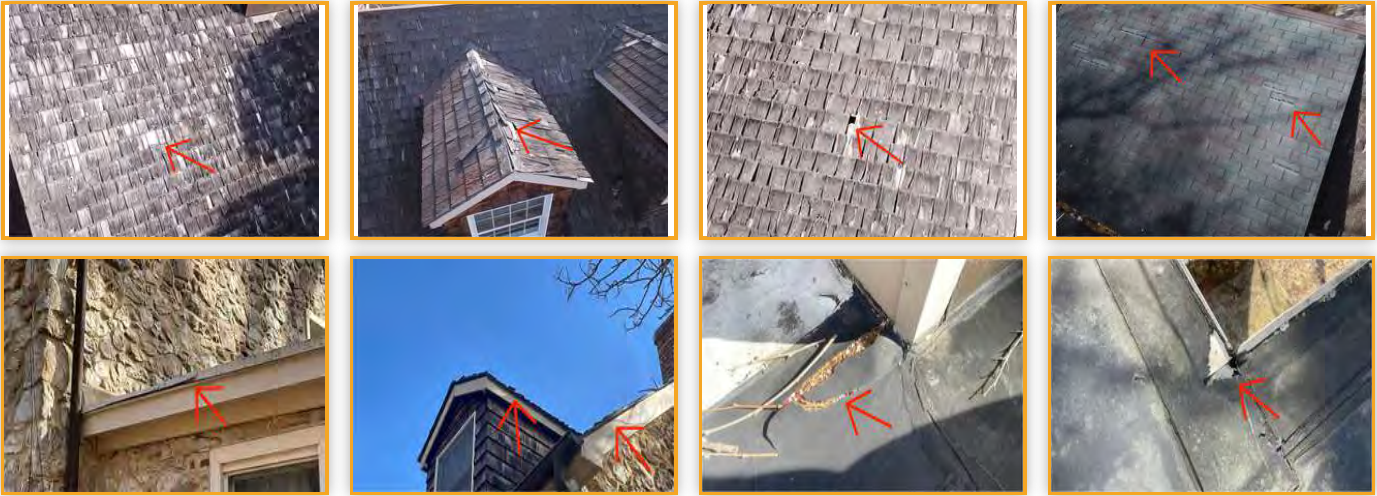
4.1.1 Roof

Roof/roof materials were heavily damaged or missing at various locations. Roof was heavily worn. Holes were present. Drip edge was not installed at areas. A qualified contractor is recommended for evaluation of roofs and repair as needed.

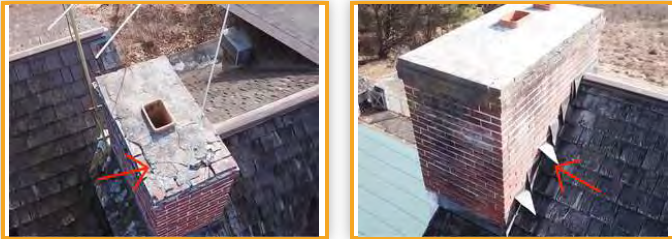
4.4.1 Chimneys

Flashing was loose/damaged at chimneys. Chimney crown was heavily deteriorated. A qualified contractor is recommended for evaluation and repair as needed.

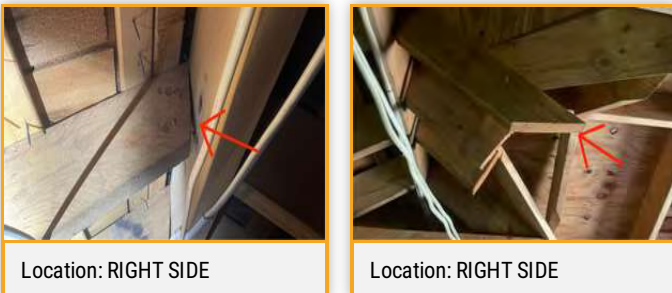
5.2.1 Rafters

Rafters showed signs of pulling away. Rafters were cut/alterd. Recommend evaluation by a qualified contractor.

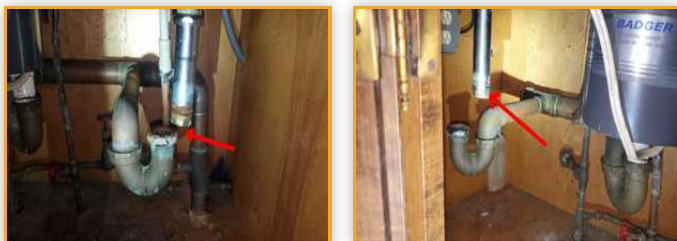
10.1.1 Disconnected

Drain lines for kitchen sink/garbage disposal were disconnected at the time of inspection. A qualified plumber is recommended for evaluation and repair as needed.

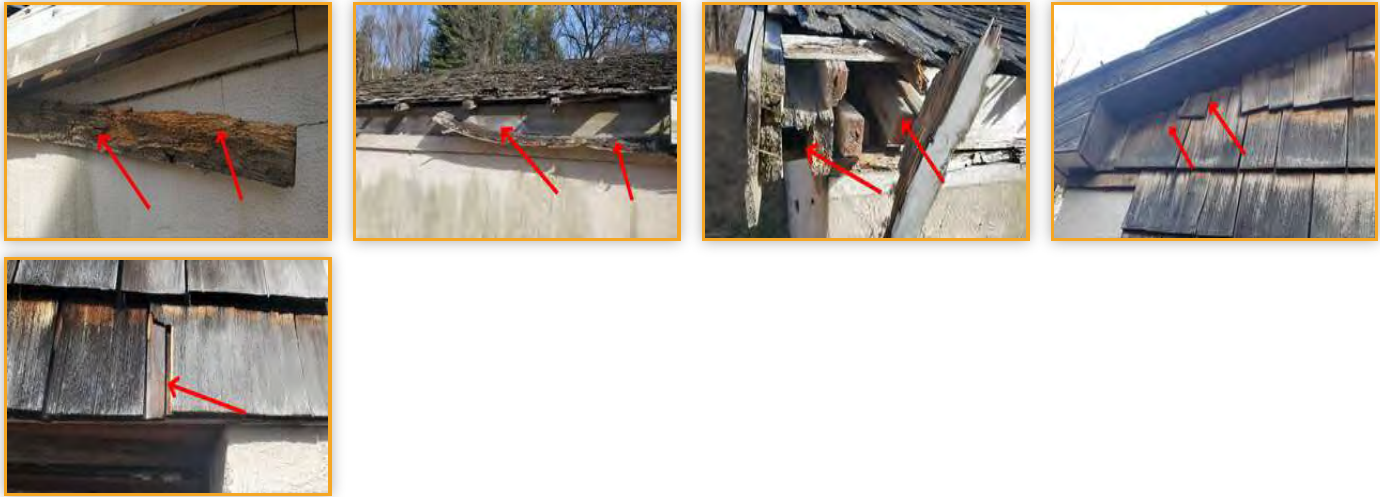
15.2.1 Heavy Rot//Termite Damage/Detached

Wood around the exterior of the garage including the fascia/soffit areas had heavy wood rot/termite damage present. Siding was heavily damaged/detached at areas. A qualified contractor is recommended for evaluation and repair as needed.

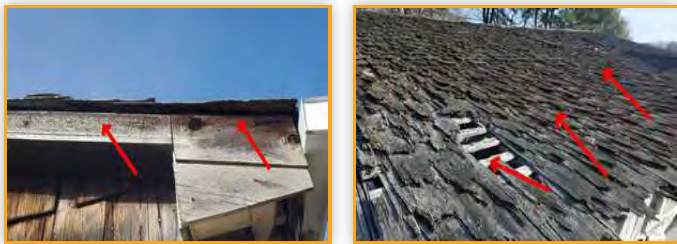
15.3.1 Missing Drip Edge/Heavy Rot/Damage

Drip edge material was missing around garage roof. This was causing concern for moisture intrusion/damage over time. Wood roof material was heavily rotted/damaged/falling apart at areas. A qualified contractor is recommended for evaluation and repair as needed.

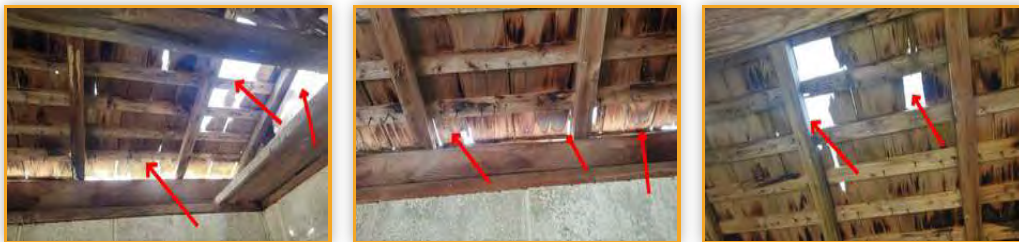
15.5.1 Heavy Wood Rot/Damage/Large Gaps

Heavy wood rot/damage/large gaps were present at areas inside detached garage with light visible from the outside. A qualified contractor is recommended for evaluation and repair as needed.

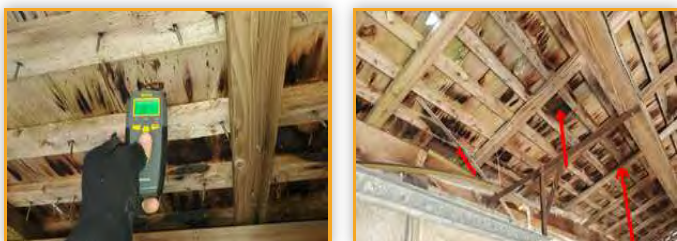
15.6.1 Moisture (Elevated)

There were indications of moisture entry made evident by staining throughout garage. Moisture readings were taken and were elevated at the time of inspection. Unable to determine condition of underlying materials. A qualified contractor is recommended for further evaluation and repair as needed.

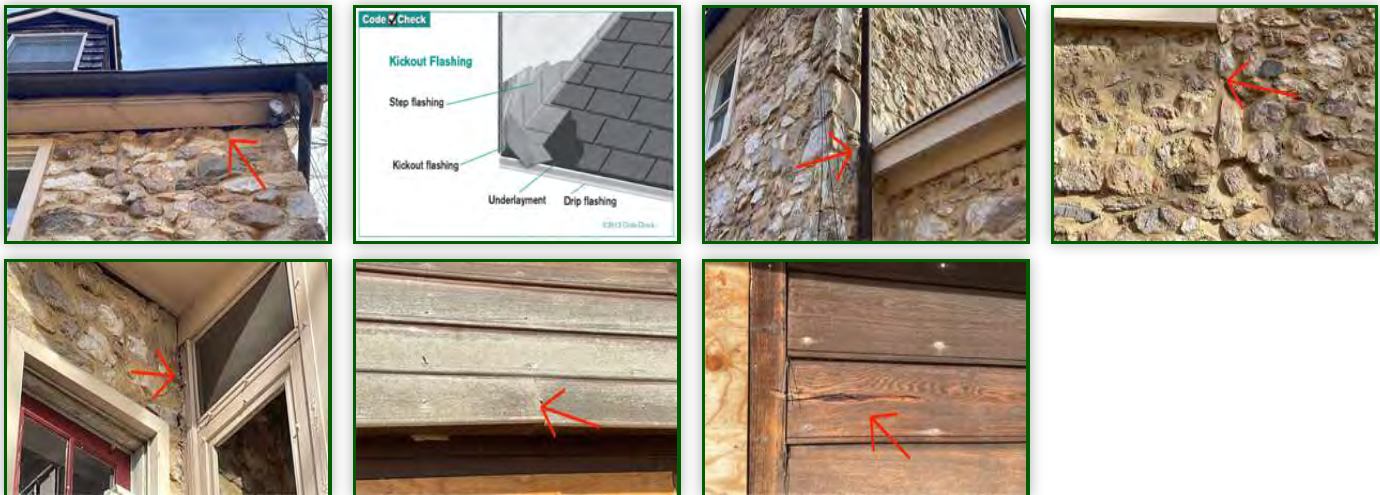
3.1.1 Siding (Multiple Defects)

Spray foam was present at areas and will need ongoing maintenance. Unable to determine underlying conditions.

Kickout flashing was not present. Kickout or diverter flashing help prevents water entry at the roof and sidewall transition. Unable to determine the condition of underlying materials .

Minor cracking was present at bricks and/or stones. Recommend monitoring.

Caulk/mortar were worn at areas. Recommend monitoring/re sealing as needed.

Damaged siding was present at exterior of residence.

The siding was loose in areas. Recommend securing.

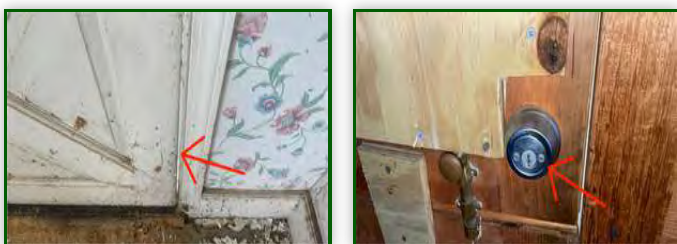
3.6.2 Doors (Multiple Defects)

The weather strip was damaged around the door; it did not seal properly and light was visible around the door.

Interior keyed locks are not recommended on entry doors. Locks should have hand operated latch. Recommend replacing keyed locks with a hand operated latch for ease of exit in the event of an emergency.

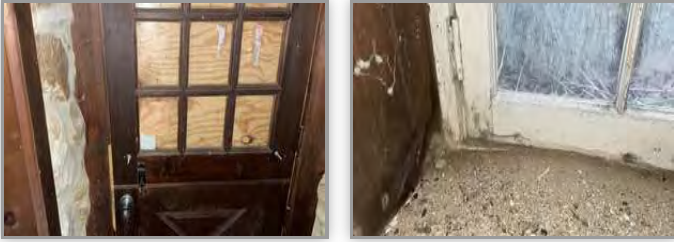
16.11.1 Boarded up/sealed

Doors and windows were boarded up/sealed shut.

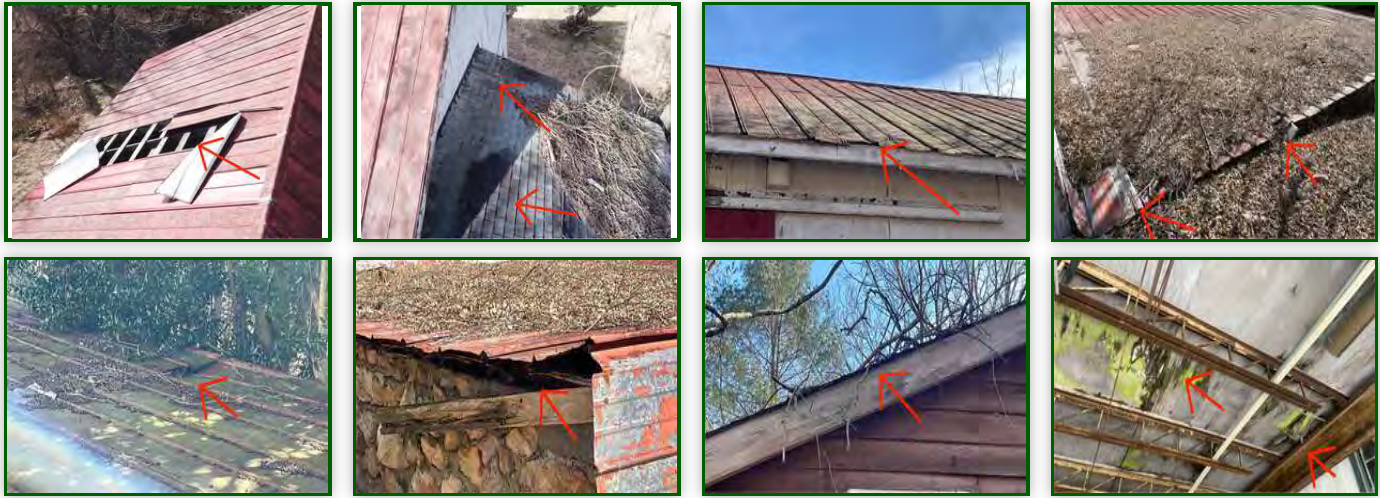
M Major

Roof coverings were heavily damaged/worn with moisture intrusion present inside. Heavy wood rot was present at sheathing. Drip edge was missing. A qualified contractor is recommended for evaluation of roof and repair as needed.

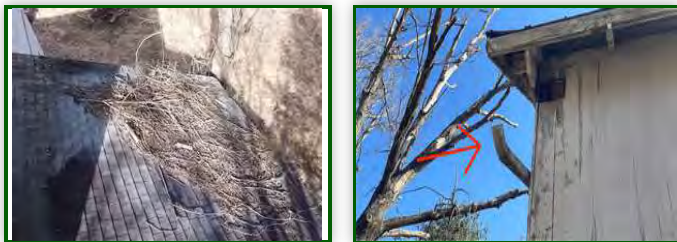
1.3.3 Debris/gutters

m Minor/Maintenance

Debris was present. Recommend removing. Unable to determine underlying conditions. Gutters were detached/missing.

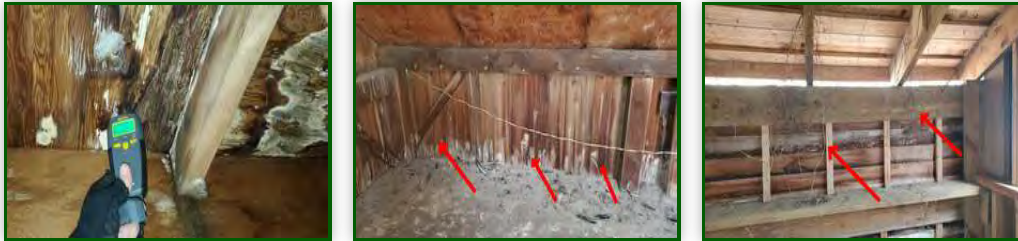
M Major

Staining was present at areas throughout outbuilding with elevated moisture readings present. Vegetation was present and growing inside the building. A qualified contractor is recommended for evaluation and repair as needed.

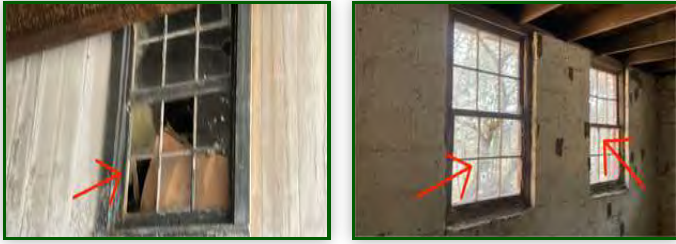
M Major

Broken glass was present at various windows/doors. A qualified contractor is recommended for evaluation and repair as needed.

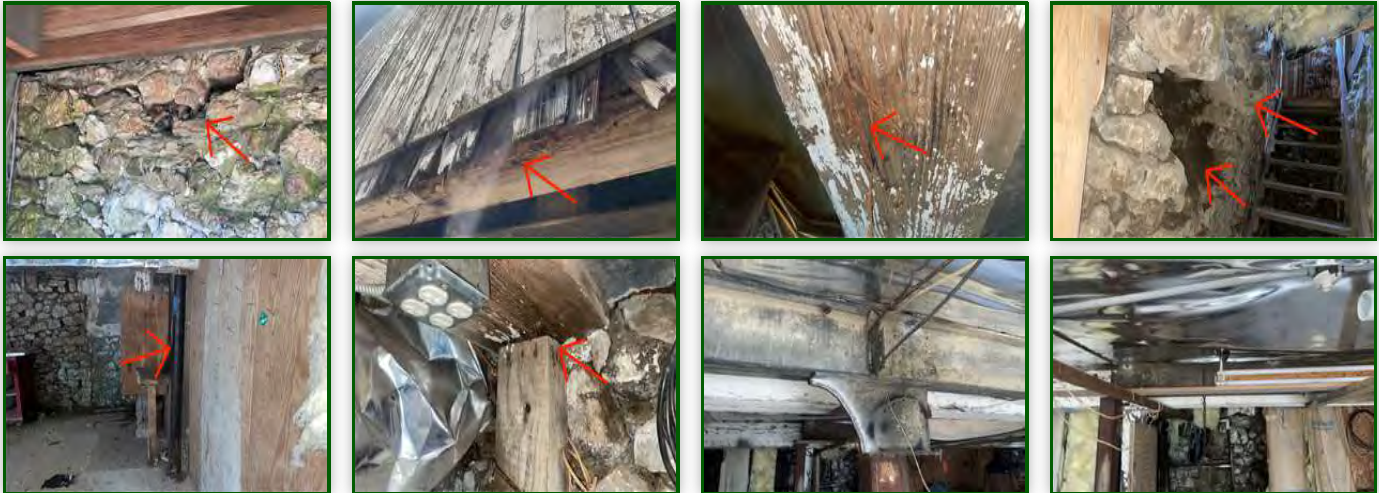
1.9.1 Foundation

M Major

Stones were missing at various locations. Heavy damage was present at beams. Bowing was present at stone foundation wall. Posts were leaning. Posts were damaged/no longer in contact with beams. Sagging/damage were present at steel beams. A licensed structural engineer is recommended for evaluation and repair as needed.

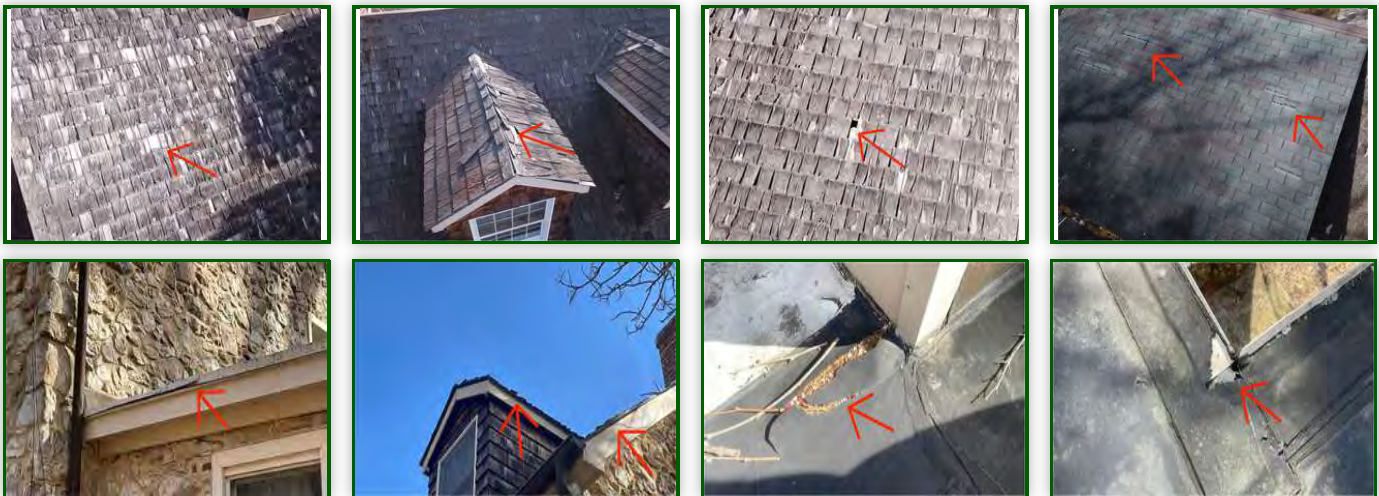
M Major

Roof/roof materials were heavily damaged or missing at various locations. Roof was heavily worn. Holes were present. Drip edge was not installed at areas. A qualified contractor is recommended for evaluation of roofs and repair as needed.

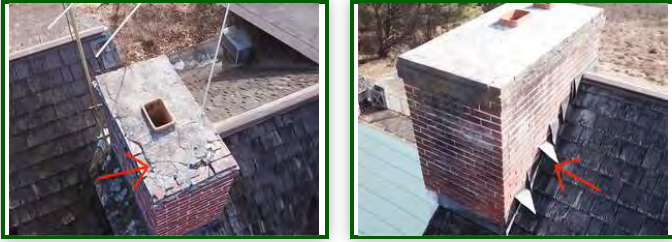
4.4.1 Chimneys

Major

Flashing was loose/damaged at chimneys. Chimney crown was heavily deteriorated. A qualified contractor is recommended for evaluation and repair as needed.

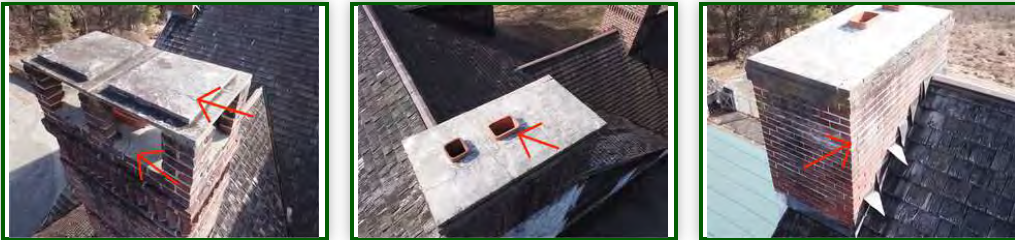
4.4.2 Chimney (Multiple Defects)

Chimney crown had cracking.

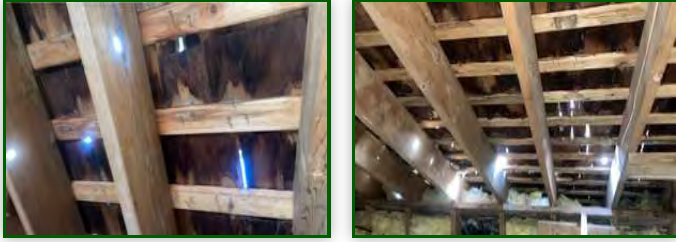
M Major

There were indications of moisture penetration made evident by staining. Moisture readings were taken and were elevated at the time of inspection. Daylight was visible from inside attic at various locations. A qualified contractor is recommended for evaluation and repair as needed.

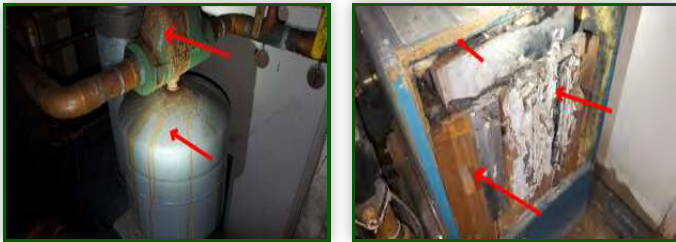
M Major

Heavy corrosion/staining was present at boiler in basement. A qualified hvac technician is recommended for evaluation and repair as needed.

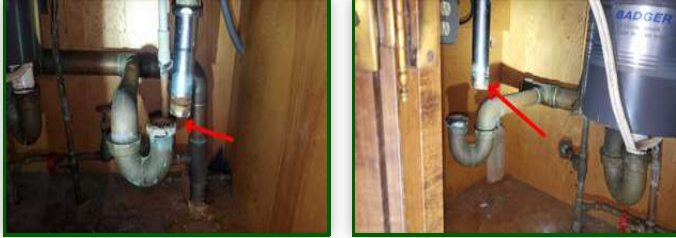
M Major

Drain lines for kitchen sink/garbage disposal were disconnected at the time of inspection. A qualified plumber is recommended for evaluation and repair as needed.

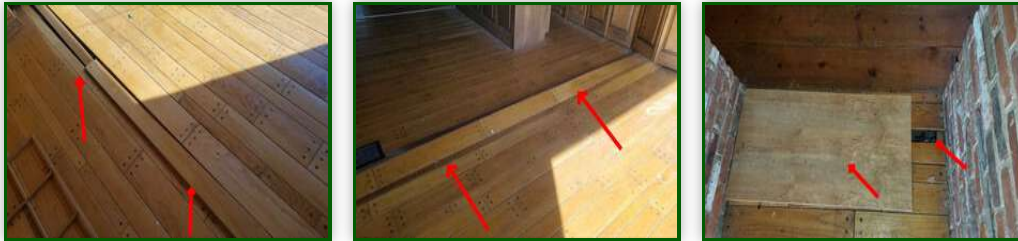
Major

Flooring was heavily damaged/unlevel/had gaps present at areas throughout the residence. A qualified contractor is recommended for evaluation and repair as needed.

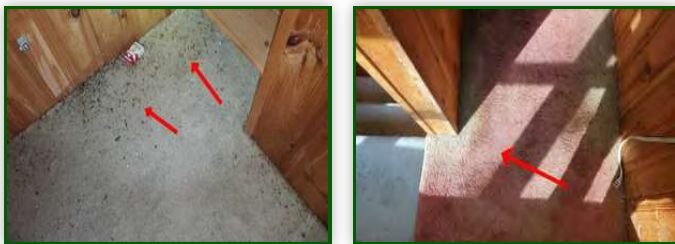
13.4.2 Floor(Multiple Defects)

The floor squeaked when walked on, typically caused by movement at sub floor from loose/missing fasteners.

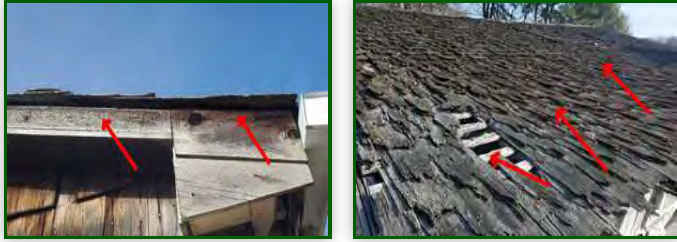
M Major

Drip edge material was missing around garage roof. This was causing concern for moisture intrusion/damage over time. Wood roof material was heavily rotted/damaged/falling apart at areas. A qualified contractor is recommended for evaluation and repair as needed.

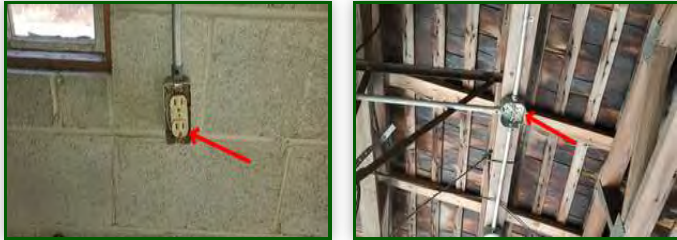
15.4.1 Missing covers/Open junction boxes

m Minor/Maintenance

Cover plates were not installed at outlets or switches. Junction boxes were not covered.

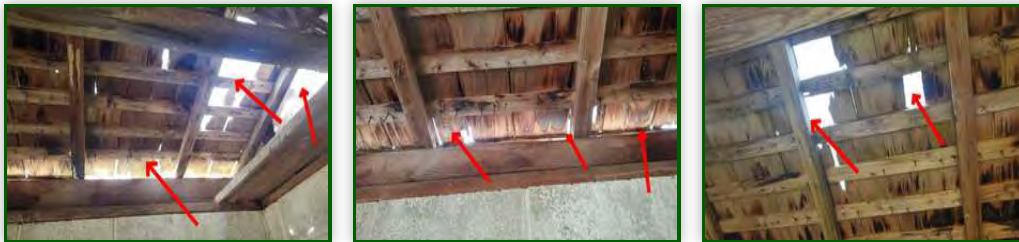
15.5.1 Heavy Wood Rot/Damage/Large Gaps

M Major

Heavy wood rot/damage/large gaps were present at areas inside detached garage with light visible from the outside. A qualified contractor is recommended for evaluation and repair as needed.

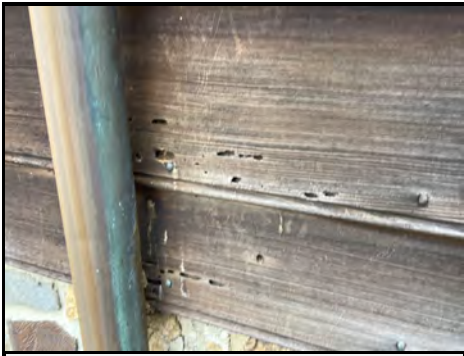
Carpenter bee damage

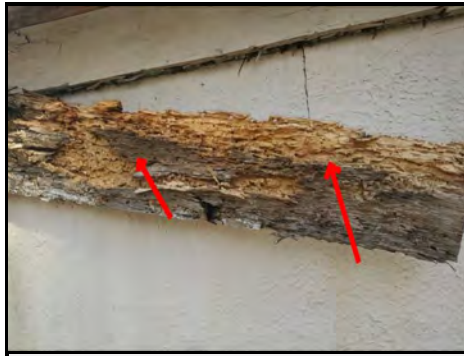
Termite damage

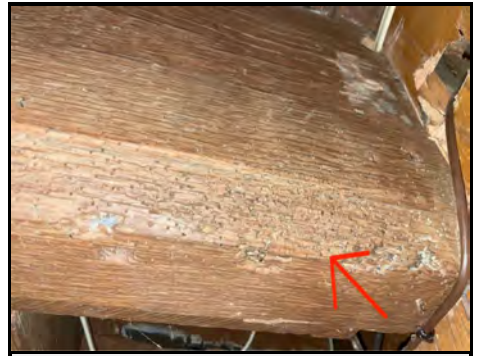
Powder post beetle damage

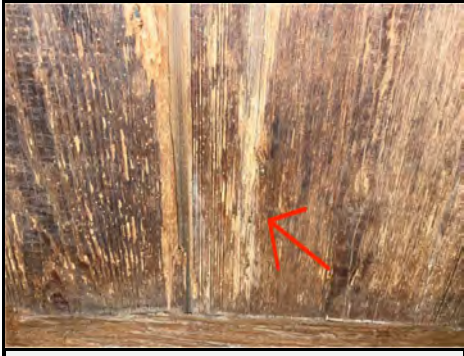
Termite damage

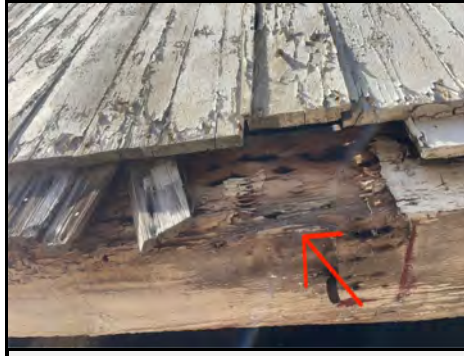
Termite damage
