**Addendum  
No. 2**

Project: Holloway Campus Carvel Bldg. Roof Replacement  
MC3501000111

**Asbestos NESHAP Inspection  
Carvel Building Roof Replacement Project**

***Roof Assessment***

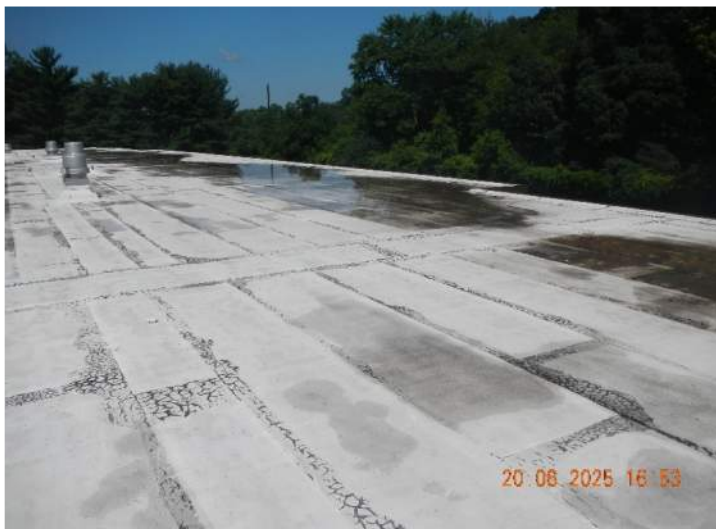
These roofs appear to be in generally poor condition. The fluid applied coating has started to fail, with widespread cracking and delamination visible. The lower portion of the roof appears to have drainage issues, with large areas of ponding water present during our survey. The flashings, though few in numbers show typical signs of aging and appear to be lower than the industry standard of 8" at the rising walls. There is also a fair amount of biological growth that is forming in the ponding areas of the roof.

Photo 3 – Overview of lower roof area covered in ponding water.

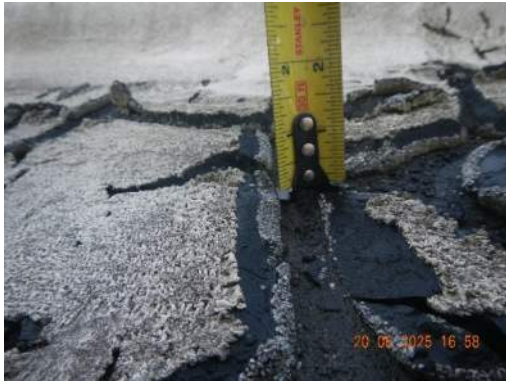
Photo 5 – Cracked roof coating material. Cap sheet also appears to be damaged.

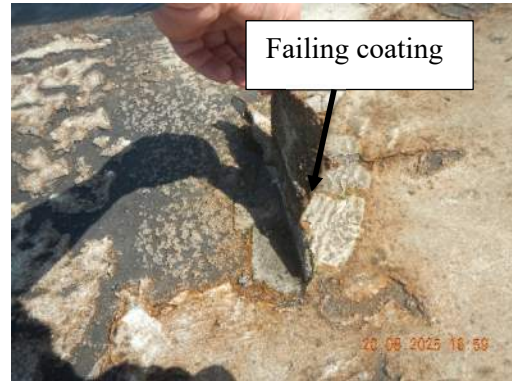
Photo 6 – Failing coating in ponding locations. The submerged coating material is separating from the cap sheet.

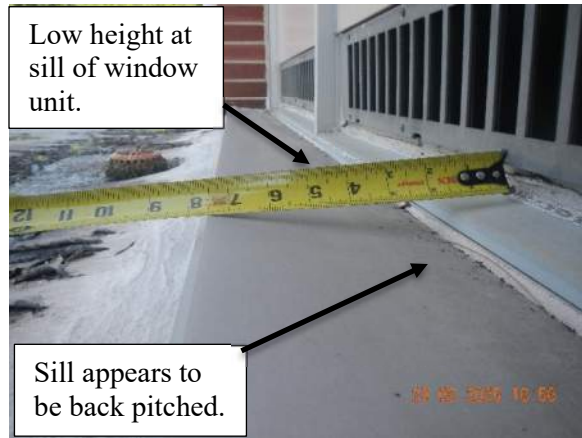
Photo 9 – Low flashing heights at window units on the lower roof.

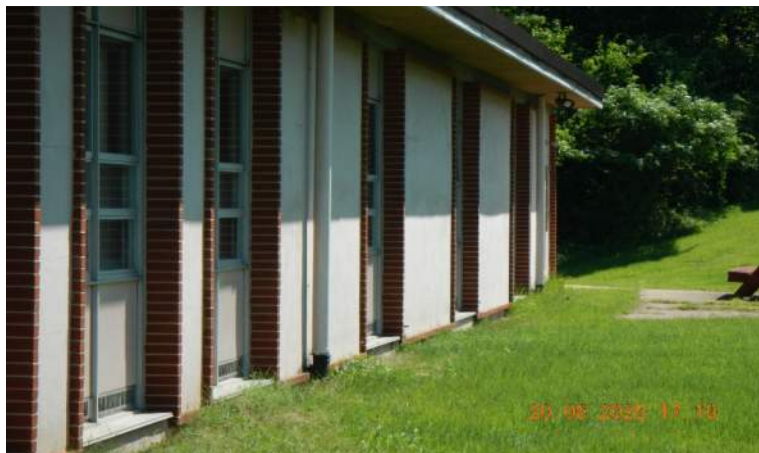
Photo 17 – Typical drain leaders from roof drains. The drains are not part of an internal stormwater system.

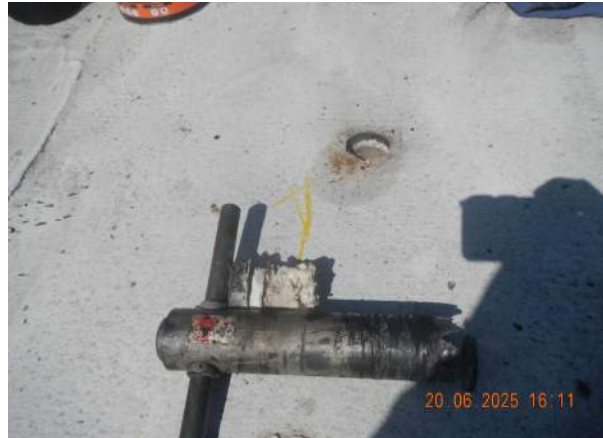
**Core 1:**

- Metal Deck
- 1 1/2" Polyisocyanurate Insulation
- 1/2" Gypsum Board Insulation
- Modified Built-Up Roof Membrane
- White Fluid Applied Coating
- Dry
- Overall Core Depth 2 1/2"

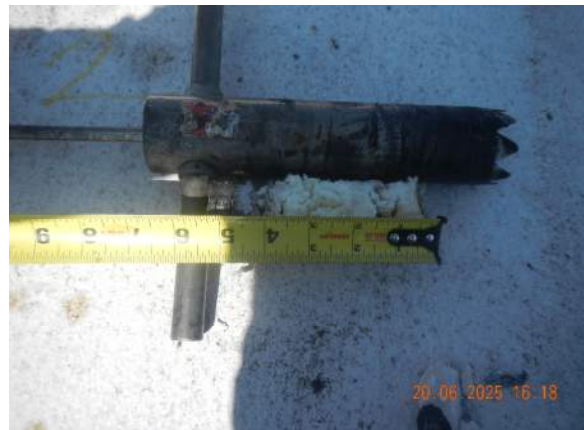
**Core 2:**

Note: The 2nd core was taken 20' from the 1st. Appears to show presence of tapered insulation

- Metal Deck
- 4" Polyisocyanurate Insulation
- 1/2" Gypsum Board Insulation
- Modified Built-Up Roof Membrane
- White Fluid Applied Coating
- Dry
- Overall Core Depth 5"

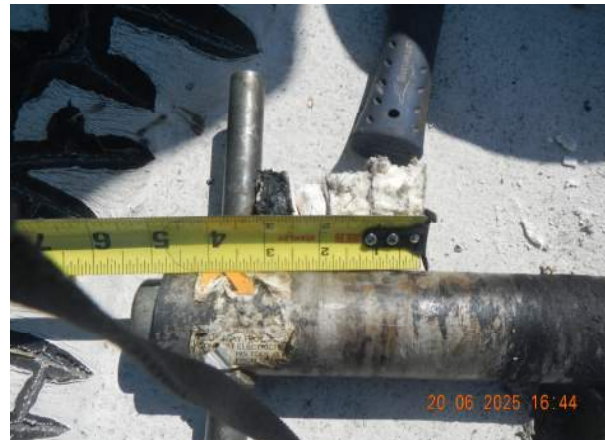
**Core 6:**

- Metal Deck
- 2 1/4" Polyisocyanurate Insulation
- 1/2" Gypsum Board Insulation
- Modified Built-Up Roof Membrane
- White Fluid Applied Coating
- Dry
- Overall Core Depth 3 1/2"
