**Addendum  
No. 3**

Project: Holloway Campus Carvel Bldg. Roof Replacement - REBID  
MC3501000111A

**Asbestos NESHAP Inspection  
Carvel Building Roof Replacement Project**

***Roof Assessment***

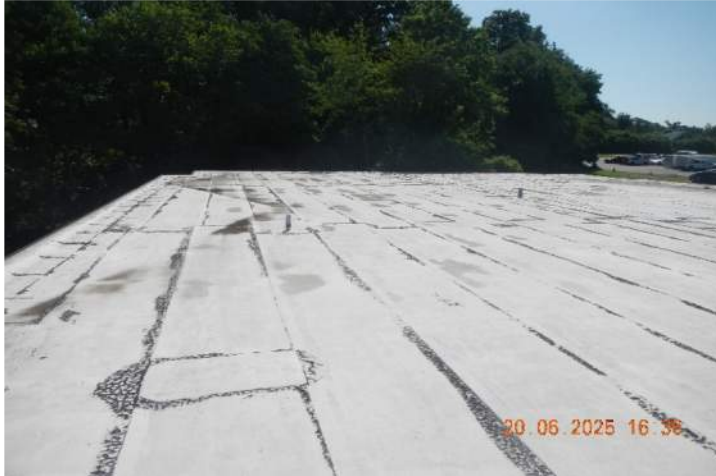
Photo 1 – Overview of upper roof section

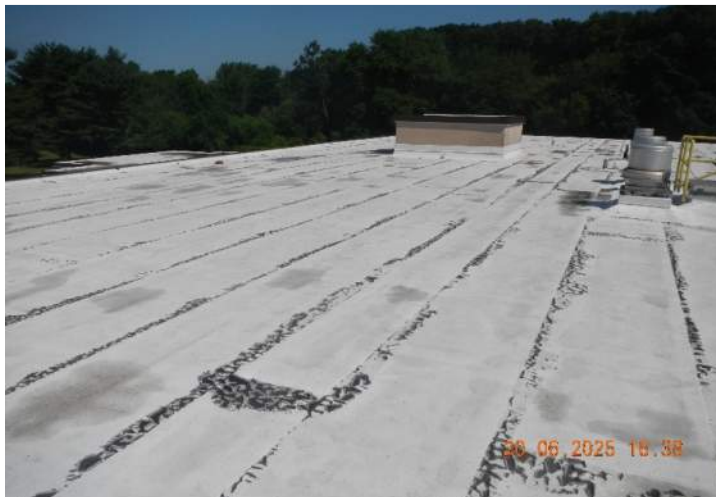
Photo 2 – Overview of upper roof section and small penthouse roof.

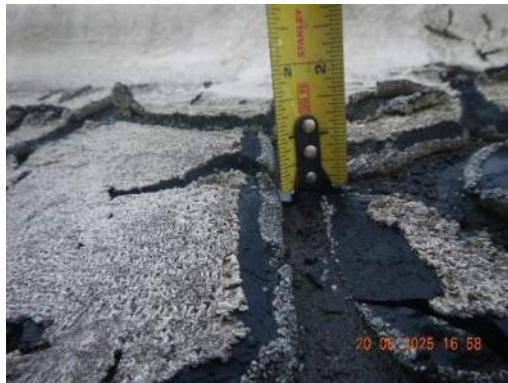
Photo 5 – Cracked roof coating material. Cap sheet also appears to be damaged.

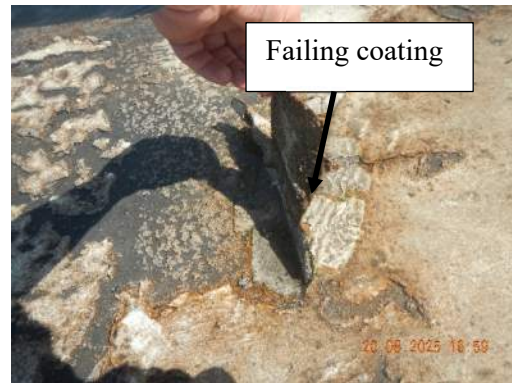
Photo 6 – Failing coating in ponding locations. The submerged coating material is separating from the cap sheet.

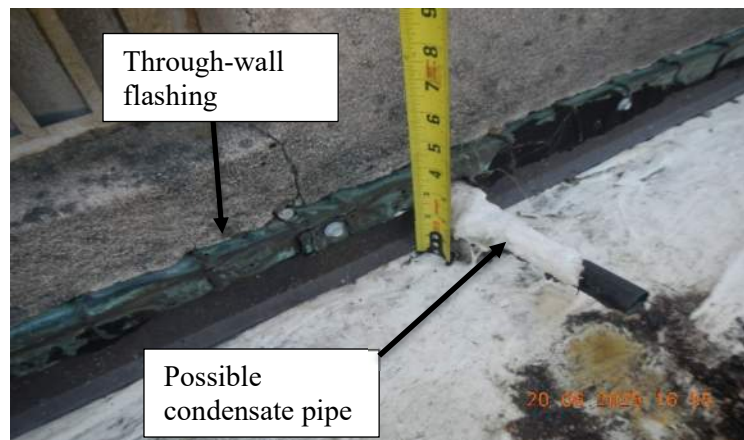
Photo 7 – Overview of low through-wall flashing at the rising wall. Several copper pipes penetrate the flashing below the through-wall flashing.

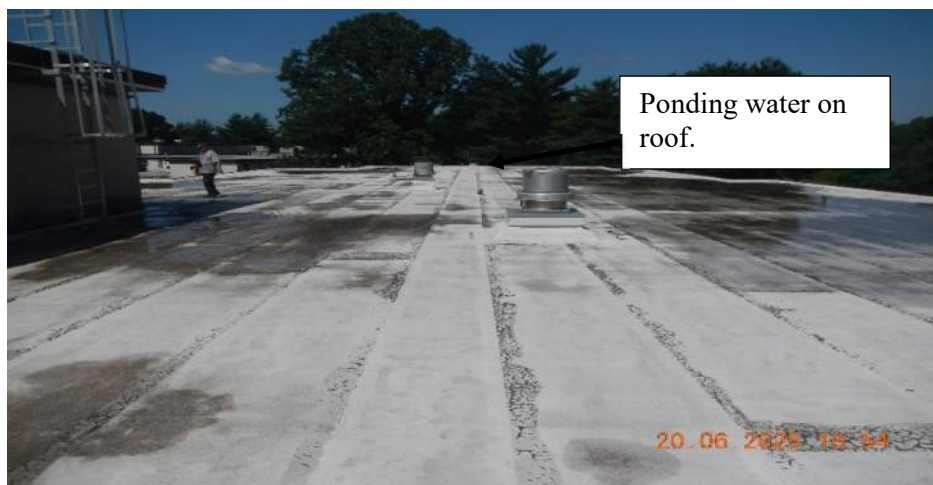
Photo 8 – Overview of ponding water around most drains on the lower roof.

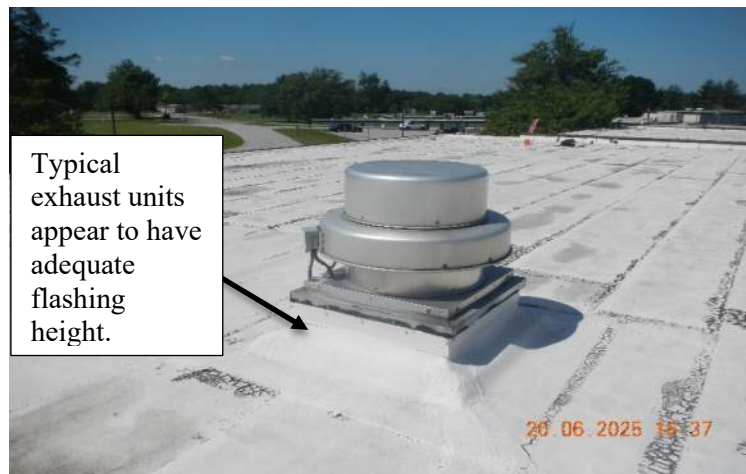
Photo 10 – Typical flashing at exhaust unit on upper roof.

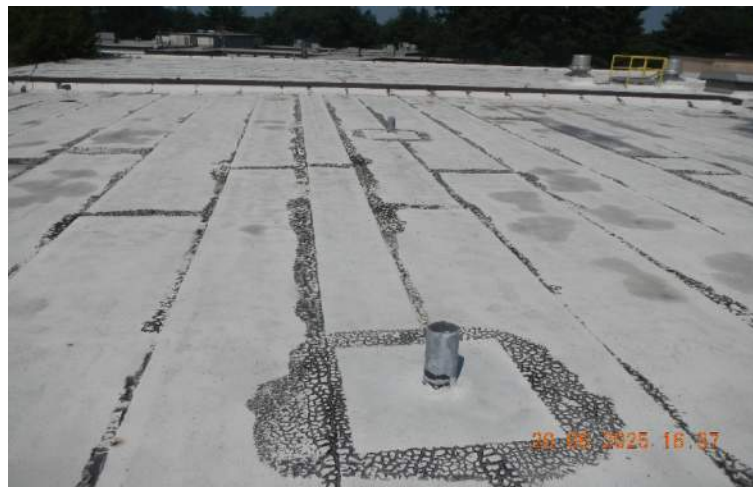
Photo 11 – Typical lead flashed pipe penetration.

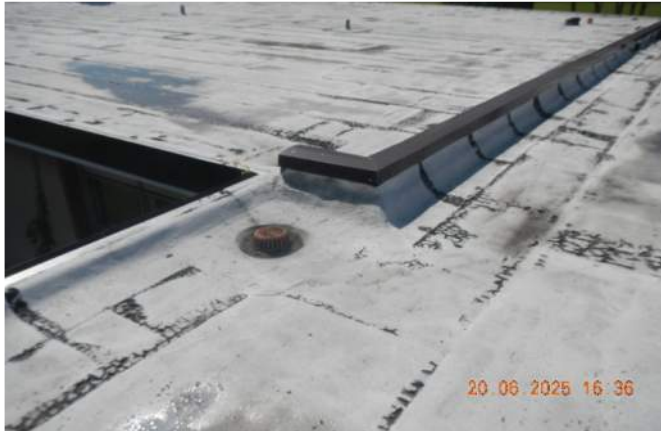
Photo 12 – Typical roof drain and roof divider.

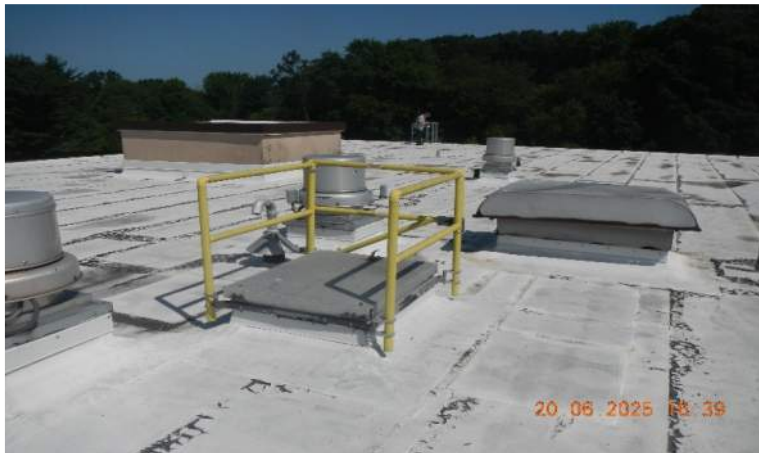
Photo 13 – Overview of typical rooftop units and penthouse roof section.

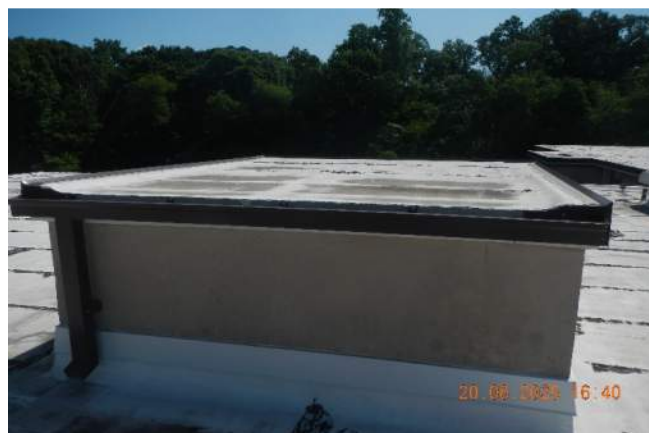
Photo 14 – Overview of penthouse gutter edge and downspout.

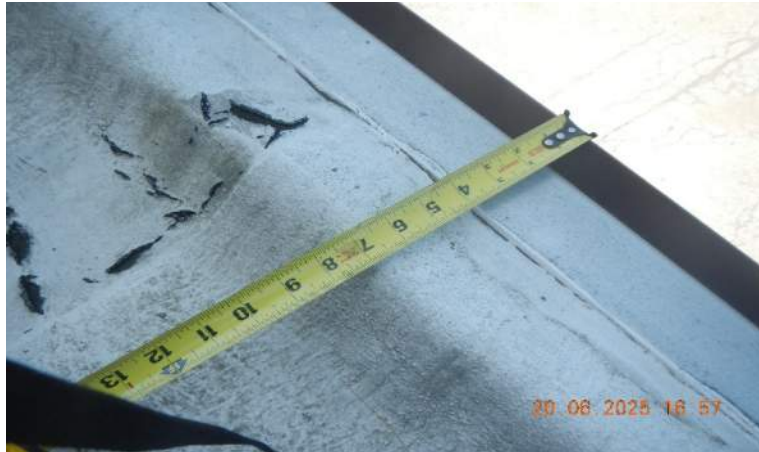
Photo 15 – Typical roof edge

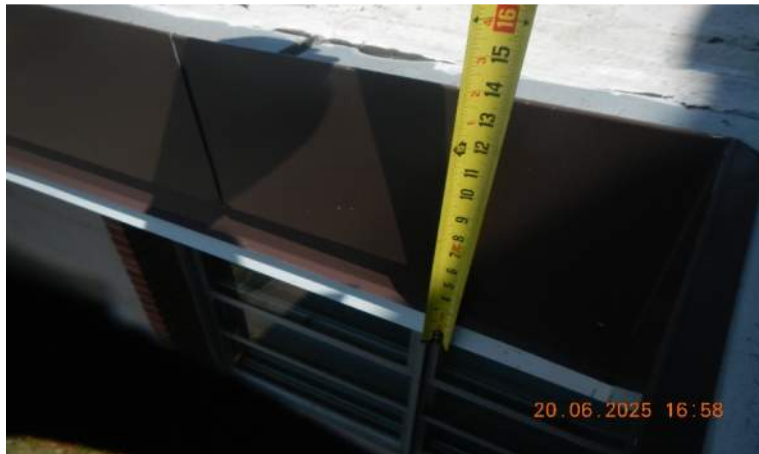
Photo 16 – Typical fascia profile

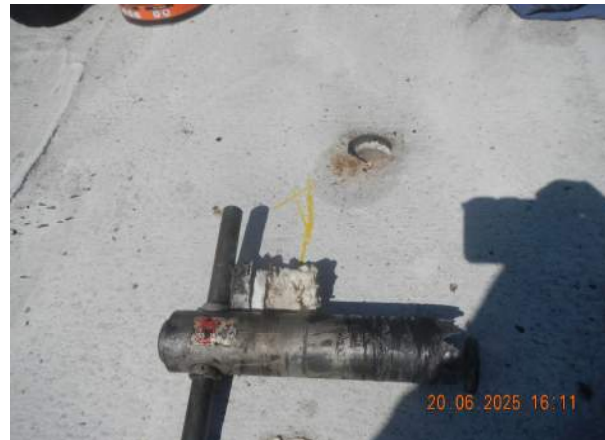
**Core 1:**

- Metal Deck
- 1 1/2" Polyisocyanurate Insulation
- 1/2" Gypsum Board Insulation
- Modified Built-Up Roof Membrane
- White Fluid Applied Coating
- Dry
- Overall Core Depth 2 1/2"

Note: The 2nd core was taken 20' from the 1st. Appears to show presence of tapered insulation

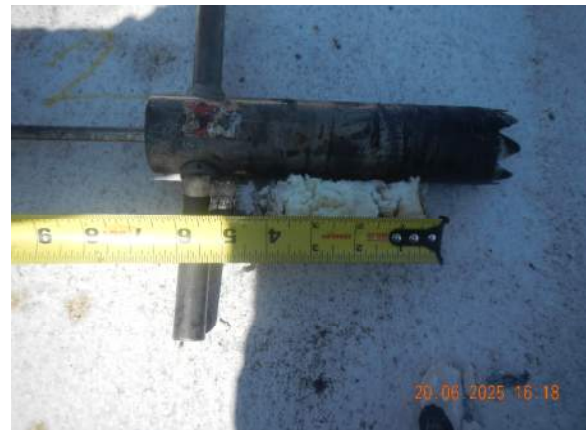
**Core 2:**

- Metal Deck
- 4" Polyisocyanurate Insulation
- 1/2" Gypsum Board Insulation
- Modified Built-Up Roof Membrane
- White Fluid Applied Coating
- Dry
- Overall Core Depth 5"

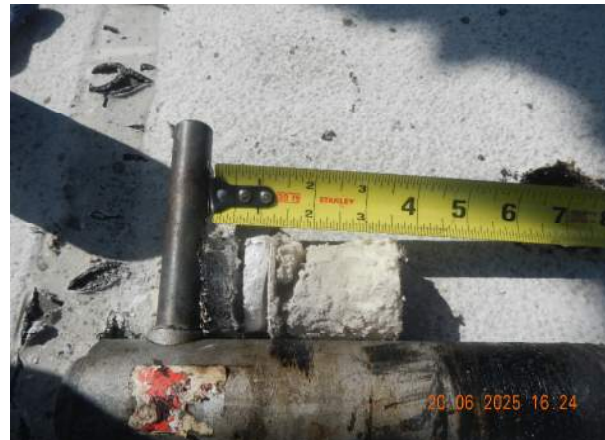
**Core 4:**

- Metal Deck
- 2 1/4" Polyisocyanurate Insulation
- 1/2" Gypsum Board Insulation
- Modified Built-Up Roof Membrane
- White Fluid Applied Coating
- Dry
- Overall Core Depth 3 1/2"

Note: The 2nd core was taken 20' from the 1st. Appears to show presence of tapered insulation

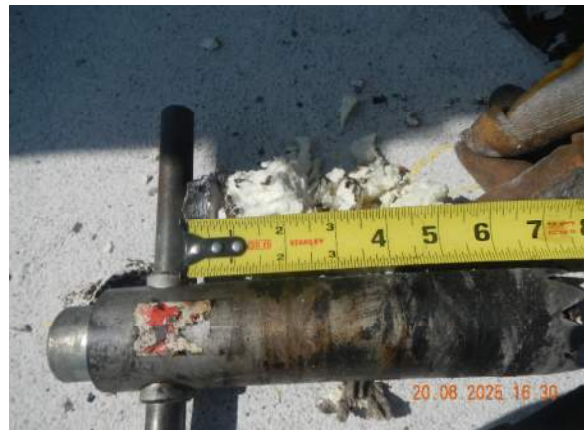
**Core 5:**

- Metal Deck
- 4" Polyisocyanurate Insulation
- 1/2" Gypsum Board Insulation
- Modified Built-Up Roof Membrane
- White Fluid Applied Coating
- Dry
- Overall Core Depth 5"

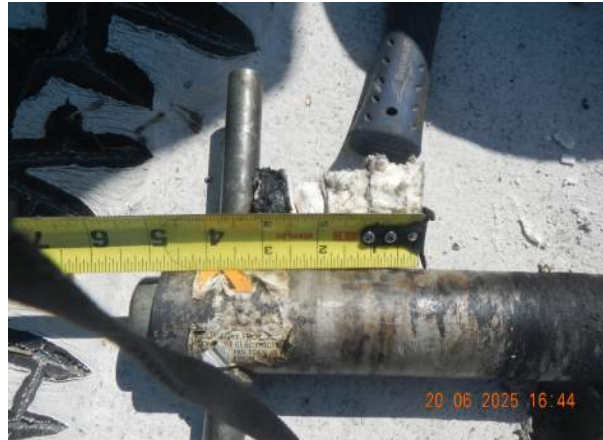
#### Core 6:

- Metal Deck
- 2 1/4" Polyisocyanurate Insulation
- 1/2" Gypsum Board Insulation
- Modified Built-Up Roof Membrane
- White Fluid Applied Coating
- Dry
- Overall Core Depth 3 1/2"

Note: The 2nd core was taken 20' from the 1st. Appears to show presence of tapered insulation

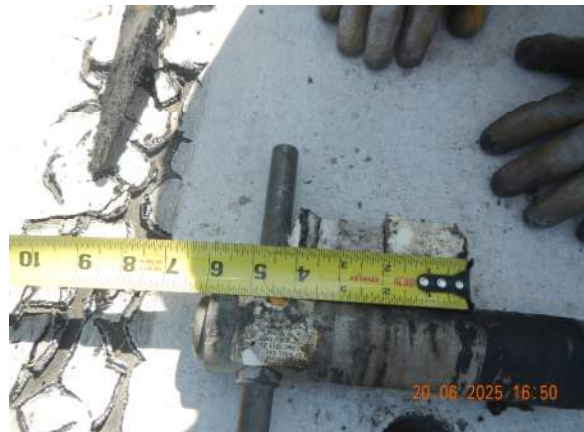
#### Core 7:

- Metal Deck
- 4" Polyisocyanurate Insulation
- 1/2" Gypsum Board Insulation
- Modified Built-Up Roof Membrane
- White Fluid Applied Coating
- Dry
- Overall Core Depth 5"
