# Final ESPC Pre-Qualification Report For Select State Properties

August 4, 2016

**State of Delaware  
Office of Management and  
Budget**

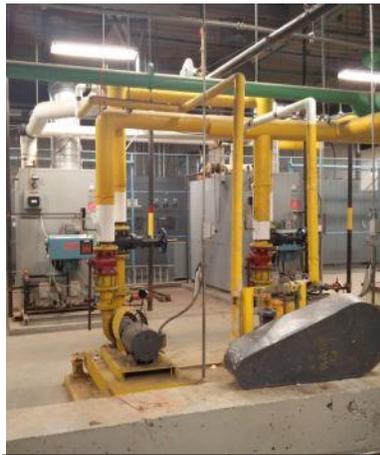
Boilers and Pumps

**New Condensing Boilers/Cooling Towers (Option 2):** The decision to migrate to the PEPCO CHW/HW loop needs to be further investigated. CEI believes the boilers have at least a 5 year remaining useful life if well maintained. Replacing these boilers with a premium efficiency condensing boiler system will save approximately 15-20% over the existing system. Cost estimates are beyond the scope of this assessment, however DEDC suggests a replacement cost of \$600,000 for the boilers. These costs and savings were used to develop the analysis table.

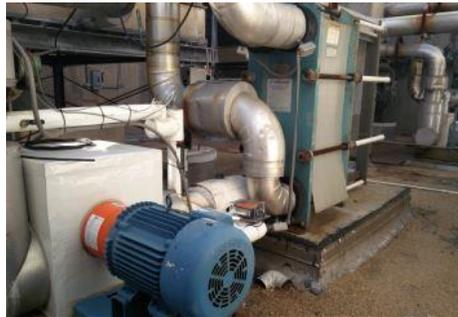
Cooling Tower Pumps and HX

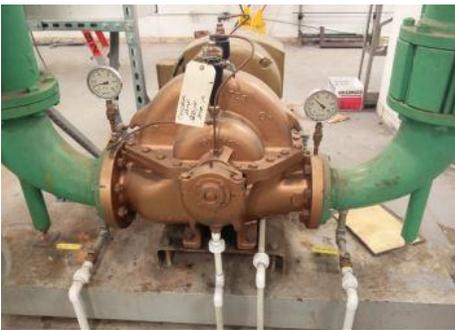
Rebuilt Condenser Water Pump

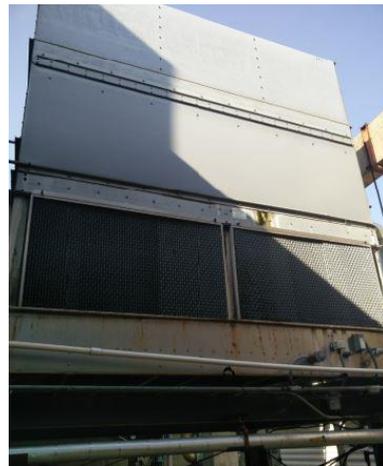
Cooling Tower 1 of 3

The cooling towers have been reconditioned and retrofitted with pump and fan VFDs and new controls under the recent ESPC. If well maintained, these CTs will have 5-10 years of useful life remaining. An engineering analysis of the existing infrastructure (specifically the existing cooling towers) will be required by the ESCO to verify infrastructure capacity. Cost estimates are beyond the scope of this assessment, however DEDC suggests a replacement cost of \$650,000 for the CTs. There will be limited or no savings by replacing these CTs with equivalent or comparable units.

Replacing boilers and cooling towers may be performed under an ESPC, but it would be the responsibility of the selected ESCO to evaluate the PEPCO option with the equipment replacement option.

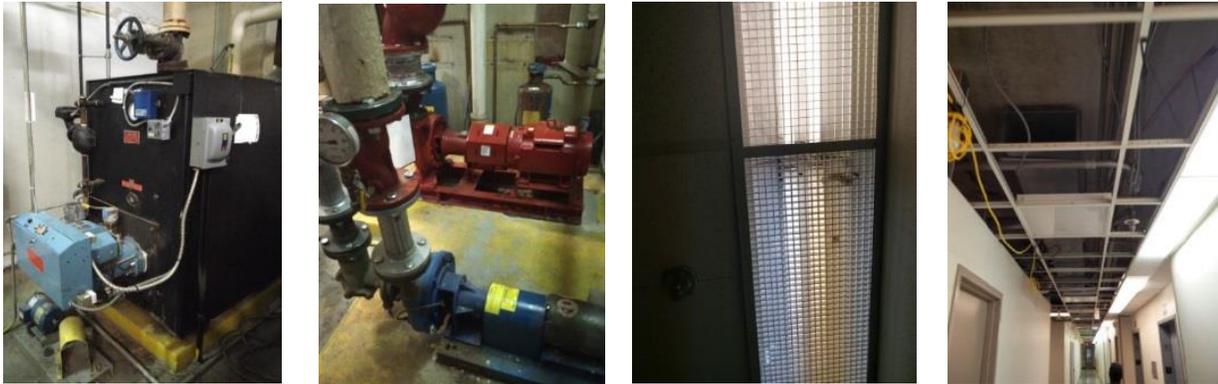
hallway. The boiler has exceeded useful life and will need a replacement, a new boiler has been approved to be installed. This site may be a candidate for district chilled and hot water through PEPCO, the selected ESCO shall evaluate costs and savings for such project.

Boiler	New CW Pump (red) Boiler Pump (Blue)	T12/T8 Lamps in Fixture	4th Floor
--------	--------------------------------------	-------------------------	-----------

**New LED Fixtures and Occupancy Sensors:** Some fixtures appeared to have been retrofitted with T8 lamps, but some had T12 and magnetic ballasts. The lighting fixtures are in poor condition with broken diffusers and lenses noted in many cases. Replacing the existing fixtures with new LED fixtures would be the best solution as it appears the facility is undergoing a minor renovation floor by floor. Lighting occupancy-based controls are limited to restrooms and some private offices. It is recommended that additional spaces be controlled to reduce run time. The table to the right shows the estimated cost and savings for both LED retrofits and occupancy sensors.

**Boiler Replacement:** The existing boiler has exceeded its useful life and needs to be replaced. There is no redundancy with this boiler system. A condensing-type boiler replacement is recommended. Having multiple condensing units in a cascading arrangement will allow for redundancy without a backup boiler; however, this claim must be determined by the installing party. This boiler project could be candidate for an ESPC. The table to the right shows the cost and savings estimates for this measure.

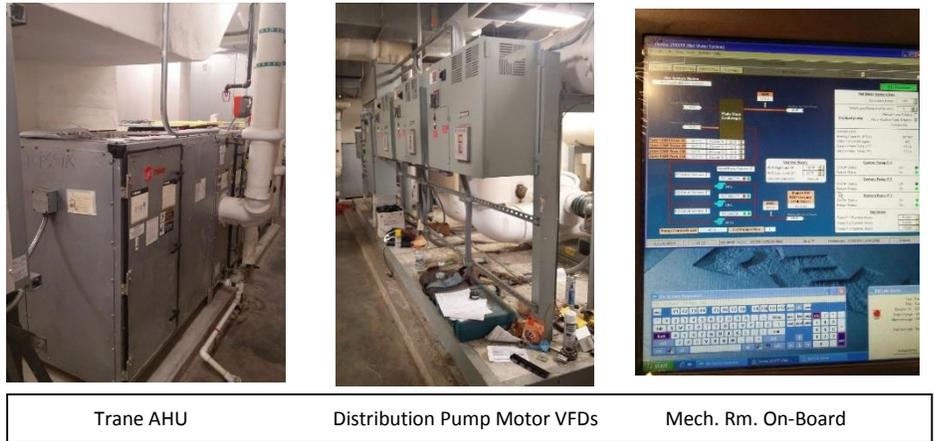
Trane AHU                      Distribution Pump Motor VFDs                      Mech. Rm. On-Board

**HVAC Retro-commissioning & Equipment Upgrades:** The majority of the equipment is in good condition; however, the building has experienced significant control issues (or lack of control) since original construction based on building design. Retrocommissioning (RCx) of the courthouse HVAC systems may have the highest returns due to the high cost of district hot and chilled water. If performed correctly, RCx may even reduce chilled water demand, which would solve the alleged capacity issue and perhaps lower capacity charges. Some equipment may need upgrades to facilitate RCx efforts, and some costs are included in the analysis. The table to the right shows the cost and savings estimate for this measure. This measure would be an excellent candidate for an ESPC.

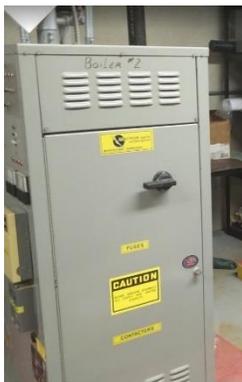
Electric Boiler 1 of 2

**Boiler Replacement:** The existing boilers are electric and, while more efficient than a fossil fuel boiler, are significantly more expensive to run and operate. There does not appear to be access to natural gas in the area, but natural gas would be the recommended fuel of choice. Replacement of the electric boilers with a high efficiency, propane-fired condensing boiler may reduce operating costs by 15% due to the fuel switch. However, since the facility uses oil for the emergency generators (oil tanks were not observed during the site visit, and are assumed to exist), a switch to oil-fired boilers may save as much as 25%. Utilizing the existing tanks will save on material and labor as the existing oil tanks may be utilized compared to propane. A condensing-type boiler replacement is recommended, but is not generally available for oil-fired units. This study assumed \$2.00/gal propane, \$2.00/gal oil, and \$0.10/kWh; more precise calculations would be necessary. Costs are estimated for material through RS Means; labor costs can vary significantly. This boiler project could be candidate for an ESPC. The included table shows the cost and savings estimates for this measure.

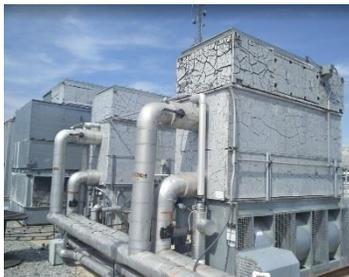
Aging Cooling Towers

**Cooling Tower Replacements and Recommissioning:** The existing cooling towers (CTs) are approaching end of useful life and do not have fan drives. Retrofitting these aging units with drives and controls is not recommended. However as part of an ESPC, the capital intensive CT replacement coupled with savings from drives and controls will be a great opportunity. There is no redundancy for the TMC CT, unifying the system to serve both DEMA and TMC may reduce operational and replacement costs.

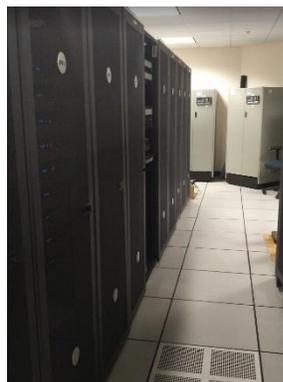
Server Room

**Data Center and Cooling Optimization:** Servers and associated cooling equipment can contribute to a large energy draw at the facility. CEI normalized electric usage to similar offices within the portfolio and found that the servers can be contributing up to 25% of the site energy use (both DEMA and TMC).
