Questions and Answers Bid 2204 – Architects – New Hodgson High School

Replacement for **HODGSON VOCATIONAL TECHNICAL HIGH SCHOOL**

Certificate of Necessity

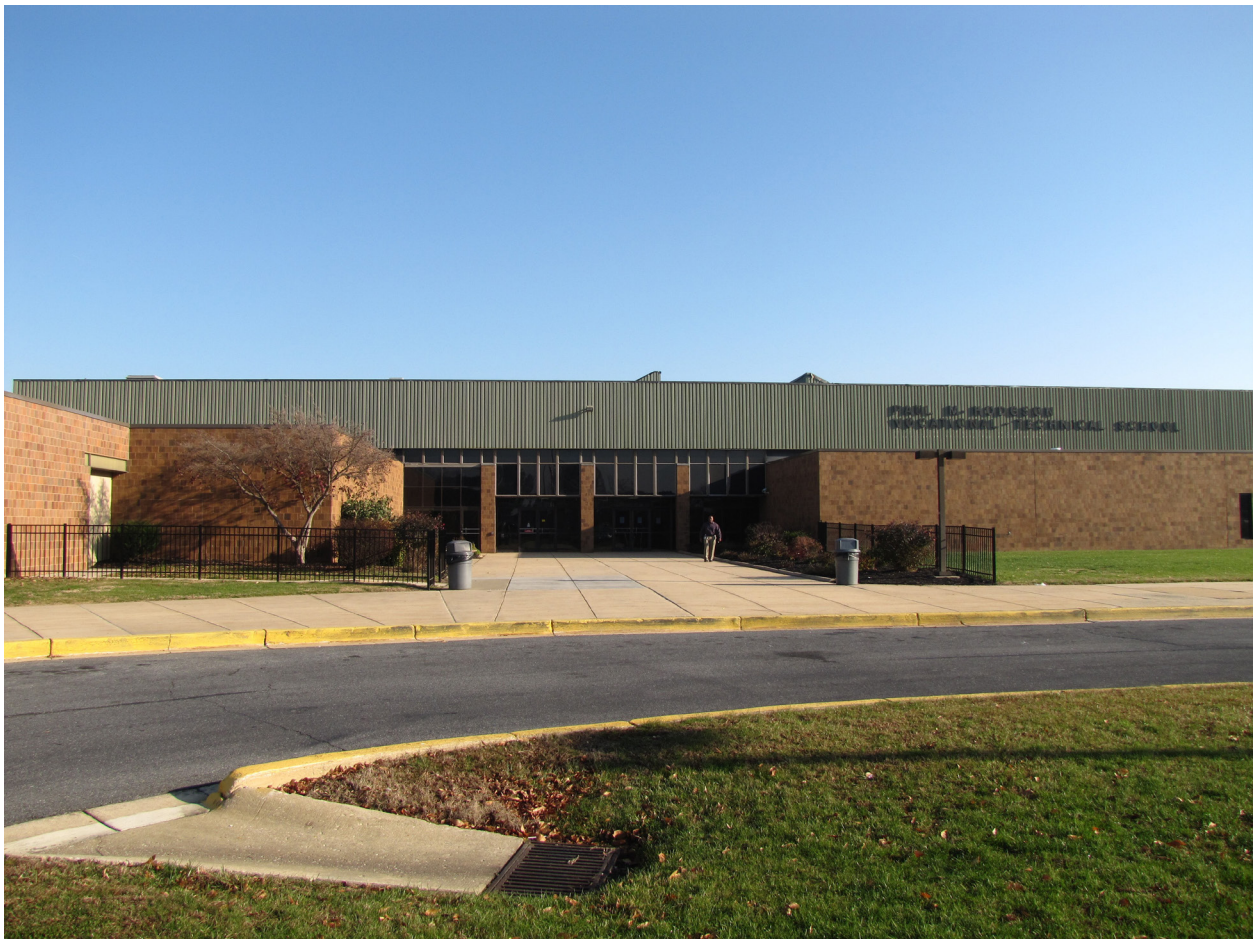
Figure 1.2
Building exterior (typical)

- ▶ Based on an energy audit, the existing school envelope is inefficient and requires a complete upgrade.
- ▶ Existing metal panel in poor condition and requires replacement throughout the entire building exterior.
- ▶ Replace all existing windows for improved efficiency.

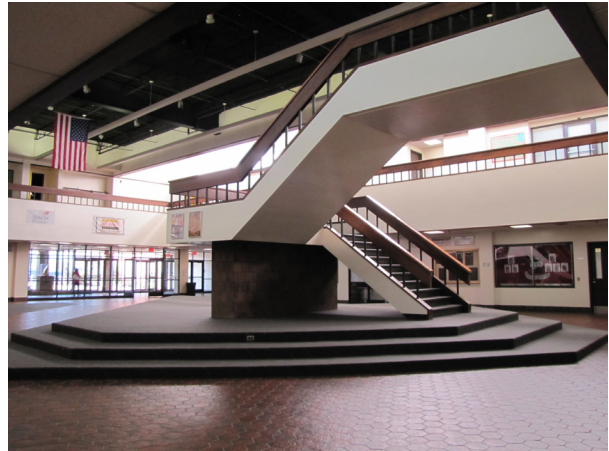
Figure 1.3
Non-Code Compliant Issues Throughout

- ▶ Corridors are circuitous and of excessive lengths in terms of travel distance.
- ▶ Several corridors have “dead-end” egress conditions that are not code compliant.

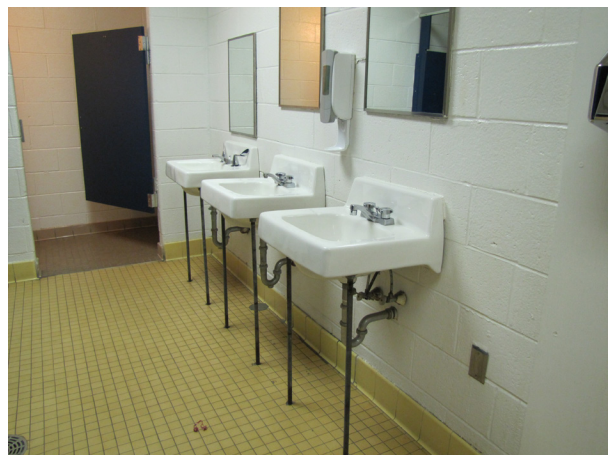
- ▶ Hardware upgrades are necessary throughout
- ▶ Toilet Rooms need to be upgraded to meet ADA code compliance and required fixture counts.

Figure 1.4
Non-Code Compliant Issues Throughout

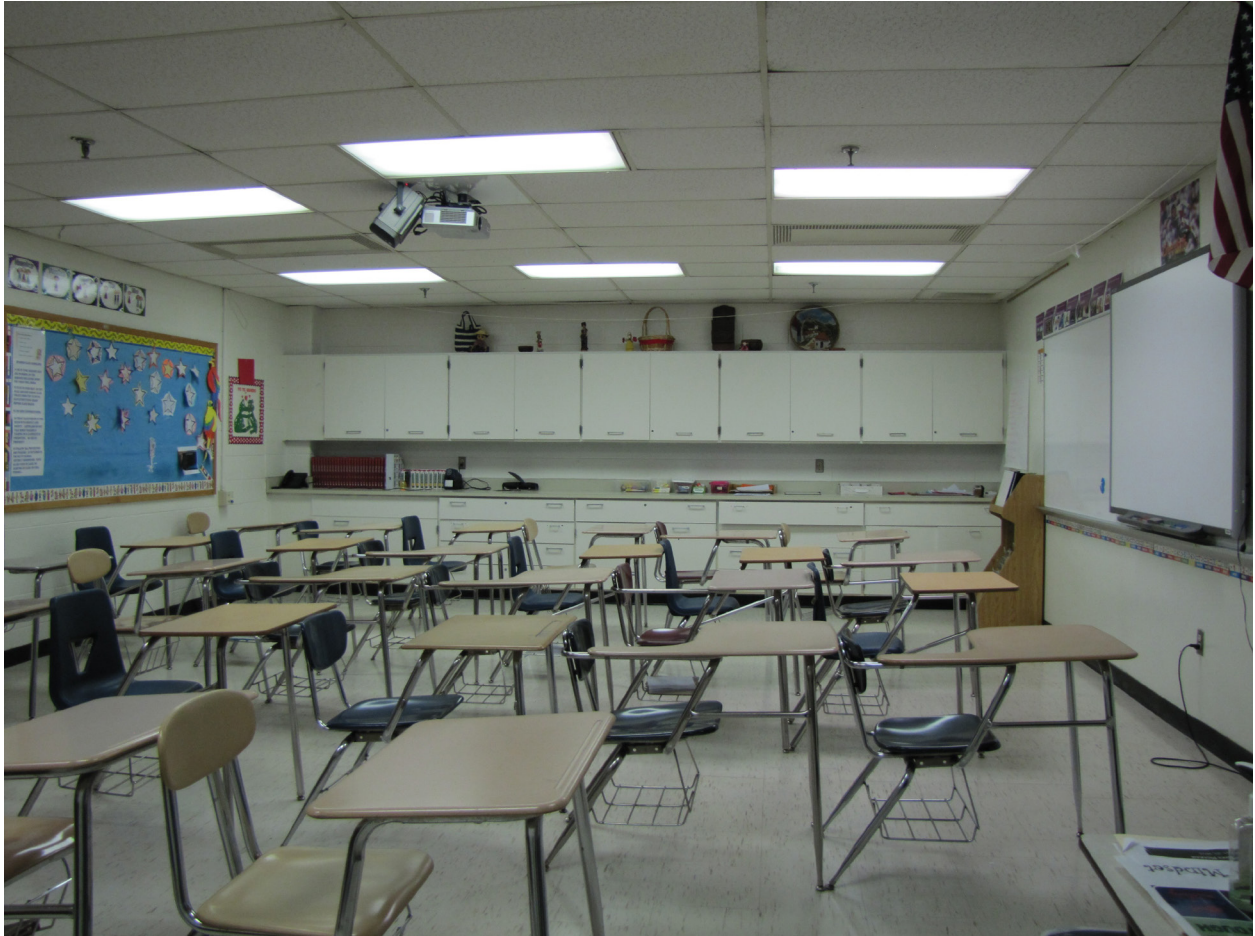
- ▶ Natural light is lacking throughout the building and in classrooms.
- ▶ Nurses suite and Wellness require additional space to operate adequately.
- ▶ Door and hardware upgrades are required throughout.

Figure 1.5
Classroom crowding: Extreme overcrowding: classrooms are not the correct size to meet state requirements. Lack of natural daylight in more than 70% of classroom spaces.

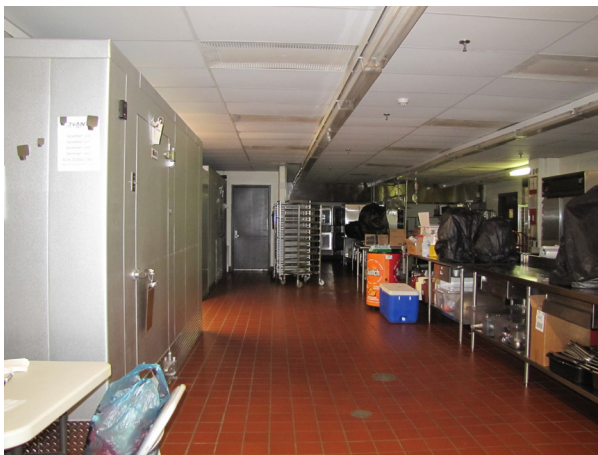
Figure 1.6
Lack of instructional space for culinary

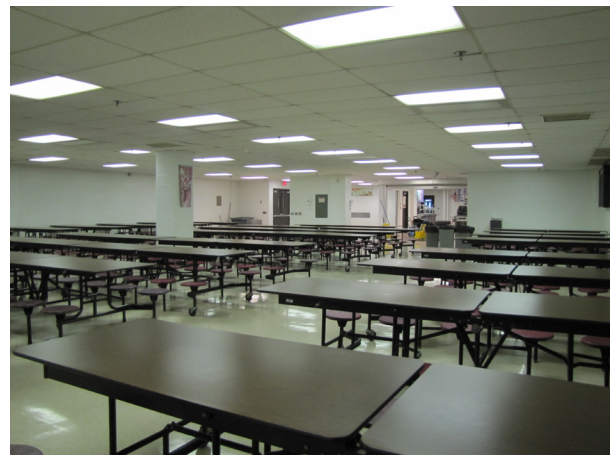
Figure 1.7
Cafeteria Seating

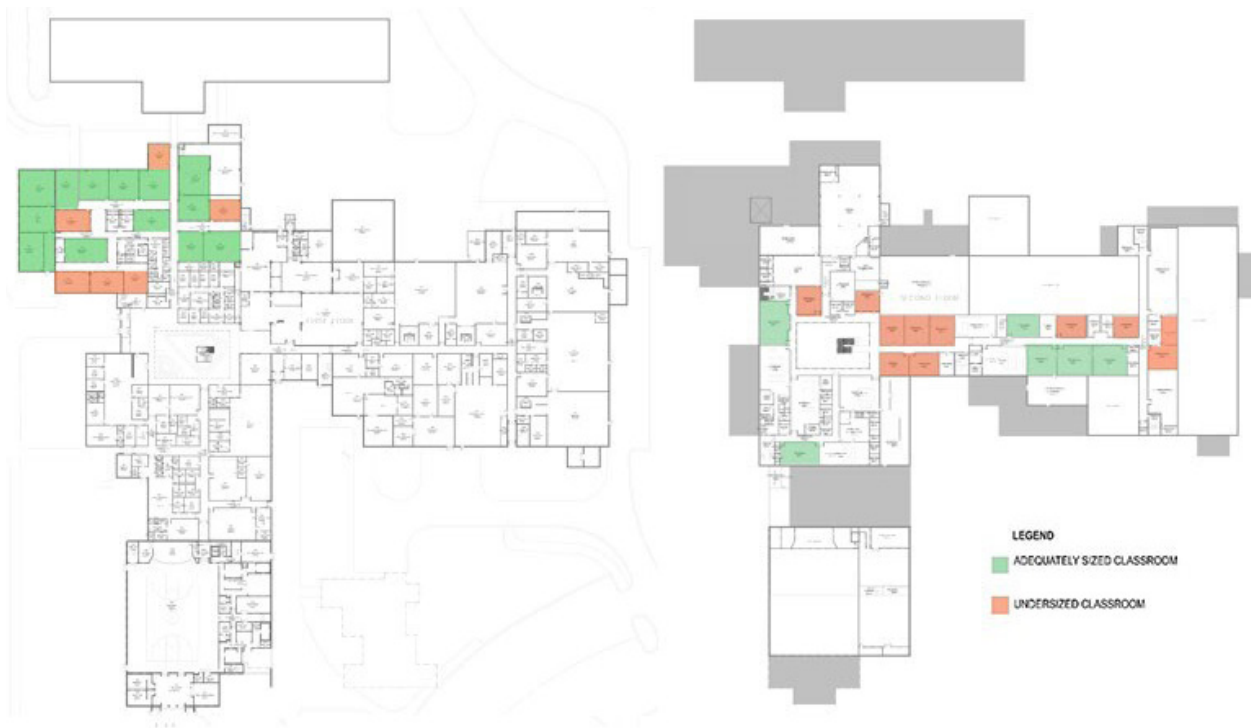
EXISTING FIRST AND SECOND FLOOR PLANS

- ▶ Existing classrooms meeting the state size requirements shown in **Green**.
- ▶ Undersized existing classrooms shown in **Orange**.

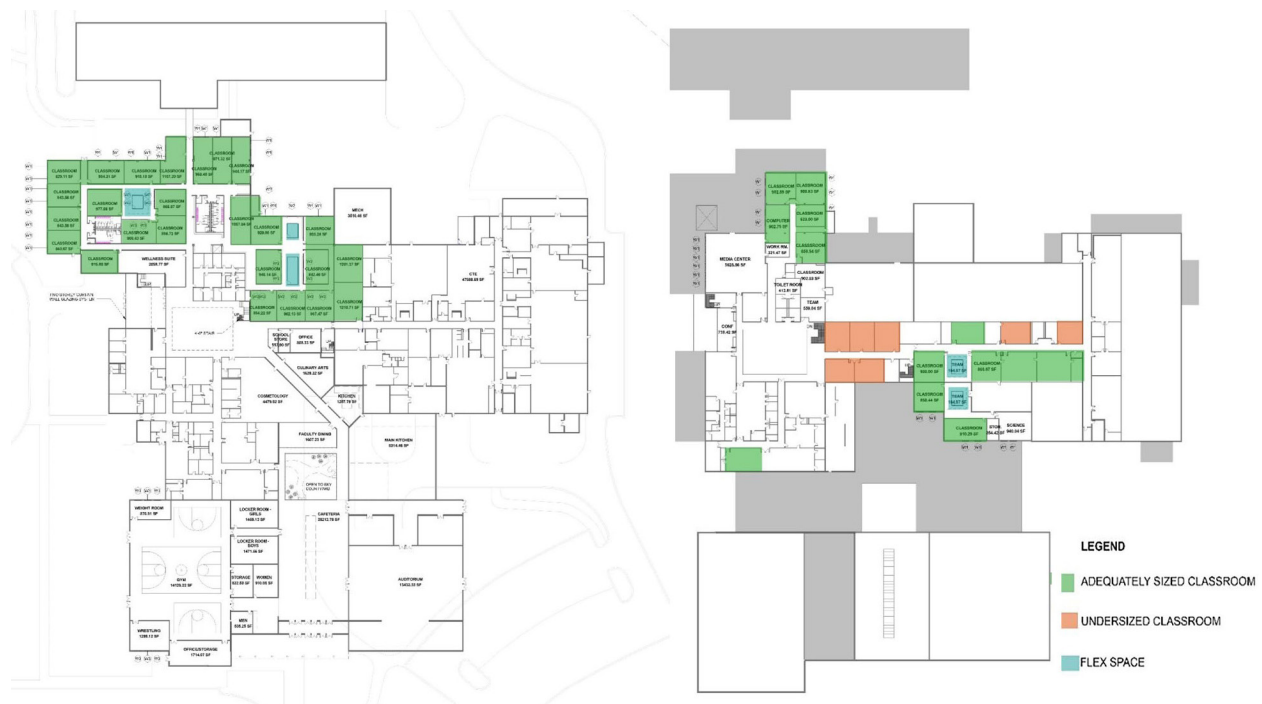
PROPOSED FIRST AND SECOND FLOOR PLANS

- ▶ Proposed redesign - classrooms meeting the state size requirements shown in **Green**.
- ▶ Undersized existing classrooms shown in **Orange**.
- ▶ Flex space shown in **Blue**.

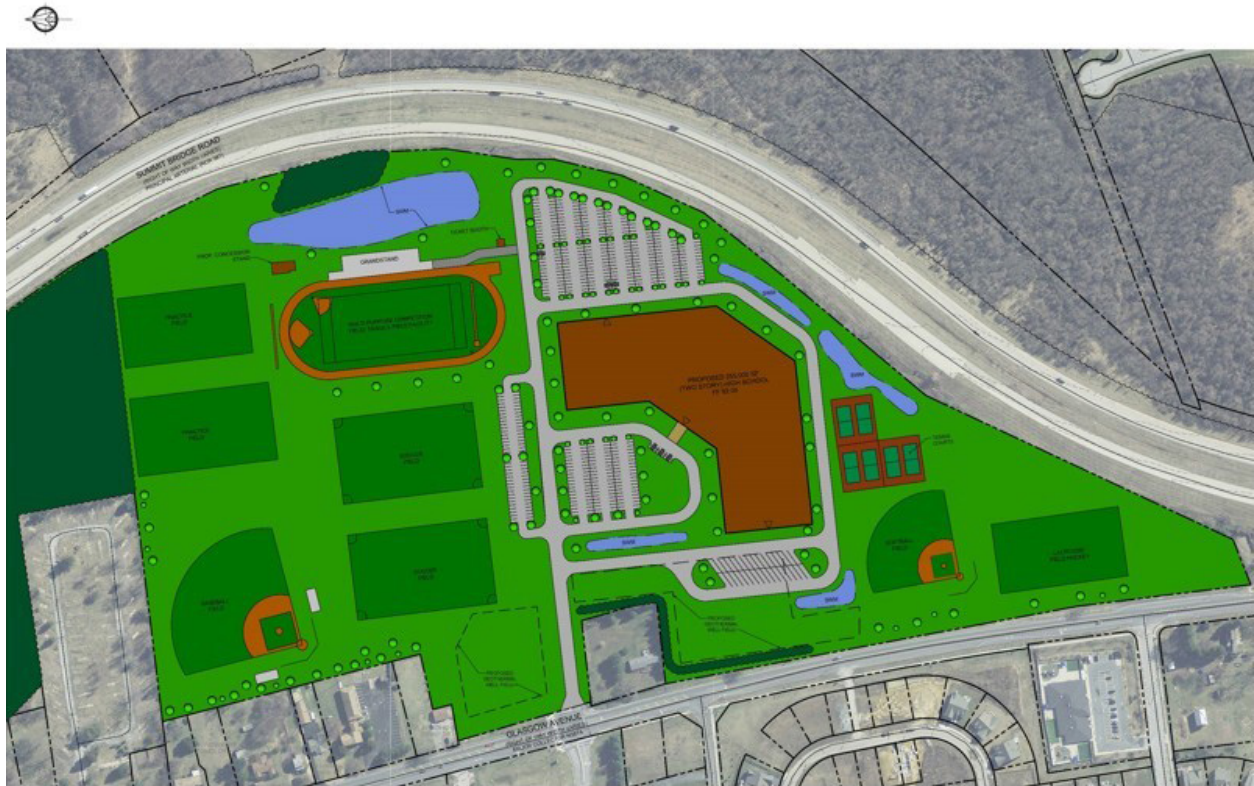
L. PROPOSED SITE PLAN FOR REPLACEMENT SCHOOL

HODGSON VOCATIONAL TECHNICAL HIGH SCHOOL – PROPOSED SITE PLAN – NEW FACILITY

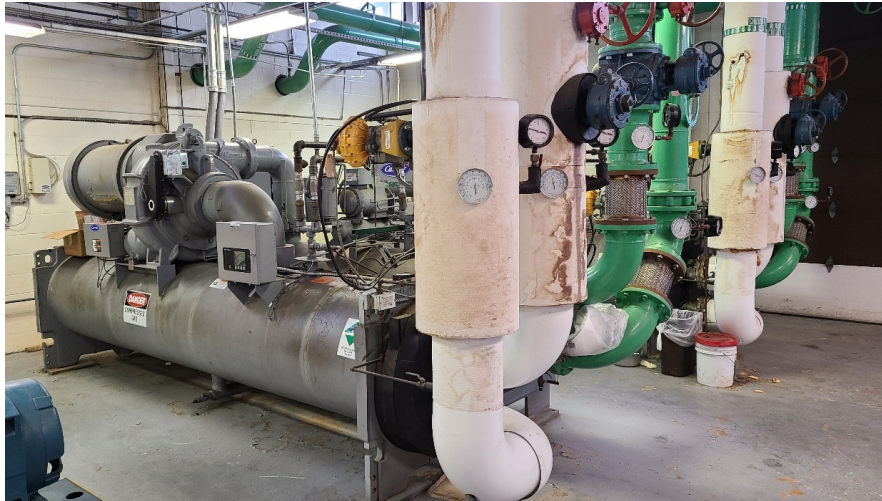
Figure 1: Chillers

Space cooling is provided by one (1) chilled water plant, located in the main building mechanical / electrical room. The plant has two (2) 1997 “Carrier” electric, water-cooled, centrifugal chillers rated for 480 nominal tons each. The chillers used R-134A refrigerant. The chilled water system operates utilizing a chilled water loop. The loop supplies constant volume to the chillers via two (2) constant speed chilled water pumps. Chilled water loop temperature is varied by either cooling it with the chillers and towers or by bypassing water through a bypass pipe. The primary pumps are each rated for 60 HP, 132 ft. of head, and 1068 GPM. These two (2) pumps were installed in 1997.

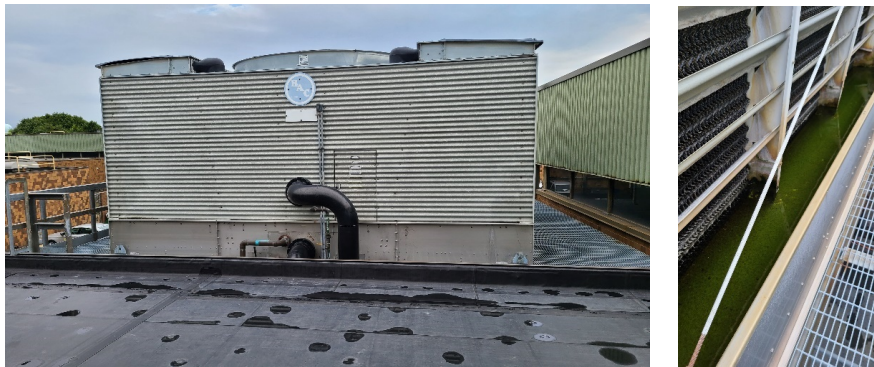
Figure 2: Cooling Tower and Basin (showing green water)

Heat rejection for the chillers is provided by Baltimore Air Coil twin cell, induced draft, cross flow cooling tower located on a steel platform west of the main mechanical room. The cooling tower is equipped with two (2) tower fans, each rated for 30 HP. Condenser water is circulated by two condenser water pumps installed in 1997. These pumps are constant speed and are rated for 1440 gpm at 50 ft. of head. During the survey, green tower water was observed in the tower basins. The tower water chemistry should be reviewed as this quality water will affect tower performance.

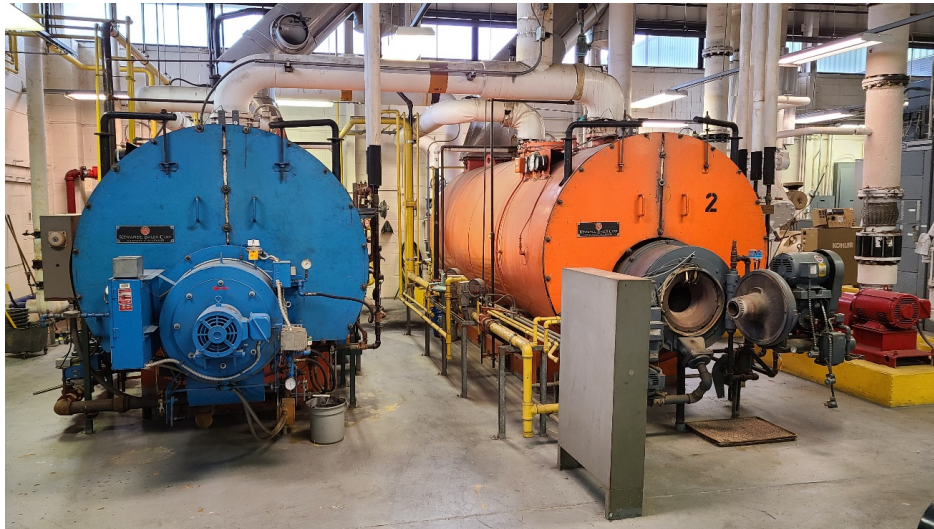
Figure 3: Boilers

Space heating is provided by one (1) heating water plant, located in the main building mechanical / electrical room. The plant has two (2) 1974 "Kewanee" hot water boilers rated for 300 boiler horsepower each. Each boiler has a Superior Boiler gas/Oil burner for dual fuel capability. The heating water system operates utilizing a heating water loop. The loop supplies constant volume to the building via two (2) constant speed primary heating water pumps. The system pumps are each rated for 30 HP, 40 ft. of head, and 1730 GPM and were replaced in 1990. The boilers inject water into the loop via (2) boiler pumps. The boiler pumps are each rated for 10 HP, 30 ft. of head, and 1000 GPM and were replaced in 1990

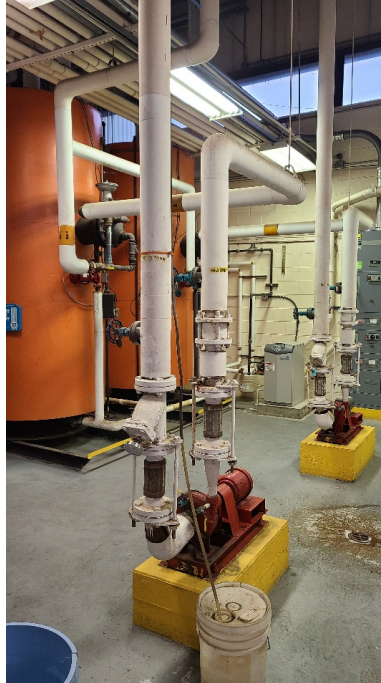
Figure 4: Domestic Hot Water System

Domestic hot water is made with indirect storage tanks. Heating hot water is pumped through heat exchangers in the tanks and warms the domestic water. In summer, a small 199MBH Lochinvar condensing boiler heats the domestic water so that the boilers can be taken off-line.

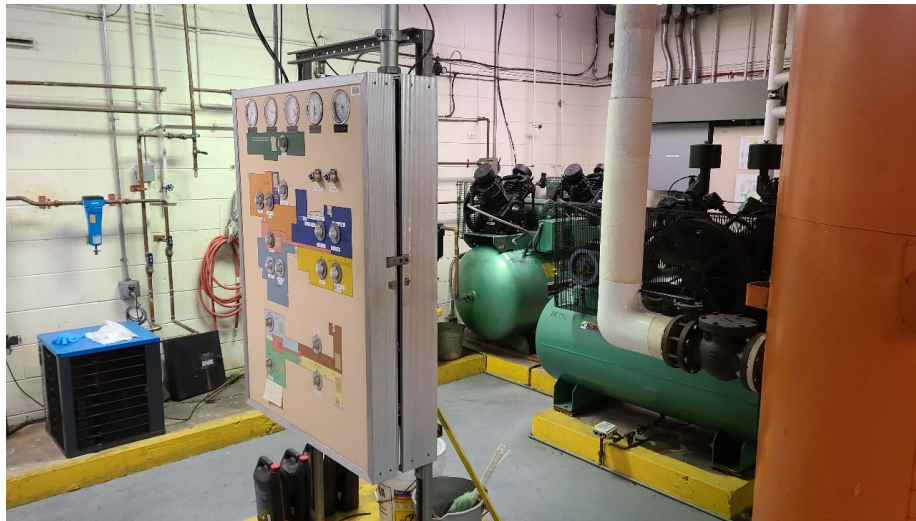
Figure 5: Pneumatic Controls Compressors, Dryers and Representative Panel

Pneumatic controls are currently used throughout the building. Air compressors in the main mechanical room are used to provide pressurized air via pneumatic piping to control valves and actuators. Pneumatic controls are accurate when maintained but doing so is time consuming. Leaks in pneumatic tubing are also difficult to isolate and repair.

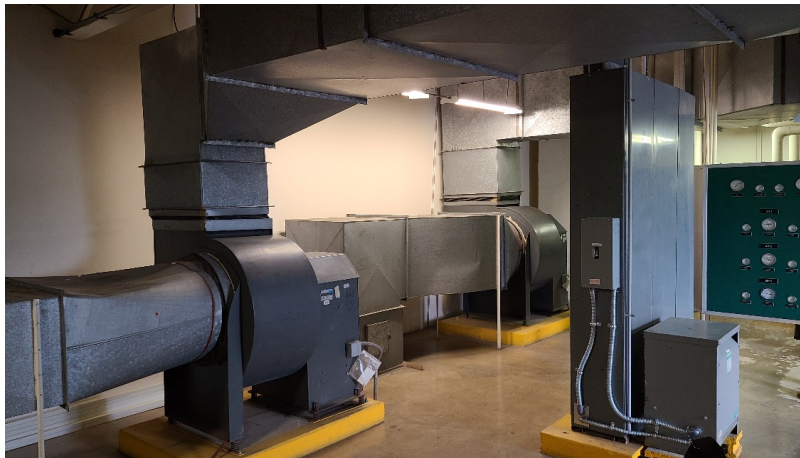
Figure 6: Typical Return Fan

Constant volume units that provide heating and ventilation air to the gym provide 50% of their airflow from the outside. Constant volume units that provide heating and ventilation air to shops can provide 100% of their airflow from the outside. Temperatures for these are controlled at the unit with no local thermostats.

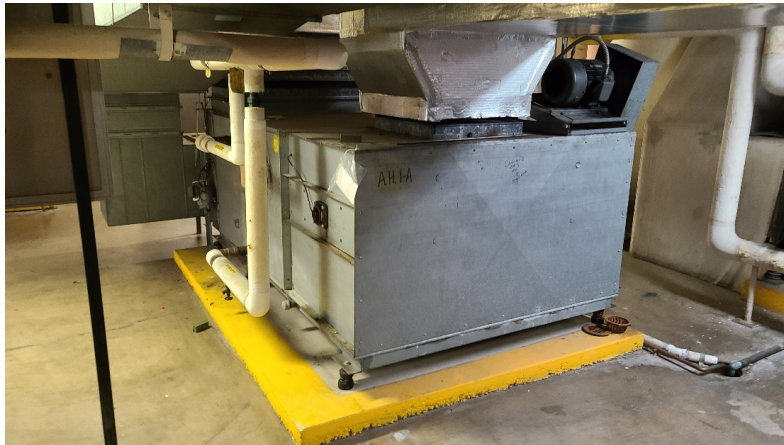
Figure 7: Typical Air Handling Unit

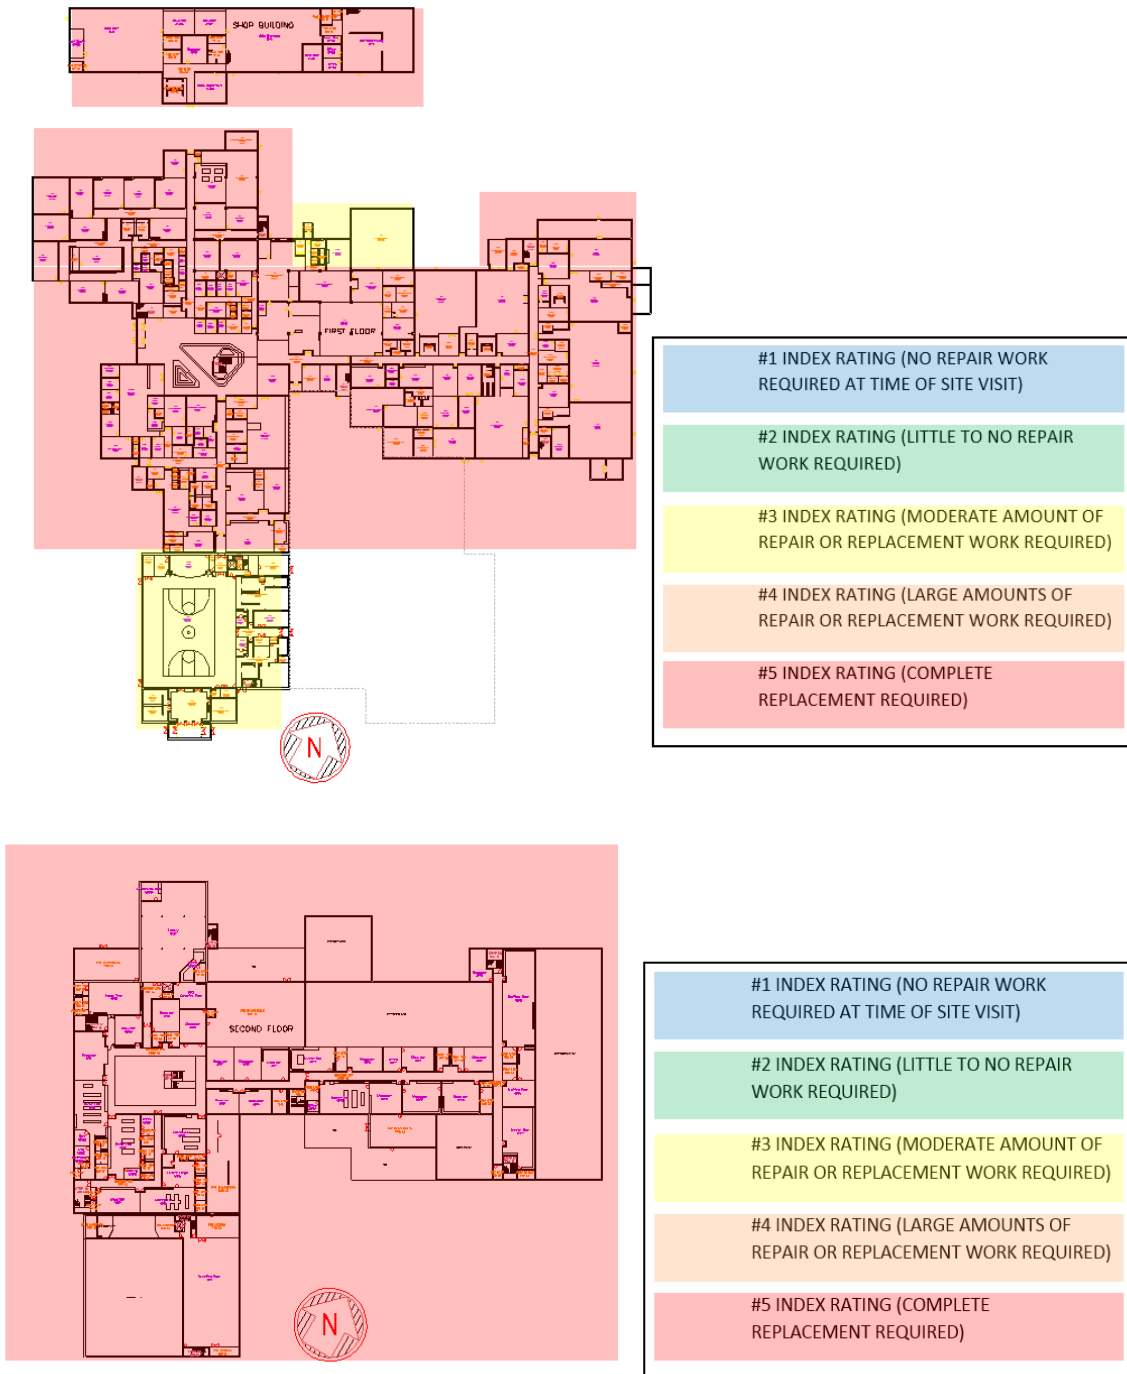
Mechanical Figure #1 – HVAC Index – Hodgson High School

Due to the age and condition of the existing HVAC systems the index rating for the majority of the school is an Index #5. Index #5 requires a complete replacement of the existing systems. **Mechanical Figure #1** illustrates the areas of the building and the associated index description.

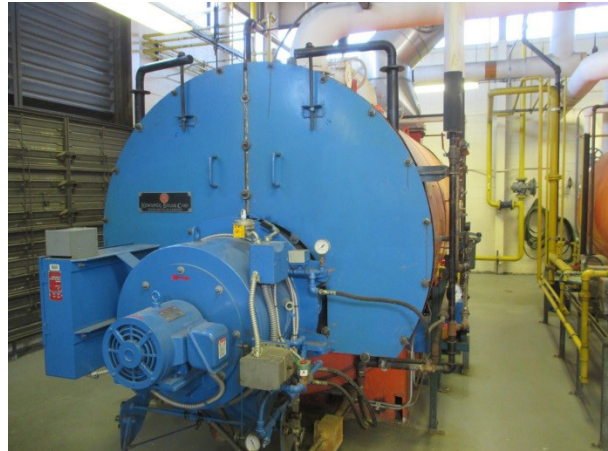
The main central hot water boilers can be seen in *Mechanical Photographs #1A and #1B*.

*Mechanical Photograph #1A
Main School Boiler*

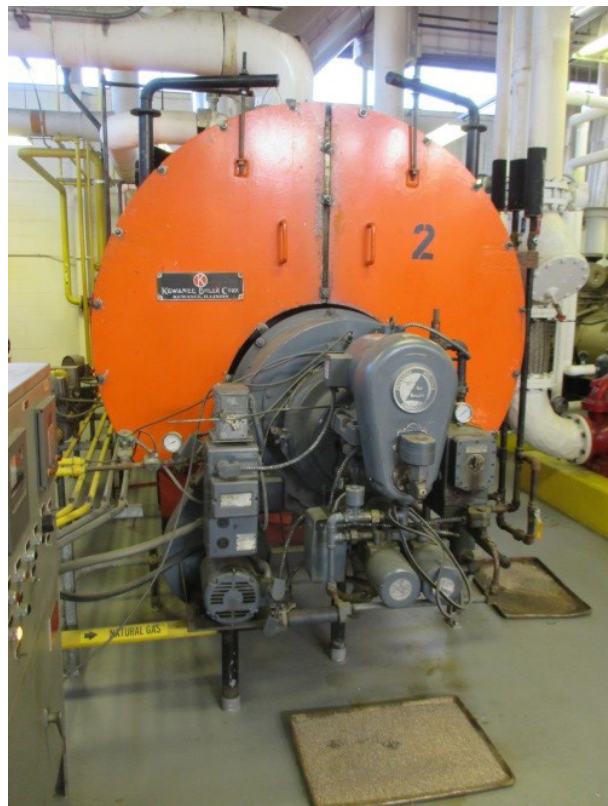
*Mechanical Photograph #1B
Main School Boiler*

The existing boilers are Kewaunee fire tube boilers with a nominal capacity rating of 10,043 MBH (MBH = 1,000 Btuhs). The boilers are approximately 43 years old and although very well maintained, the boilers are at the end of their useful service life and should be replaced. Based on the age of the equipment, the boilers are operating at approximately 60% to 70% efficiency, which is very poor compared to current standards. The boilers are currently served by natural gas and No. 2 Fuel Oil. The hot water plant provides hot water to a variety of air handling units, unit heaters, VAV boxes, terminal re-heat boxes, and duct coils. **Mechanical Figure #2** shows the existing hot water system serving the Main School Building. As indicated, the heating water pumps are arranged in a primary/secondary arrangement with a lead/lag redundant pump on the secondary loop.

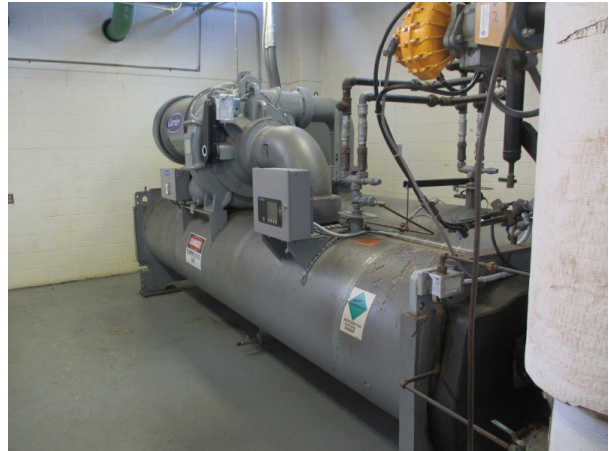
Mechanical Photograph #2
Water Cooled Chiller

The existing cooling plant consists of two (2) water cooled Carrier chillers coupled to two (2) Baltimore air coil cooling towers as shown in *Mechanical Photograph #2* and *Mechanical Photograph #3*. The chillers have a nominal capacity of 480 tons each. The cooling towers have a nominal capacity of 500 tons each. Both the chillers and the cooling towers along with the central chilled water piping/pumps in the main mechanical room were replaced in 1997. Therefore, the central chilled water cooling plant is approximately 19 years old. The central chilled water plant is in good condition and has been well maintained. While we rated these chillers a HVAC Index of #3, the proposed replacement HVAC systems are likely to move toward a distributed geothermal system making the chilled water plant obsolete. The existing chiller plant is arranged in a constant primary flow system with parallel base mounted evaporator and condenser pumps as shown in *Mechanical Figure #3* on the following page.

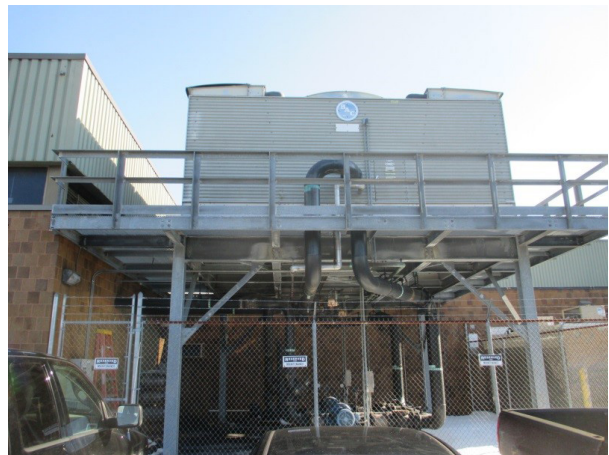
Mechanical Photograph #3
Cooling Tower

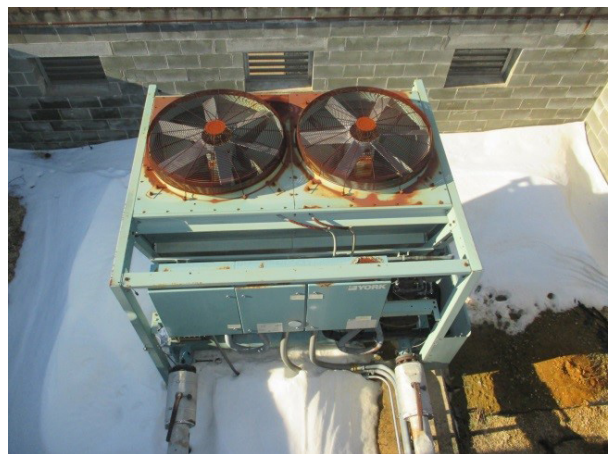
In addition to the central chilled water system a small air cooled chiller plant was installed in 1991 to serve the library and the spaces below the library. This chilled water plant was installed after the gym addition was constructed in 1990. This 30-ton chilled water plant consists of a single air cooled chiller, constant speed pump, controls, VAV boxes, and air handling unit to serve the 1990 renovated library area.

Mechanical Photograph #4 shows the existing air cooled chiller outside of the storage room that houses the air handling unit and pump.

*Photograph #4
Air Cooled Chiller*

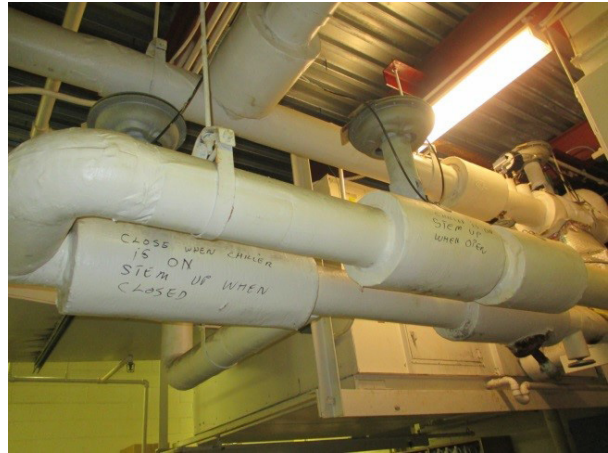
Photograph #5
Air Cooled Chiller Changeover Valves

One final observation that should be noted, is the fact that none of the existing heating water, chilled water, or condenser water systems utilize variable speed pumping. The lack of variable flow hydronic systems contributes to excessive operating costs.

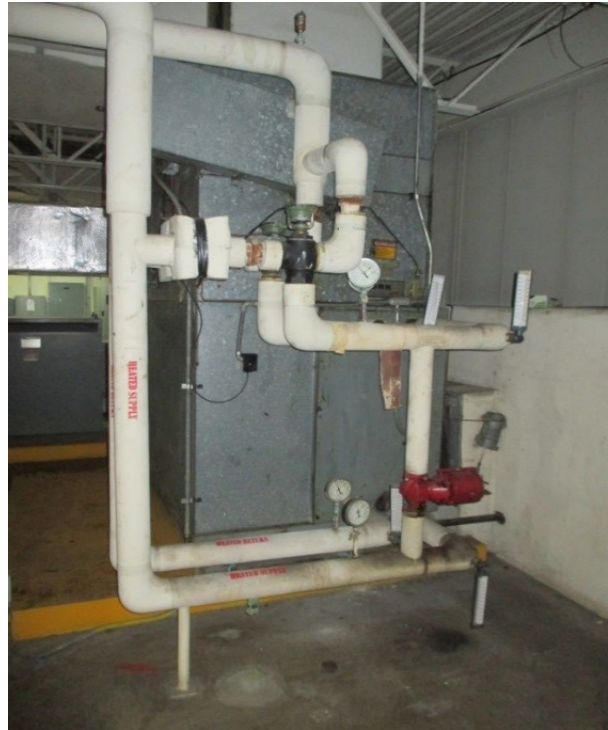
*Mechanical Photograph #6
Typical Air Handling Units*

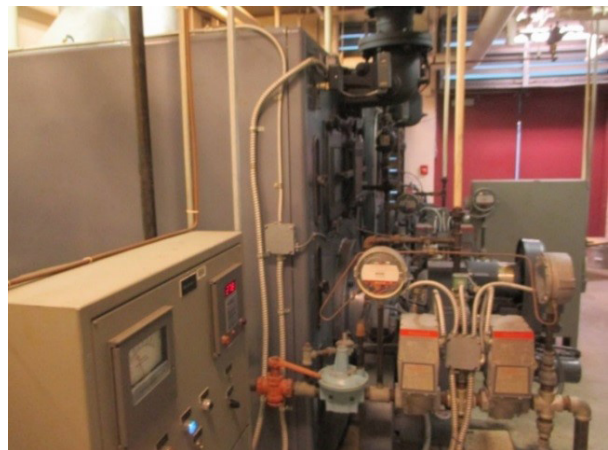
In 1990 a gym addition was constructed to better serve the student body attending the Hodgson High School. The gym addition included a stand-alone heating plant that is completely separate from the main school heating plant. The central hot water boilers can be seen in the **Mechanical Photograph #7**.

*Mechanical Photograph #7
Gym Hot Water Boilers*

The existing heating plant utilizes two (2) Weil McLain cast iron sectional boilers with a capacity of 2,300,000 btu/hr each. These boilers are approximately 26 years old and are in good condition. Therefore we have given these systems a HVAC Index Rating of #3. **Mechanical Figure #5** illustrates the major components and arrangement of the pumps, boilers, etc. in the gym heating plant.

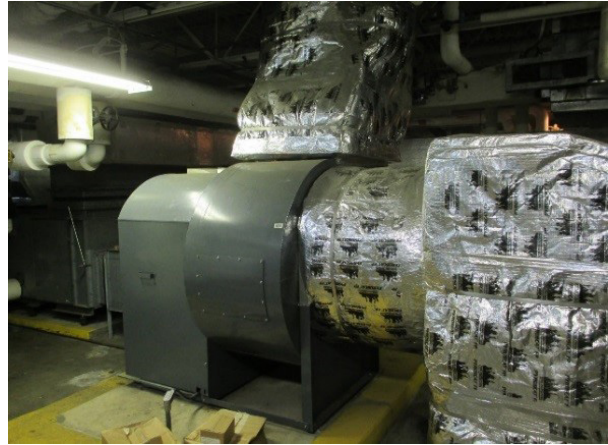
*Mechanical Photograph #8
Kitchen Hood Exhaust Fan*

The kitchen hood exhaust and make-up air fans are all constant speed fans which should be replaced with variable air volume fans to allow energy reductions during part load conditions.

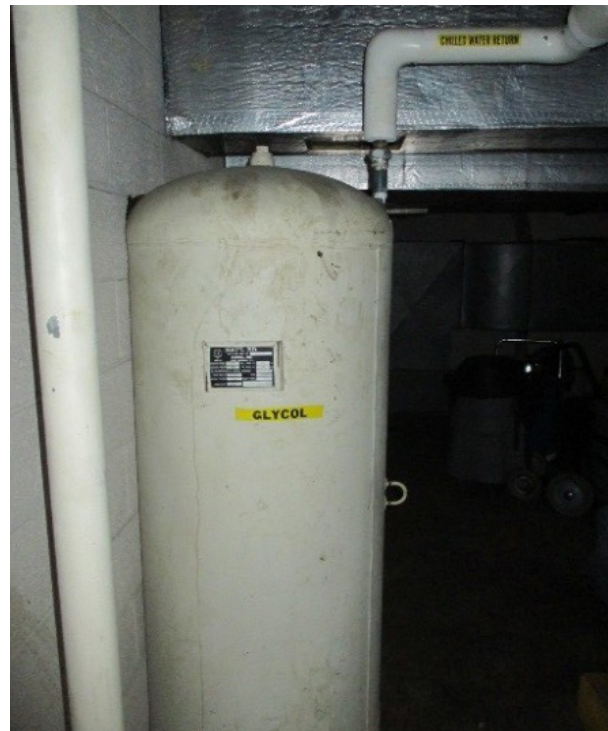
As indicated in Mechanical Photograph #8, the kitchen hood exhaust ductwork is wrapped with a U.L. Listed fire wrap. The kitchen make-up air is provided by a 100% outside air heating and ventilating unit. The kitchen make-up air unit is served by a heat exchanger that separates the central heating plant water from the antifreeze in the hot water fluid that serves the kitchen make-up air unit. The expansion tank for the kitchen make-up air unit glycol loop is shown in *Mechanical Photograph #9*.

*Mechanical Photograph #9
Kitchen Make-up Air Unit Glycol Expansion Tank*

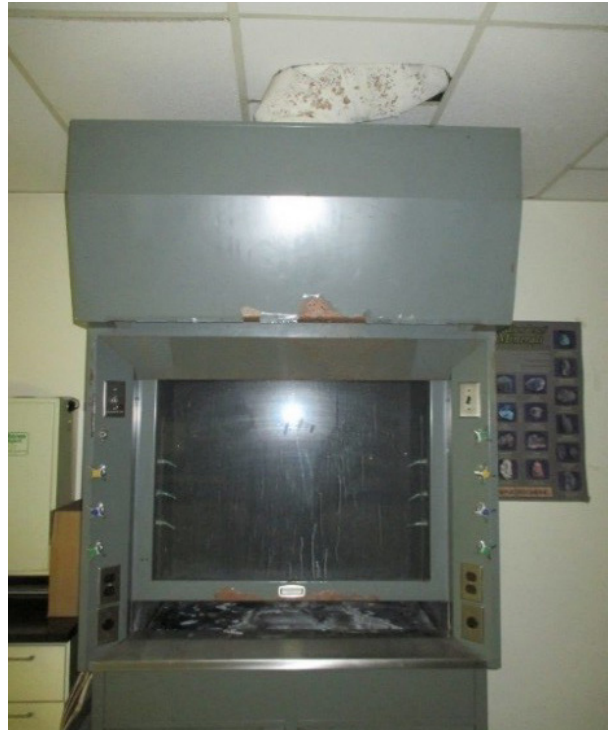
*Mechanical Photograph #10
Chemical Fume Hood*

In summary, the majority of the existing HVAC equipment is well beyond its expected useful life. The Equipment/ Systems are inefficient and not compliant with current codes. We would recommend that the HVAC systems/ equipment be replaced with systems/equipment that are appropriate for current educational facilities.

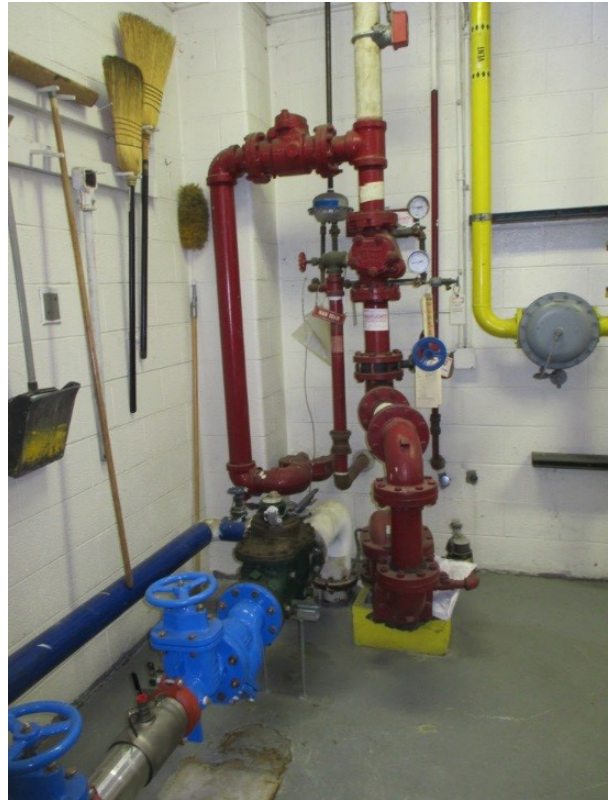
*Mechanical Photograph #11
Wet Pipe Riser in Main Mechanical Room*

A flow test will be required to determine if a fire pump is required for the facility. This will be further discussed in our recommendations section of the report. However, assuming the need for standpipes we would expect this building to require a fire pump and fire pump controller with automatic transfer switch. The use of a fire pump will allow all of the wet pipe risers to be consolidated and served by a single fire pump. This fire pump and associated controller, jockey pump, jockey pump controller, risers, and backflow preventer should be located in a dedicated, fire rated room.

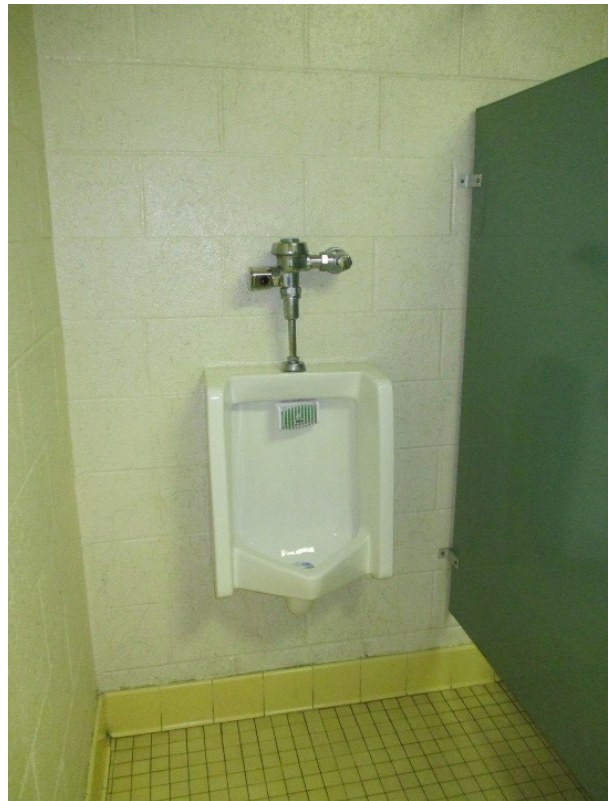
*Mechanical Photograph #12
Typical Urinal*

- ▶ Water Closets (Floor Mounted Flush Valves)
- ▶ Urinals (Wall Mounted Flush Valves) (Shown in **Mechanical Photograph #12**)
- ▶ Lavatories (Wall Mounted - Mechanical Faucets)
- ▶ Mop Sinks
- ▶ Lavatory Stations (Stainless Steel)
- ▶ Emergency Eyewashes (Lab Areas)

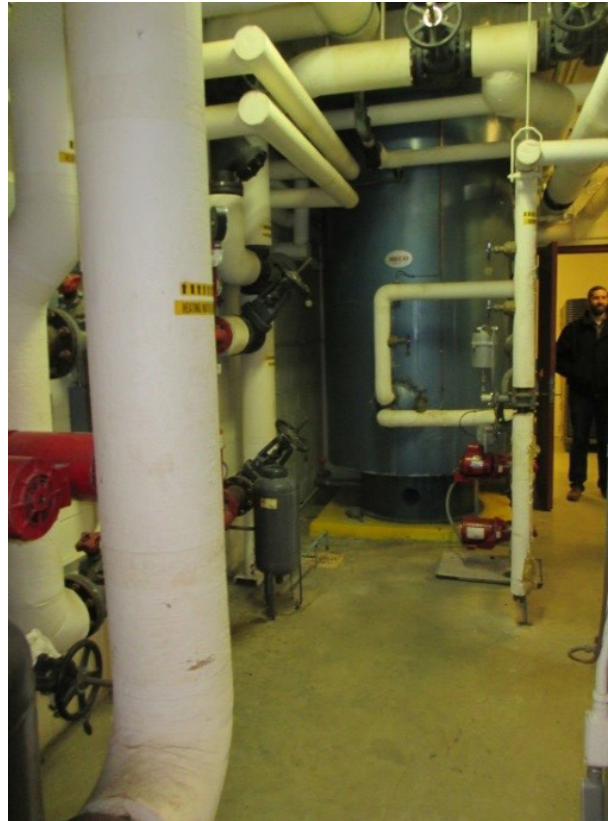
Hot water for both the main school and gymnasium were originally produced by the boilers. Large storage tanks with shell/tube heat exchangers were provided with hot water via the boilers and dedicated pumps as shown in the *Mechanical Photograph #13*.

The problem with this approach is the fact that the boilers must operate all year round to provide domestic hot water. The Owner addressed this limitation by adding gas fired water heaters that are piped into the recirculating pipes at each existing storage tank as shown in the *Mechanical Figure#8*.

*Mechanical Photograph #13
Domestic Water Storage Tank*

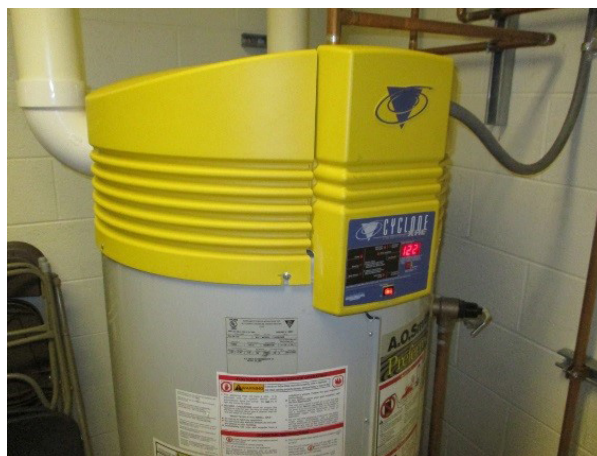
*Mechanical Photograph #14
Domestic Hot Water Heater*

The existing roof drains and roof drain piping also appear to be greater than 43 years old and should be replaced. It is also important to note that since the existing roofs are surrounded by parapets it is critical that scuppers are provided/maintained to serve as the overflow drainage system.

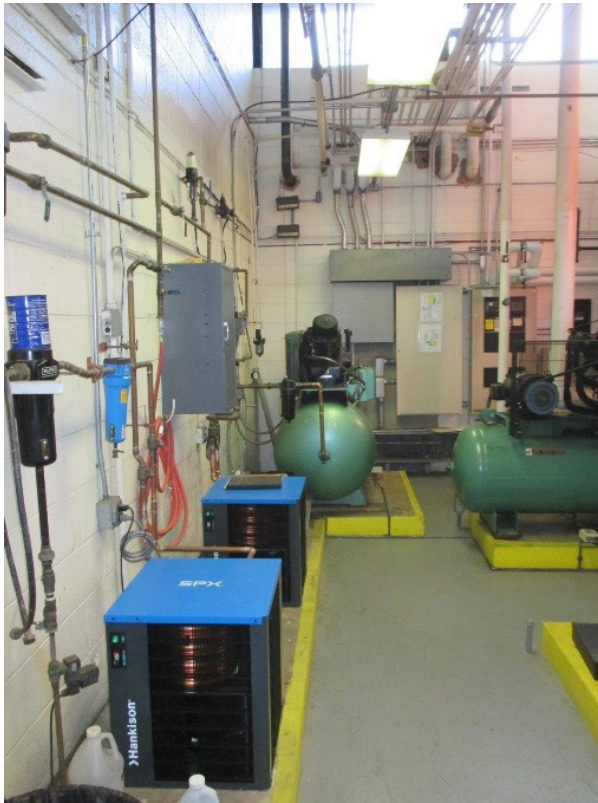
*Mechanical Photograph #15
Existing Air Compressors*

In addition to the domestic plumbing systems there are a few compressed air systems that serve the existing pneumatic ATC control system, lab, and maintenance tool outlets. The existing air compressors serving the pneumatic ATC control system and labs can be seen in **Mechanical Photograph #15**.

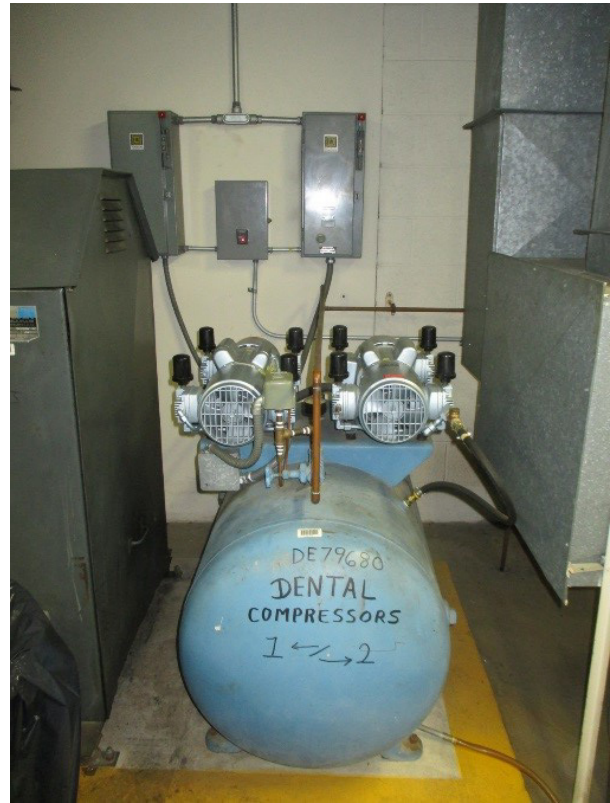
*Mechanical Photograph #16
Dental Equipment*

Furthermore, the school contains dental equipment as shown in **Mechanical Photograph #16**. The dental equipment is in good condition.

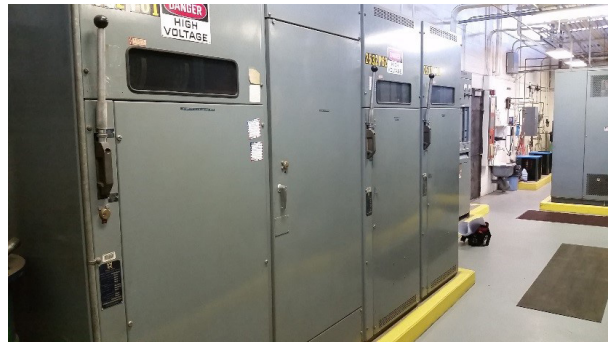
*Electrical Photograph #1
Incoming Primary Metering Compartment
and Primary Switches*

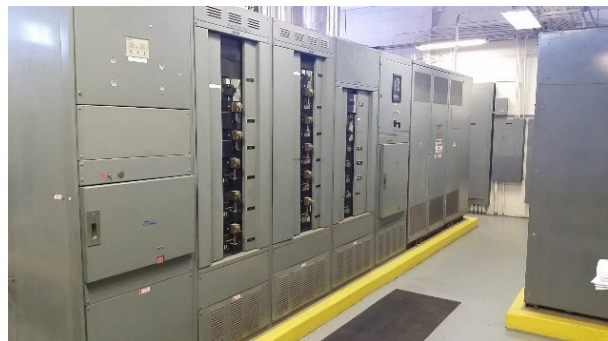
*Electrical Photograph #2
2000kVA Transformer and Switchboard*

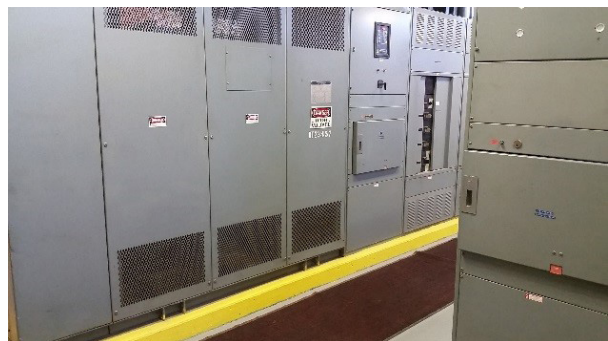
The second 600A switch fused at 125A feeds a three phase, 1500kVA, 12,470V to 480Y/277V transformer that serves a switchboard with a 2,000A main circuit breaker as shown in *Electrical Photograph #3*. The utility has installed an electricity meter on the exterior of the building on the outside wall of all the incoming electric service so that the meter can be read without entering the school.

*Electrical Photograph #3
1500kVA Transformer and Switchboard*

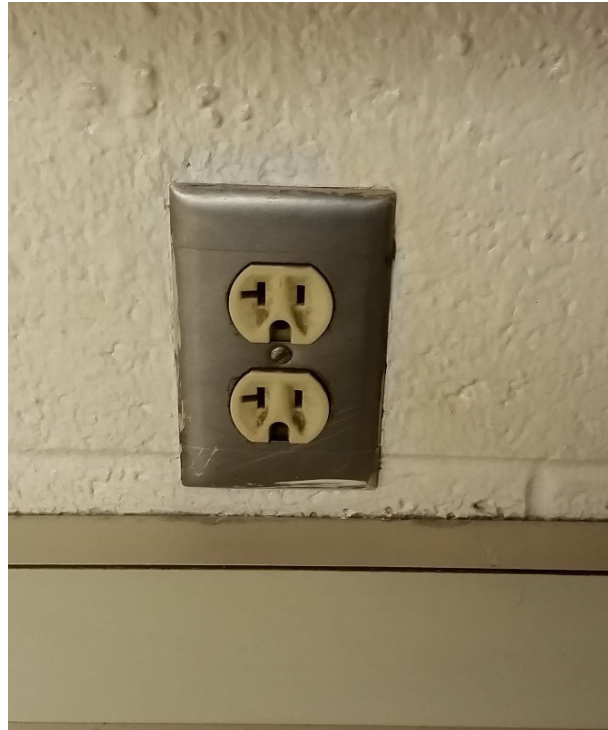
*Electrical Photograph #5
Typical Receptacle*

We have rated the general building power system as an Index Rating #5 due to the age/condition. The equipment, panelboards, conduit and wiring should be replaced.

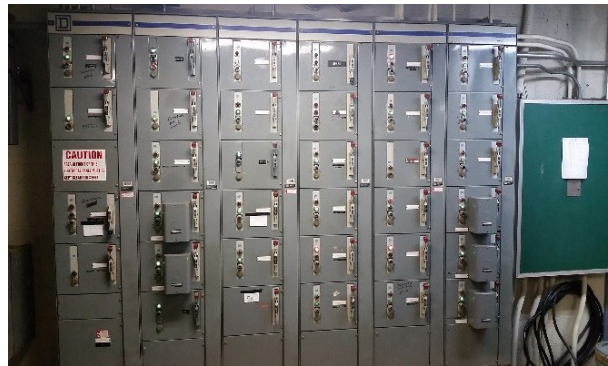
gency circuit breakers have Kirk Key interlocks so that the motor control centers can be manually switched to generator power when utility power is lost.

*Electrical Photograph #6
Typical Motor Control Center*

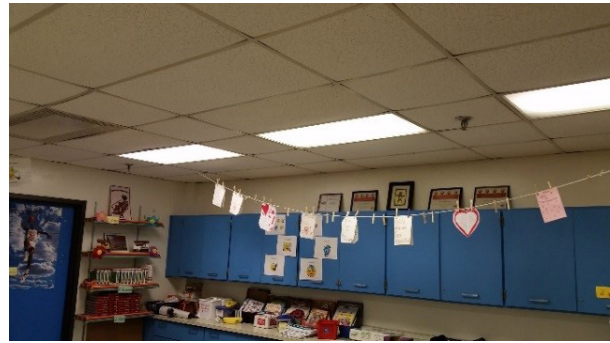
*Electrical Photograph #7
Typical 2'x4' Acrylic Lens Fluorescent Fixtures*

The mechanical mezzanines do not have lay-in ceiling grids and have 1'x4' fluorescent strip lights suspended from the ceiling/structure above. The boiler room has 1'x4' fluorescent suspended fixtures with acrylic lenses. The typical lighting fixtures utilize 34 watt T12 linear fluorescent lamps as shown in *Electrical Photograph #9*, which Federal energy legislation such as The Energy Policy Act (EPACT) mandated be phased out of manufacturing starting in July 2012. This is due to the fact that T12 lamps have a lower efficacy and efficiency compared to modern counterparts, i.e. T8/T5 fluorescent lamps and LED technologies. Efficacy is the measure of how well a light source produces visible light, also commonly referred to as "lumens per watt", whereas efficiency is the ratio based on total energy (wattage) consumed versus useful energy out as light. The following Electrical Table compares the efficacy and efficiency of T12 lamps to other common light sources.
