Questions and Answers Bid 2204 – Architects – New Hodgson High School

Replacement for **HODGSON VOCATIONAL TECHNICAL HIGH SCHOOL**

Certificate of Necessity

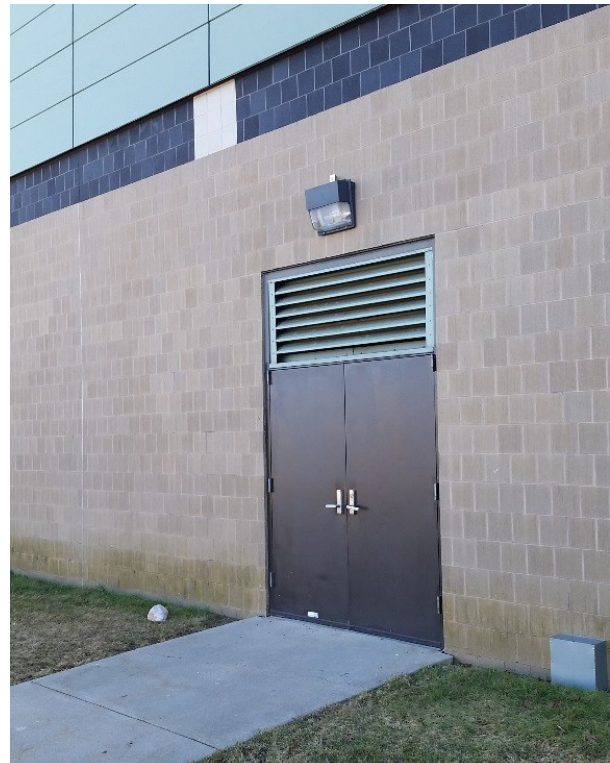
The exterior lighting fixtures on the original portion of the school are wall mounted metal halide flood lights. These fixtures are not full cut-off as shown in *Electrical Photograph #10* and do not have provisions to reduce light trespass. The gymnasium, which was built in 1990, also has metal halide wall packs without full cut off and an external photocell mounted on selected fixtures as shown in *Electrical Photograph #11* to control when lights are on or off.

*Electrical Photograph #11
Exterior light with photocell at 1990 Gym Addition*

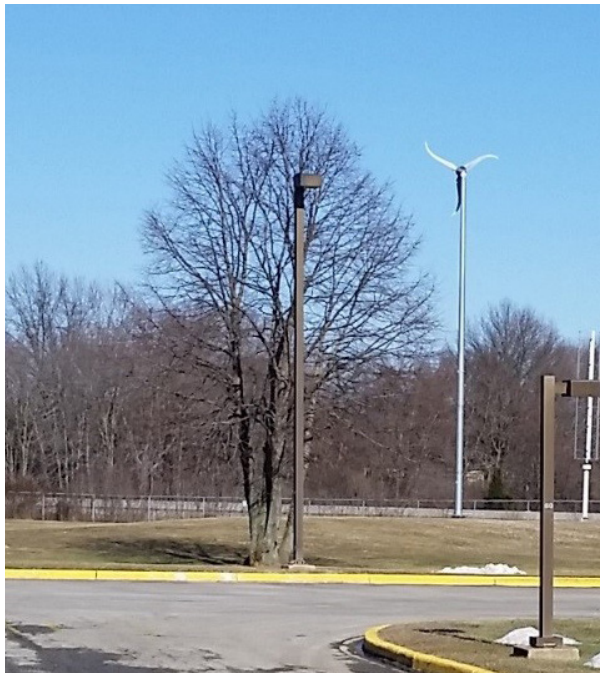
Electrical Photograph #12
Exterior Lighting Fixtures - Parking Lot

The exterior lighting has been given a #5 Index Rating, due to the age/condition of the exterior lighting, the inefficient light source, and should be replaced.

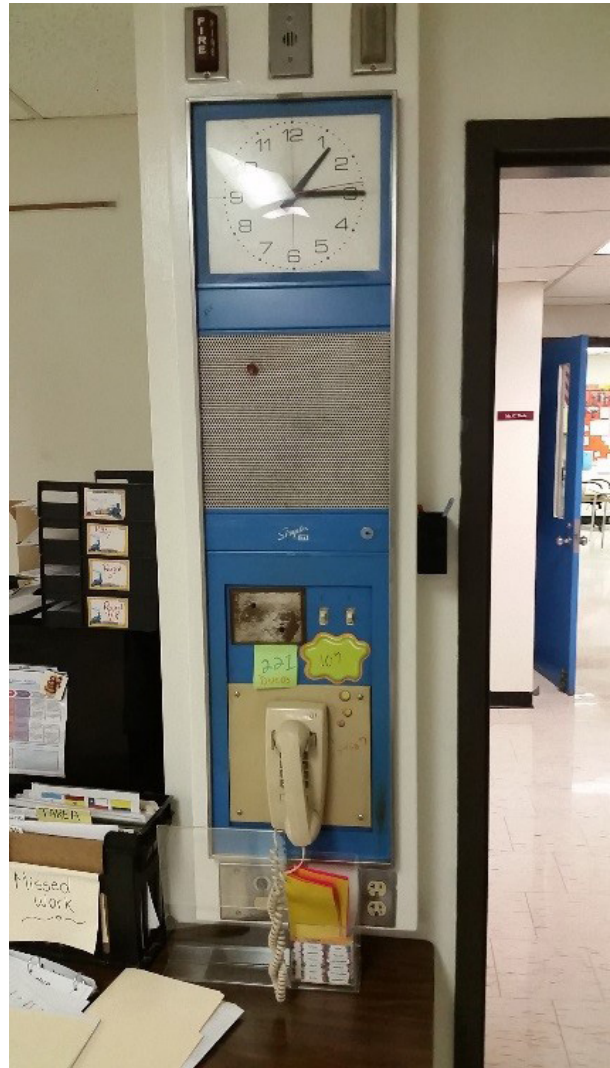
*Electrical Photograph #14
Classroom Utility Panel*

We rated Lighting Controls as an Index #5 due to the lack of code required lighting controls. The lighting controls should be replaced with code compliant devices.

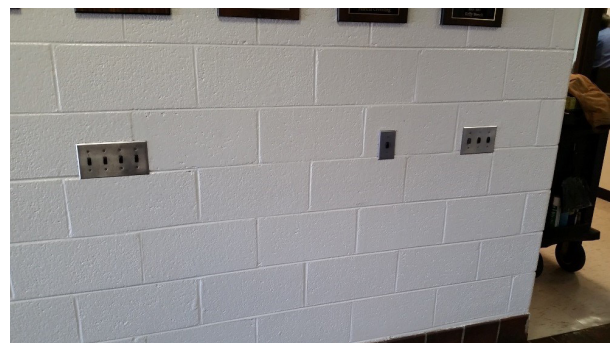
The Hodgson Vo-Tech School does not appear to have any occupancy sensors or programmable lighting control panels in the building. The classroom lights are currently controlled by toggle switches located on the wall as part of the classroom utility panel as shown in *Electrical Photograph #14*. The corridor lighting is currently controlled by keyed switches on the wall as shown in *Electrical Photograph #15*. ASHRAE 90.1 requires that all interior lighting shall be controlled by an automatic means of turning off the lights after a certain period of space vacancy and/or between nighttime hours. Automatic shut-off reduces energy consumption, resulting in a lower electricity bill, and can also extend the life of lamps and ballasts and reduce maintenance costs. Relying solely on the occupant to cut the lights off manually can allow for the lights to be left on accidentally and therefore result in a waste of energy if no one is in the space. The lighting throughout the rest of the school, including storage, shops, library, restrooms, and mezzanines are controlled by toggle switches on the wall. ASHRAE 90.1 requires that the interior lighting in each space be controlled so as to provide at least one intermediate step in lighting power in addition to full “on” and full “off”.

*Electrical Photograph #15
Existing Keyed Lighting Switches*

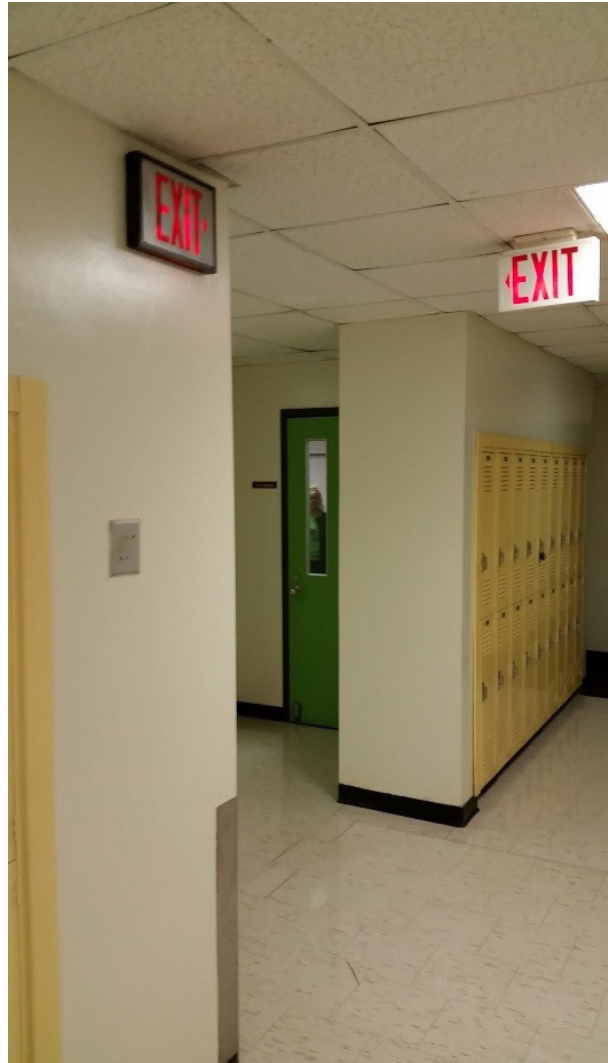
*Electrical Photograph #16
Mis-Matched Exit Signs*

The Life Safety Systems are a #5 Index Rating due to the age, condition and the fact that the current egress lighting does not meet the NFPA 101 Life Safety Code for the egress lighting and exit signs.

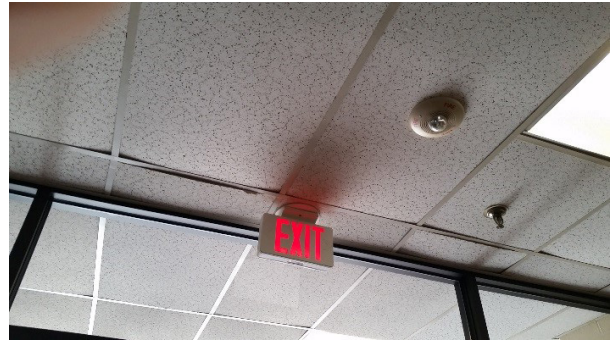
The hallways through most of the school have been upgraded to addressable devices mounted in the ceiling tiles but in each classroom there are classroom utility panels which contain non-addressable devices as shown in *Electrical Photographs #18 and #19*.

*Electrical Photograph #18
Upgraded Addressable Devices*

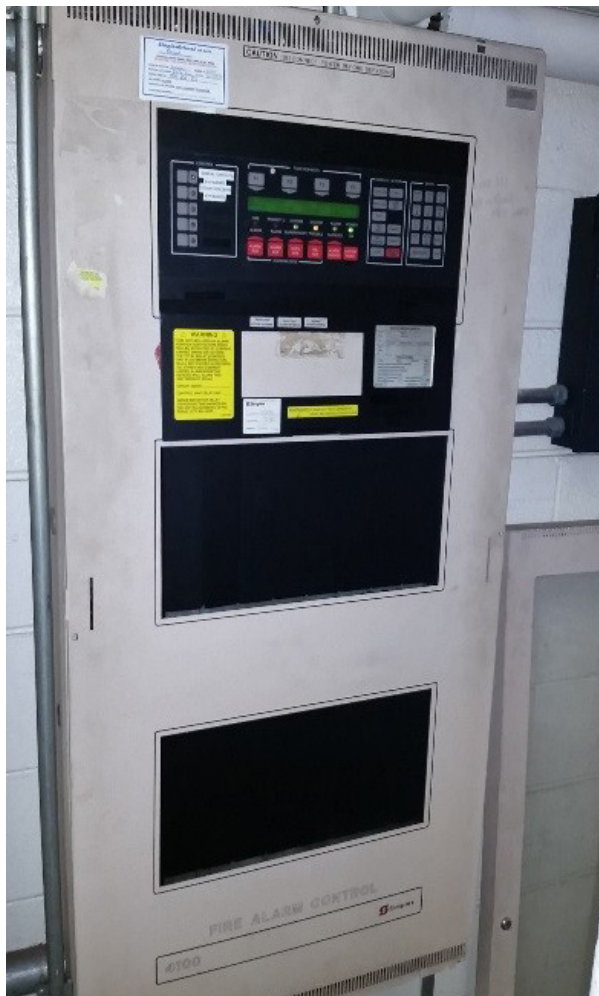
The fire alarm control panel presently serving the school is a Simplex Grinnell model 4100 fire alarm control panel located in the boiler room as shown in *Electrical Photograph #17*. The existing fire notification devices are a combination of addressable and non-addressable.

*Electrical Photograph #17
Simplex Grinnell Fire Alarm Control Panel*

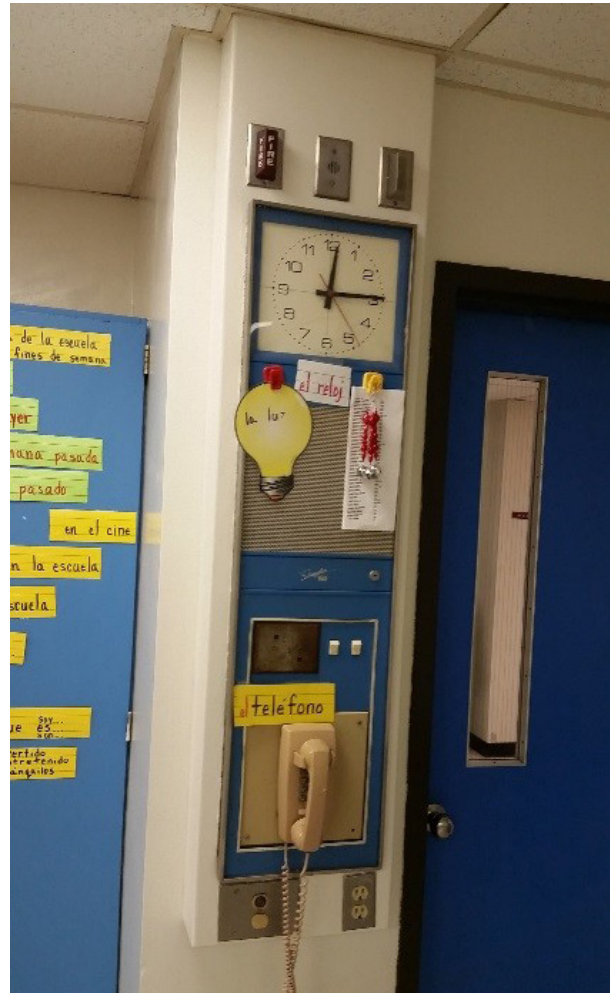
*Electrical Photograph #19
Classroom Utility Panel with
Non-Addressable Devices*

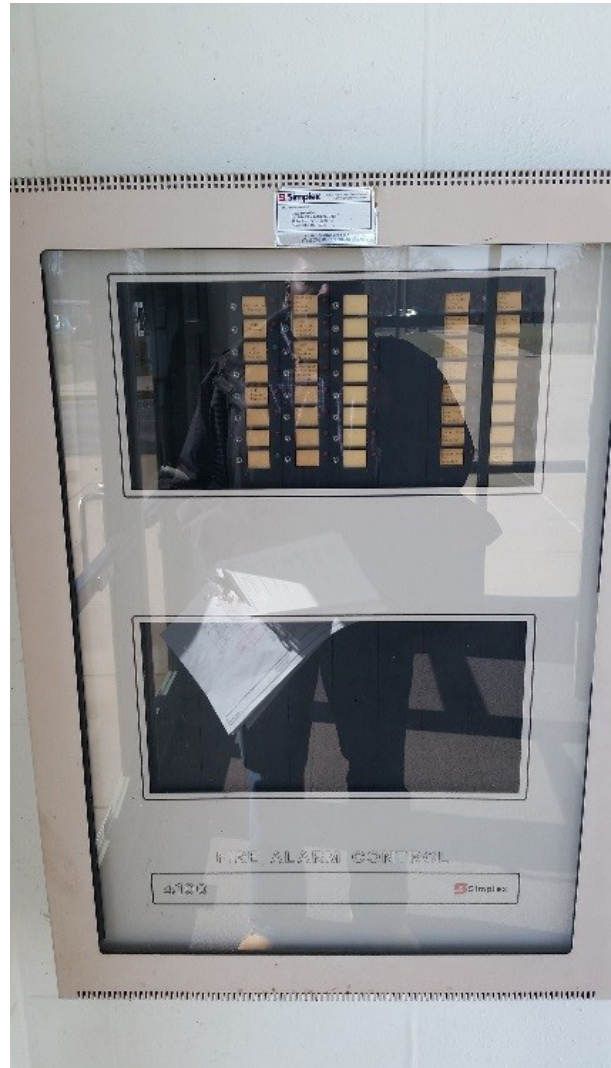
*Electrical Photograph #20
Simplex Grinnell Model 4100 Fire Alarm
Control Panel with Voice Evacuation*

The Fire Alarm System has been rated as a #4 Index Rating. Some of the notification devices have been upgraded recently and may be able to be reused but the overall system should be replaced.

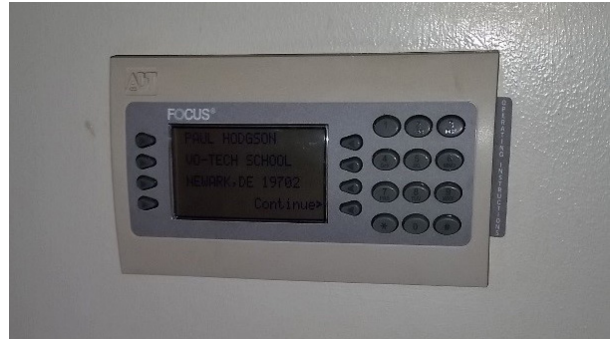
The school has an existing ADT security system with the main alarm control panel and associated power supplies located in the lounge off of the main office as shown in *Electrical Photographs #21 and #22*. Based on our survey it appears that the school doesn't have any exterior keypads, intercom stations or other access control means. The exterior doors are just locked and unlocked via keys.

*Electrical Photograph #21
ADT Security System Control Panel*

The Security System has been rated as an Index #4 Rating due to the lack of access control and video surveillance inside and outside the building. Our recommendation for the security system would be to replace the system with a new system with full building coverage. The existing video cameras that are in good condition could potentially be reused.

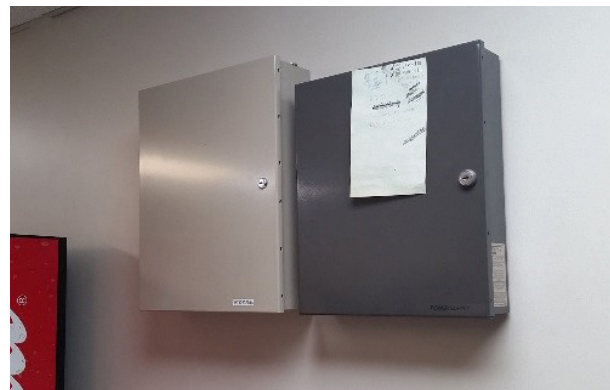
*Electrical Photograph #22
ADT Security System Power Supply Panels*

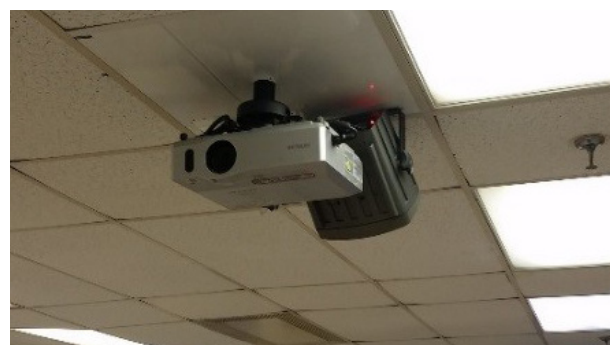
The majority of the data devices were added over the years using surface mounted raceway as shown in *Electrical Photograph #24*. The classrooms utilize overhead projectors, whiteboards, and a speaker to present information to the students in the classroom as shown in *Electrical Photograph #25*. There are limited wireless access points located throughout the school to provide internet access to laptops and tablets. There is an existing 700-800 MHZ system that the state of Delaware provided so that first responders can communicate within the building is located on the second floor mezzanine and shall be retained for reinstallation after renovation. The head end equipment for the paging/intercom and clock systems are located in the lounge located inside of the main office.

*Electrical Photograph #25
Overhead Projector and Speaker*

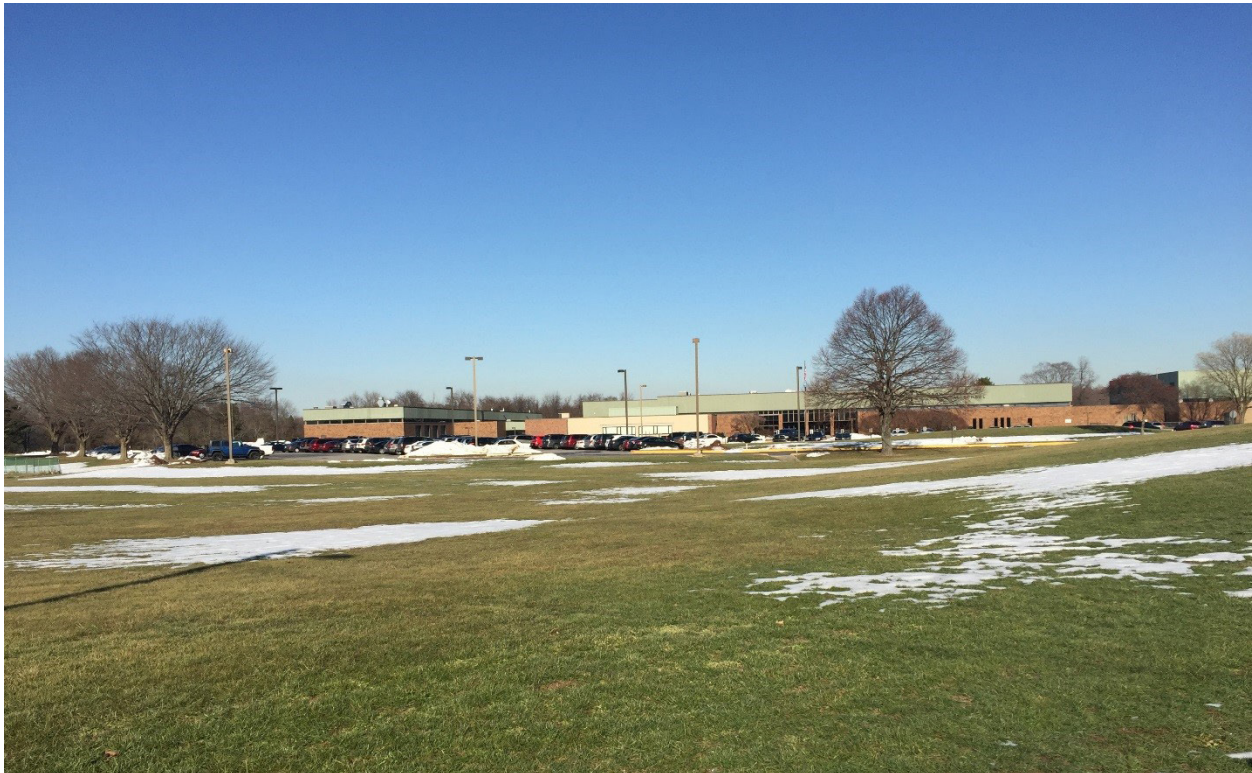
There are several factors that go into place when deciding whether or not a school site is adequate for the surrounding community. Elements such as size, shape, topography, safety, and access are just a few of the guidelines that need to be analyzed. With that in mind, one major factor includes the total size of the high school property to make sure that there is a sufficient amount of space to operate effectively. The Department of Education (DOE) requires 30 acres for a base high school plus one acre per 100 students at final school capacity. Hodgson currently enrolls roughly 1,200 students and so the required size for this school should be approximately 42 acres in size. At 64.16 acres, the existing site is large enough to handle this amount of students, as well as the staff and faculty. (see Figure 2.1)

*Figure 2.1
Existing school looking northeast
from athletic fields*

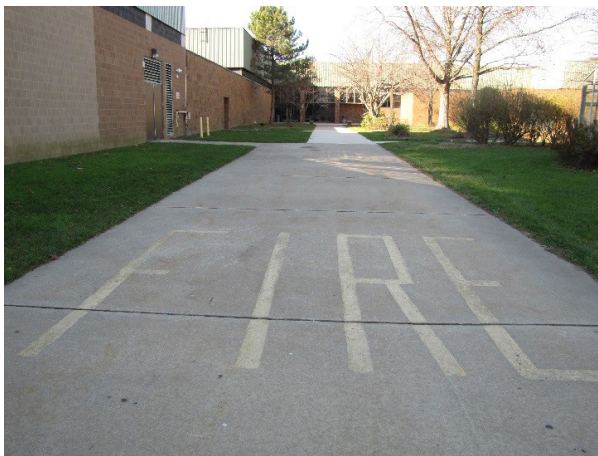
Figure 2.2
Exterior Bus Access

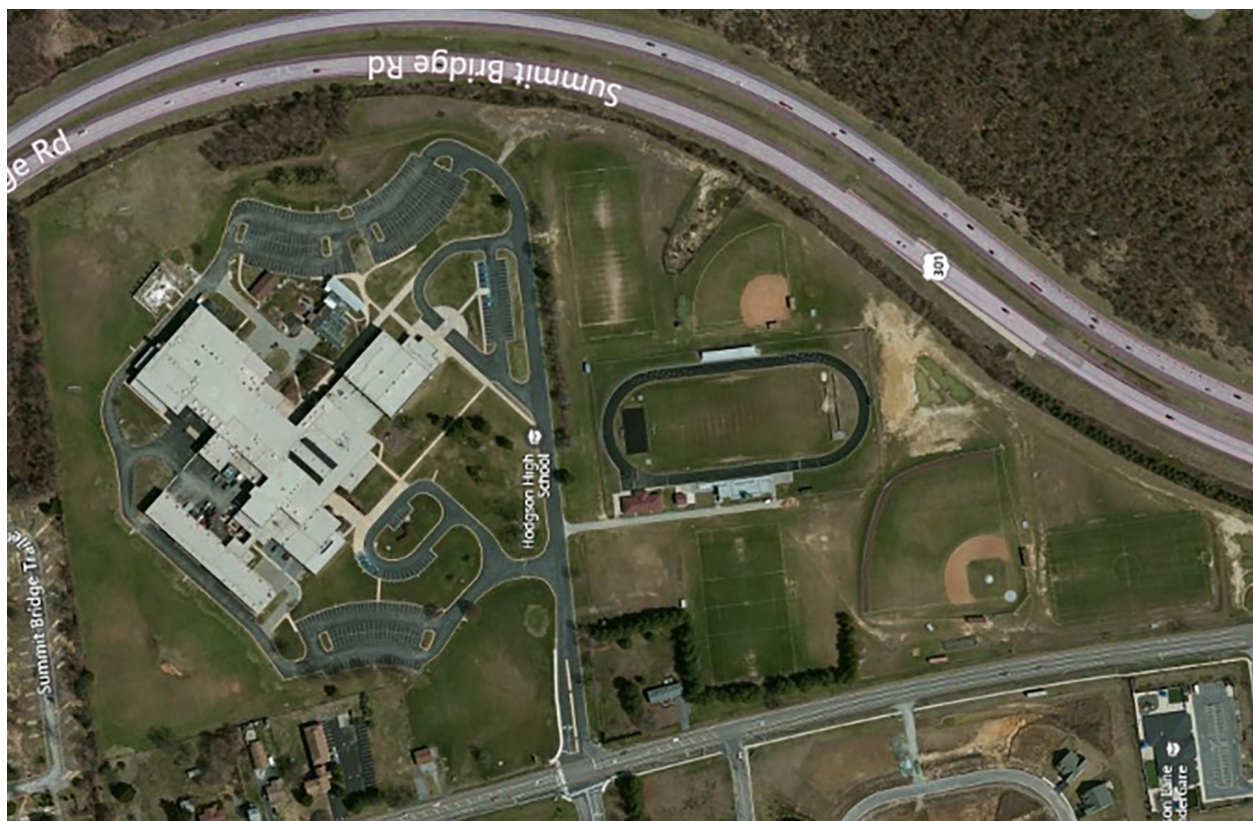
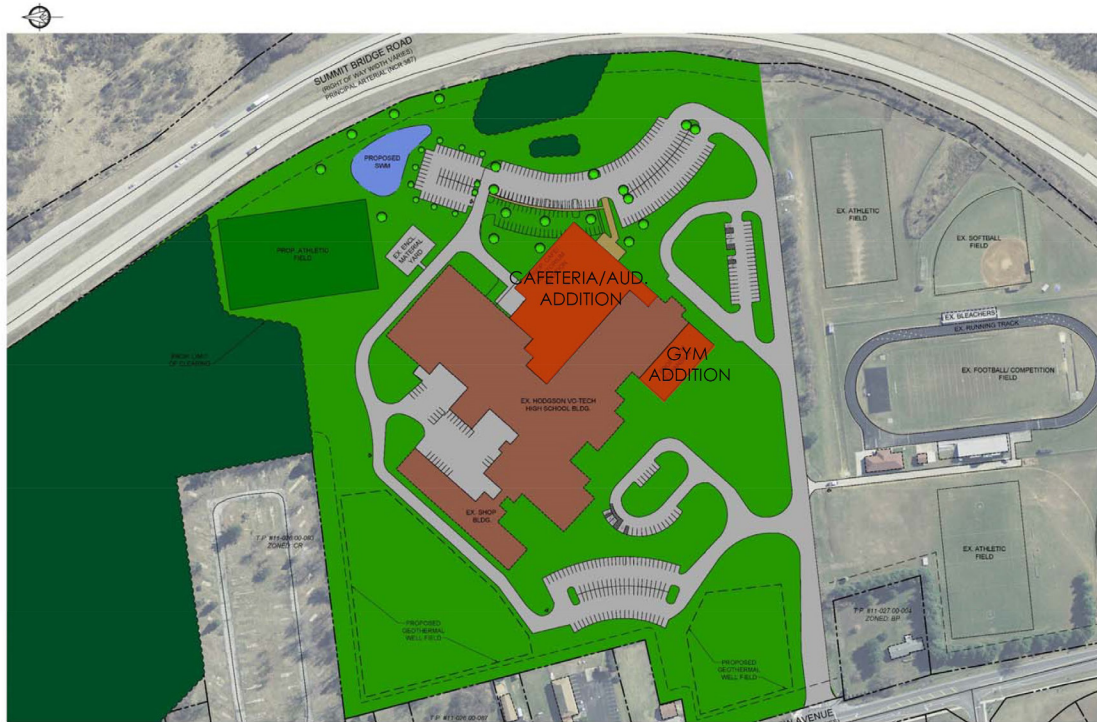
Figure 3.1
Existing Site Plan

Due to extremely limited interior and site related 'swing' space, and the configuration of the facility's circulation and egress patterns, it is anticipated that with the consideration for the renovation and addition to existing facility, the construction process will require multiple year, occupied phasing over a duration of four years. Currently, the anticipated construction will occur over a 12 month period for four years including summers and is factored into the cost estimate documentation. A majority of the work is intrusive to the basic function of the school and will mandate summer or other off-session time period for work to be executed in an efficient and safe manner. Multiple student classroom trailers would be required as a result of the sequencing of renovation required, especially to existing classrooms. The space for the trailers on site is limited and not adjacent to appropriate interior functions or circulation. (Refer to figure 3.1, 3.2 and 3.3)

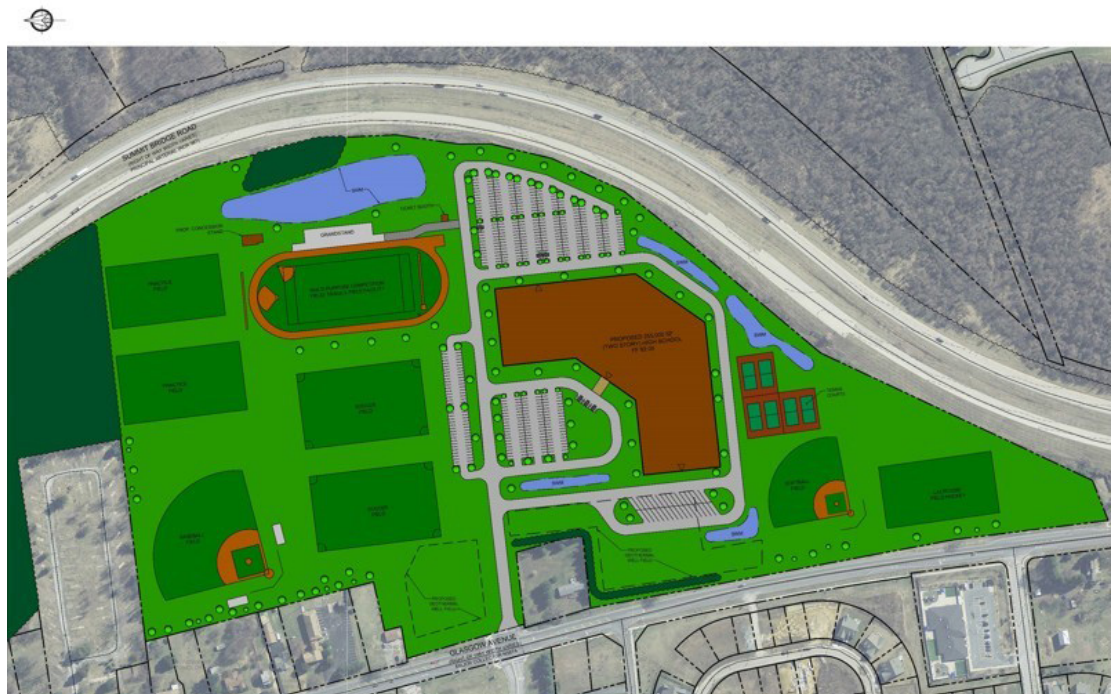
Figure 3.5
Proposed Site Plan - New Facility

As a result with increased capacity, it is recommended that the District construct a replacement school with increased capacity. The proposed new school would be on site and in the location of current athletic fields, thereby displacing athletics fields offsite for a three-year duration. This would allow students and staff to remain in the existing school throughout the two year building construction duration with minimal disruption to school functions. The additional one-year athletic field construction on site would then occur after the new facility is occupied. Overall, this eliminates the need for costly trailers for classroom space, multiple occupied phasing, increased costs and an overall shorter duration of construction. See the following proposed phasing plans for intent of execution.

- ▶ Existing school remains functional
- ▶ Athletic field use moves off site to other vocational technical schools for two-year construction duration
- ▶ Construct new 275,000 comprehensive vocational technical high school on site in location of existing athletic fields. (See Figure 3.2 & 3.3)
- ▶ At completion of the new building, transition students into new facility
- ▶ Demolish existing facility
- ▶ Construct new athletic fields and fieldhouse in place of demolished facility.

The proposed development for the Hodgson Vocational Technical High School Replacement school, includes the demolition of the existing school, parking lots, stadium and athletic fields and replacement with a new updated, school and fields with a new site layout. A new two-story 275,000 +/- GSF building will be located on the south side of the existing entrance road, at the location of the current competition athletic stadium. A new bus loop will be located on the west side of the building, where there will be 32 bus spaces available. In addition, there will be new access roads around the site with 475 paved parking spaces and over 200 overflow lawn spaces. It is anticipated that the existing main ingress/egress driveway on-site can remain intact, with surface paving upon completion of the new school (see Figure 2.4). The existing signalized entrance location will also remain in place (see Figure 2.5), although minor upgrades for ADA compliance will be required. Student parking will be provided to the east of the new school. Staff parking will be provided north of the main building entrance. Additional event and athletic park-

will be incorporated into the site design, as well as a large SWM facility east of the multi-purpose stadium. This latter SWM location east of the stadium is designed at a low spot, so converting it to a SWM facility is an effective use of the land. Two geo-thermal well fields are also proposed on both sides of the site entrance and will be designed to convert groundwater into usable heat for the new building. The proposed site layout utilizes all 64 acres of property in a much more practical way that will aid both the Hodgson HS students and faculty.

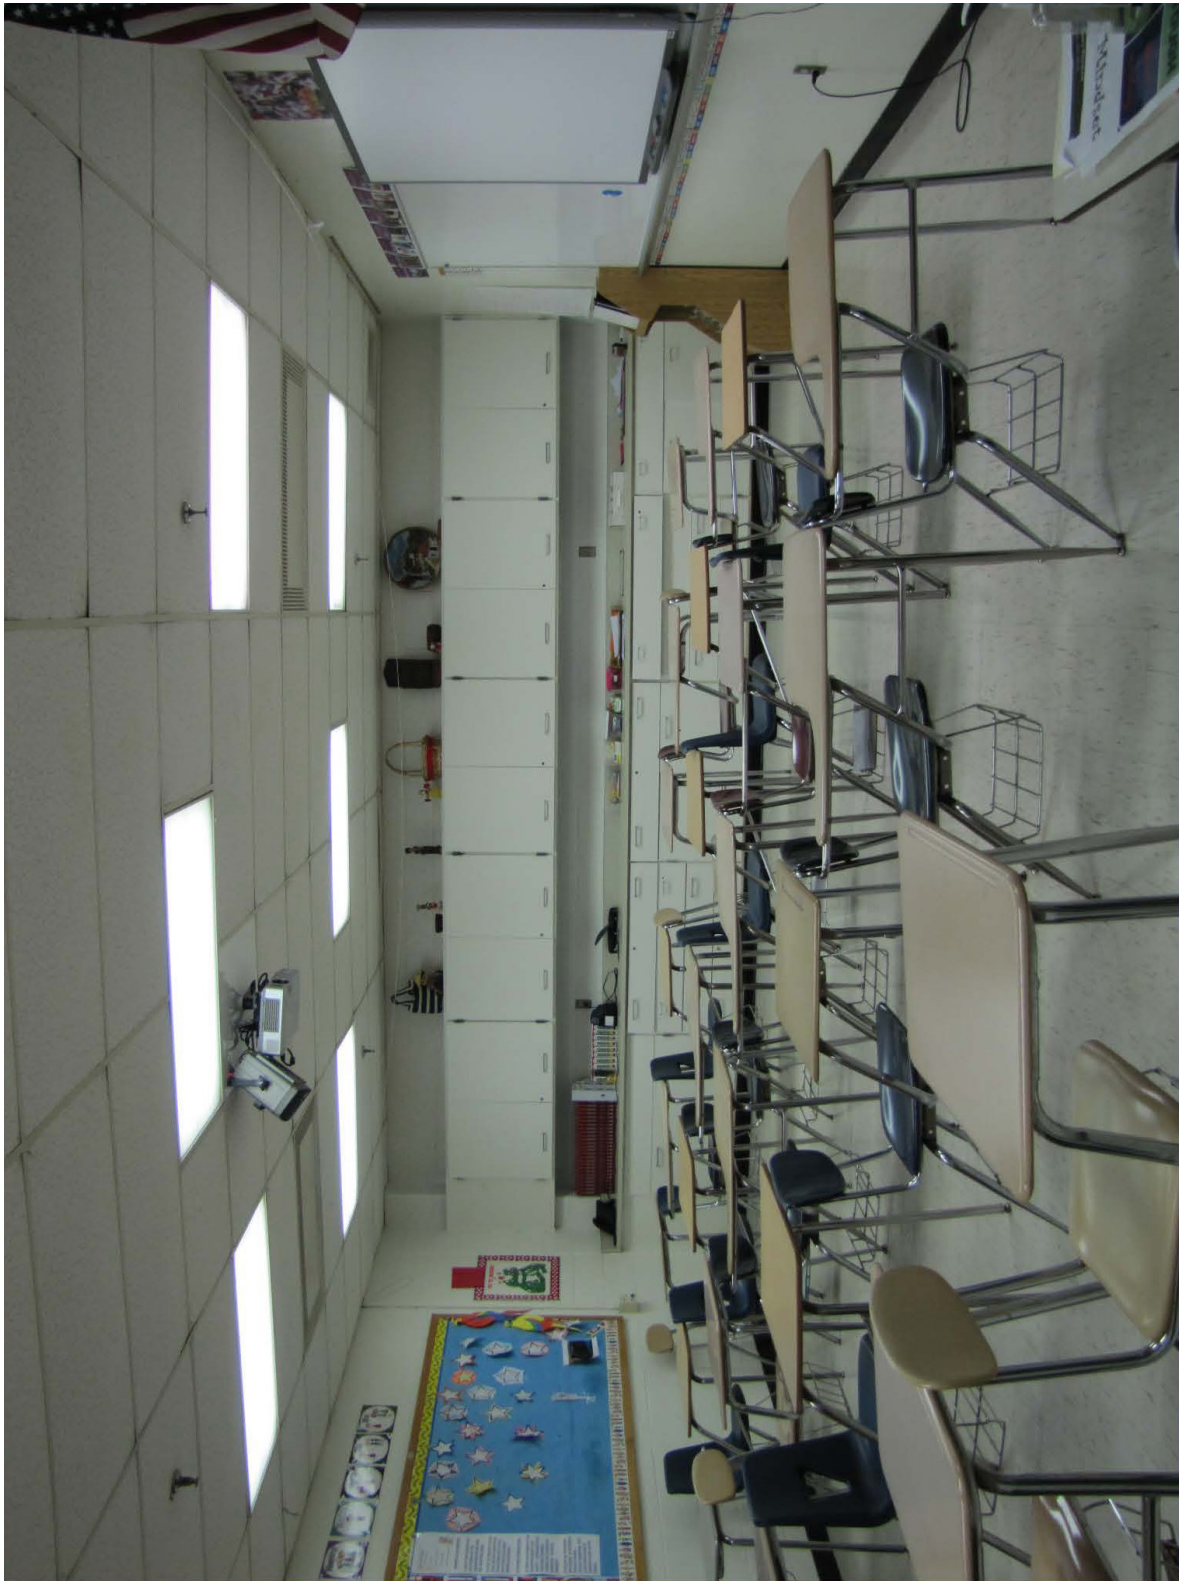
Figure 1.5
Classroom crowding: Extreme overcrowding: classrooms are not the correct size to meet state requirements. Lack of natural daylight in more than 70% of classroom spaces.

Figure 1.5
Classroom Crowding

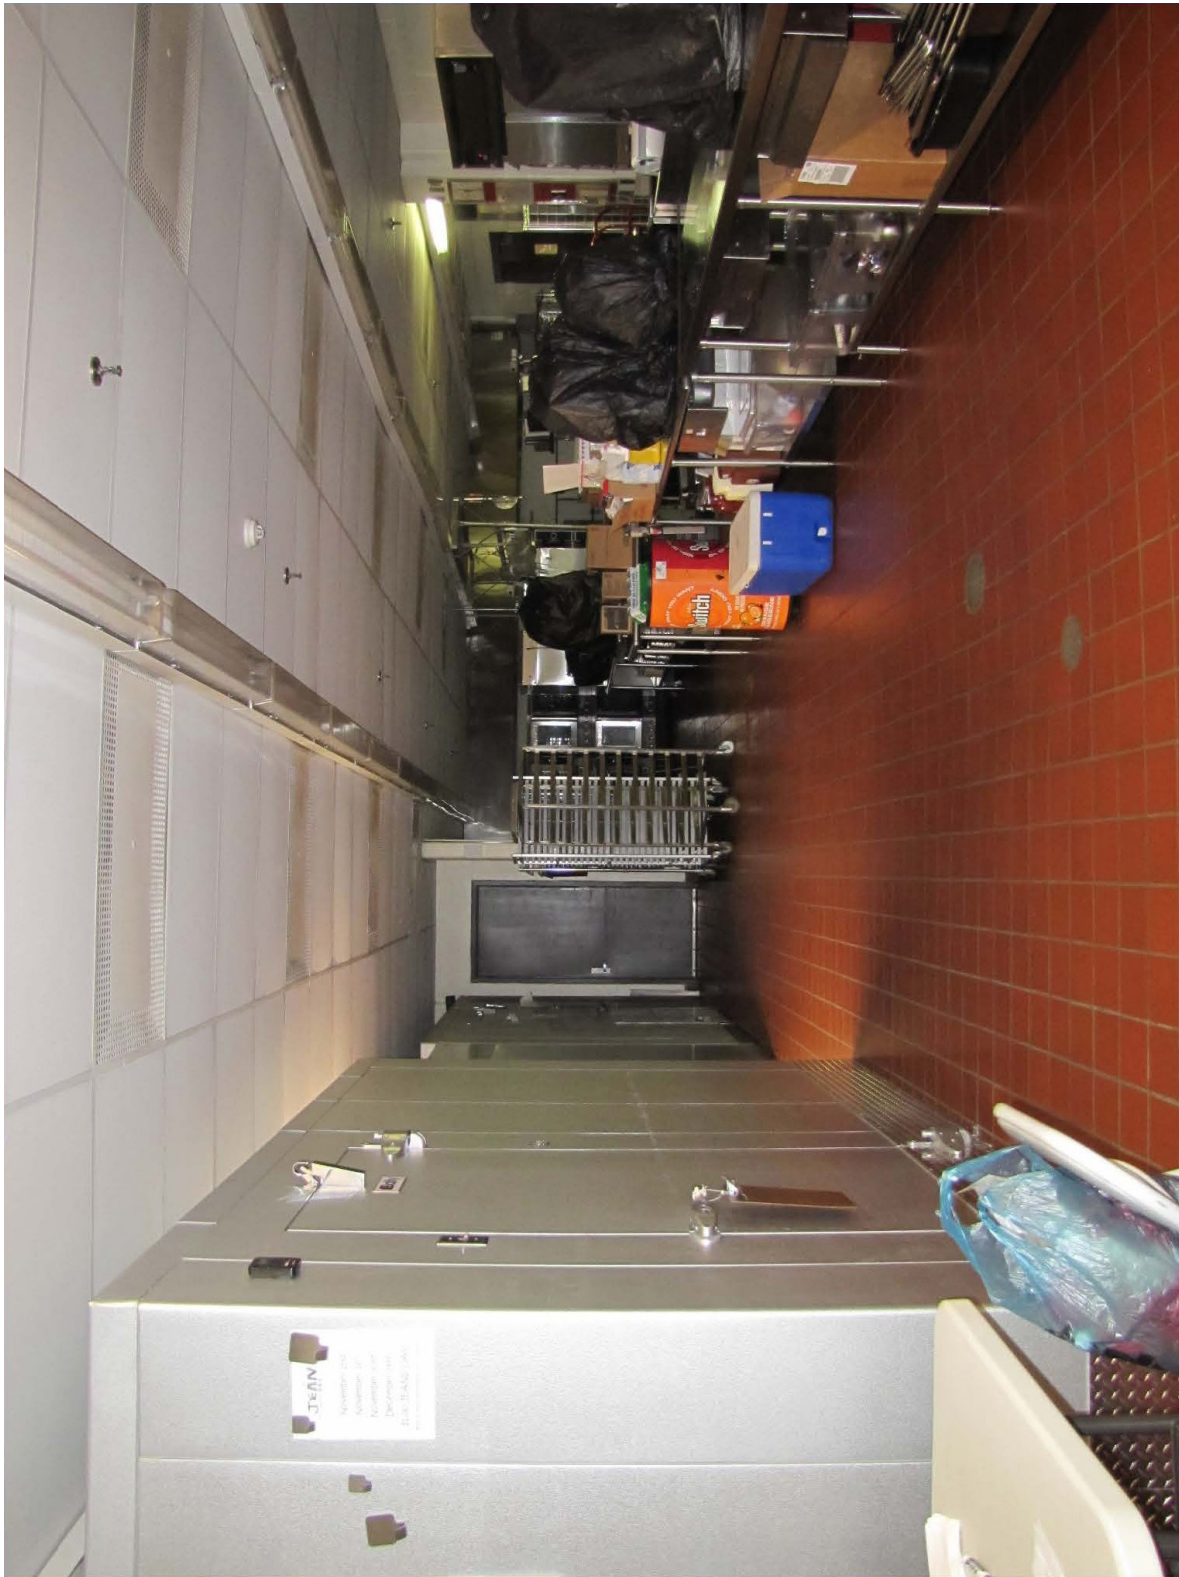
Figure 1.6
Lack Of Instructional Space For Culinary
